FEBRUARY 20, 2023

Global Rapid Post-Disaster Damage Estimation (GRADE) Report

February 6, 2023 Kahramanmaraş Earthquakes

Türkiye Report

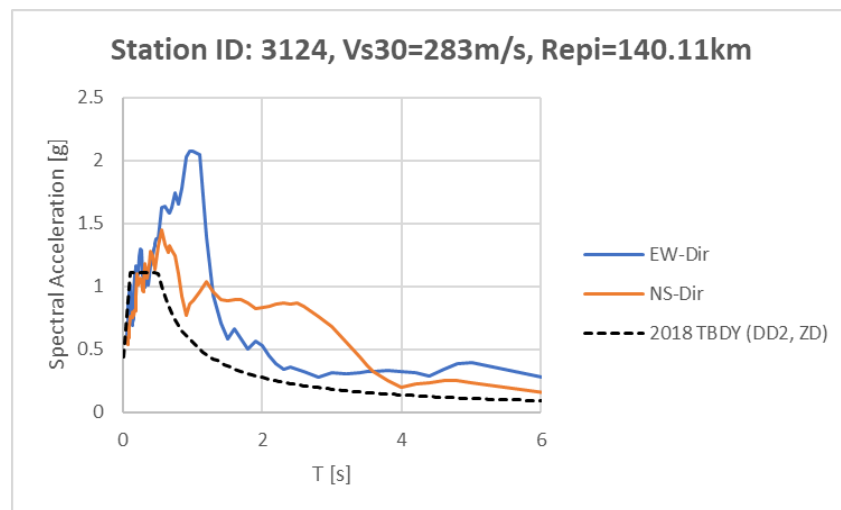
- **At some locations in the affected area, such as Antakya, recorded ground motions associated with the earthquakes were very high.** These high levels of ground motion may have contributed, alongside other critical factors, to the extensive damage observed in the affected areas (Annex A1.7 provides further information). Liquefaction¹⁵ was also observed in some areas.

Figure 7: Plots comparing the EW and NS components of spectral acceleration at a station in Antakya to the horizontal elastic response spectrum according to the seismic design code in Türkiye (2019). Recording relates to the magnitude 7.7 earthquake occurring on 06/02/23 at 01:17 UTC. More recordings are provided for multiple locations in Annex 0.

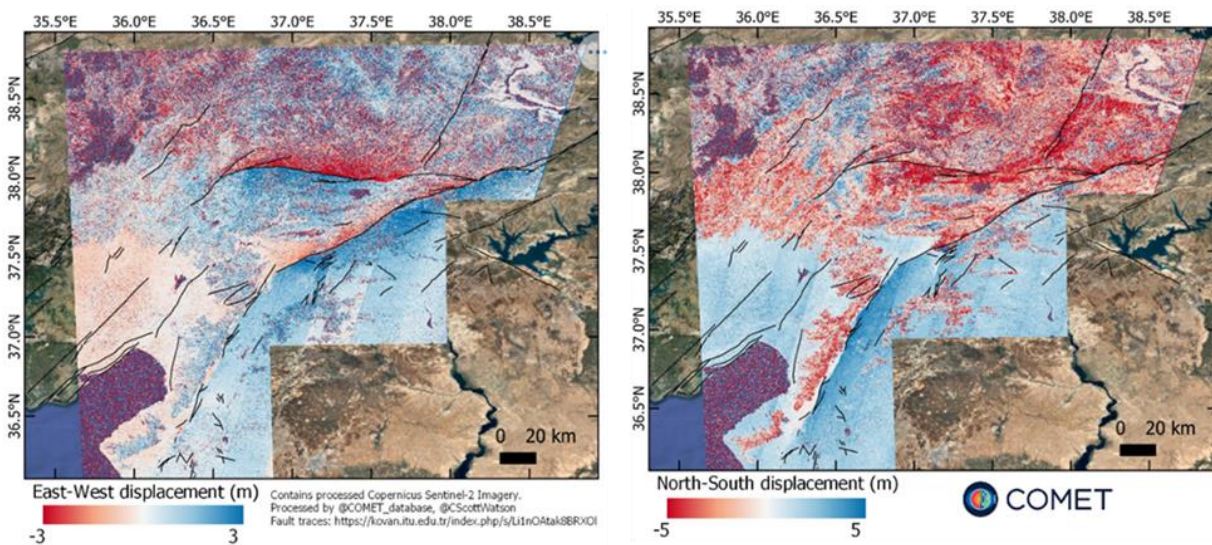
Figure 9: Surface displacement in (1) east-west and (2) north-south direction derived from pixel tracking using Sentinel-2 pre- and post-event imagery. Source: Watson (2023).

Maps that were produced using pixel offset or tracking are useful to measure surface slip, localize earthquake surface ruptures and to estimate the distribution of damages to better understand earthquake disasters. In Figure 9, two large surface displacements can be observed. The longer surface displacement rupture along the East Anatolian Fault in northeastern direction from the tip of the Mediterranean Sea was caused by the first of the two major earthquakes. It is about 300 km long. The second smaller surface displacement rupture is about 125 km long and was created by the second earthquake that occurred about nine hours later. According to Prof. Tim Wright, COMET team lead, the length of these two cracks indicates the large amount of energy that was released during the twin earthquake events; stronger earthquakes form larger and longer faults. The analysis of the COMET researchers shows horizontal displacements of up to 5 m (Pultarova, 2023).

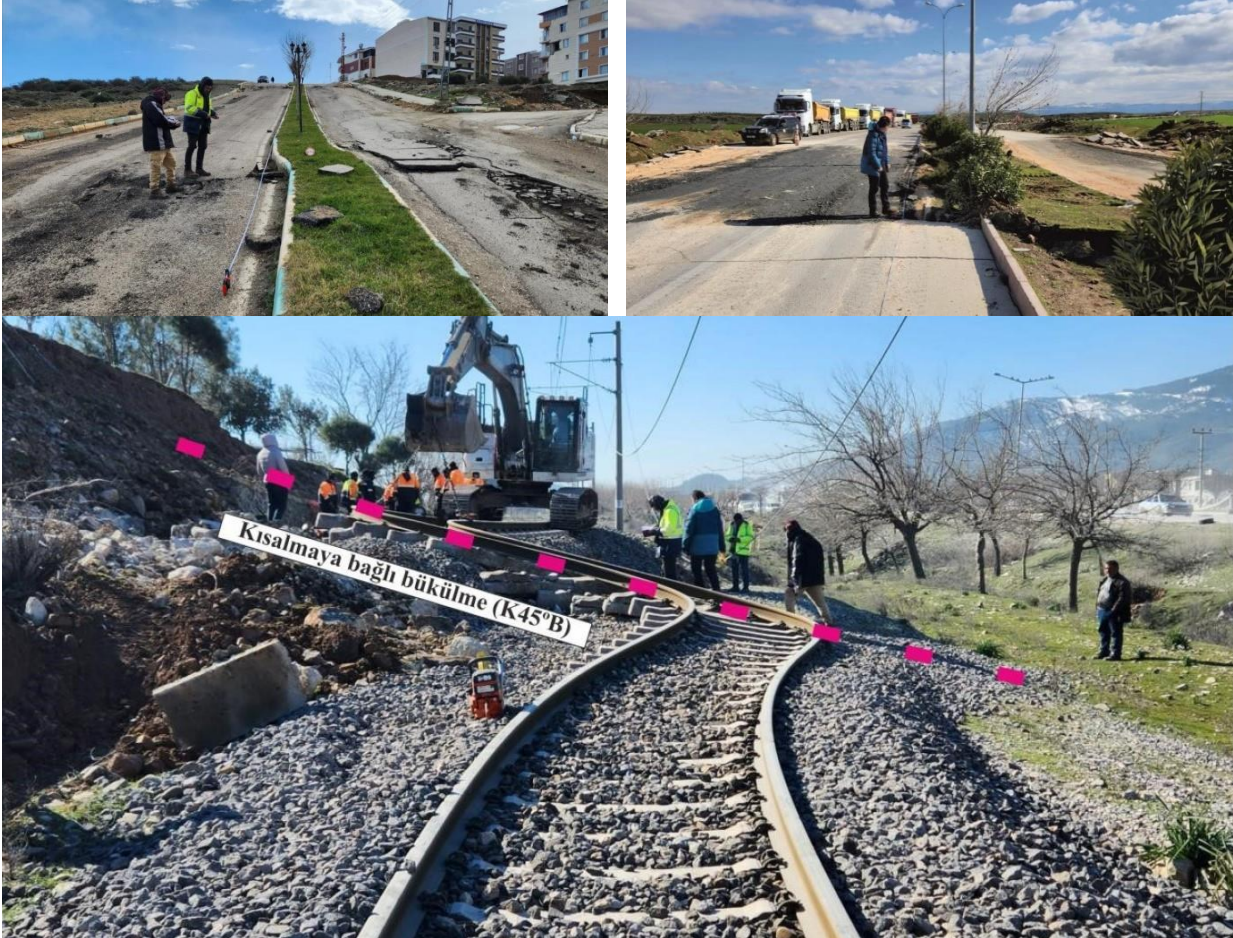
Figure 10: Examples of visible surface ruptures along roads and railways captured during field investigations in southeastern Türkiye. Source: MTA (2023).

According to the examinations and findings of the MTA team, several displacements and fault ruptures expanding up to 4.5 m were visible on roads, railways, fields and in stone walls.
