**A.A.W.S.A Water Supply and Sanitation Development and Rehabilitation
Project Office**

Final Report

**Environmental Audit of the Boreholes in an around the City
of Addis Ababa**

November 2009

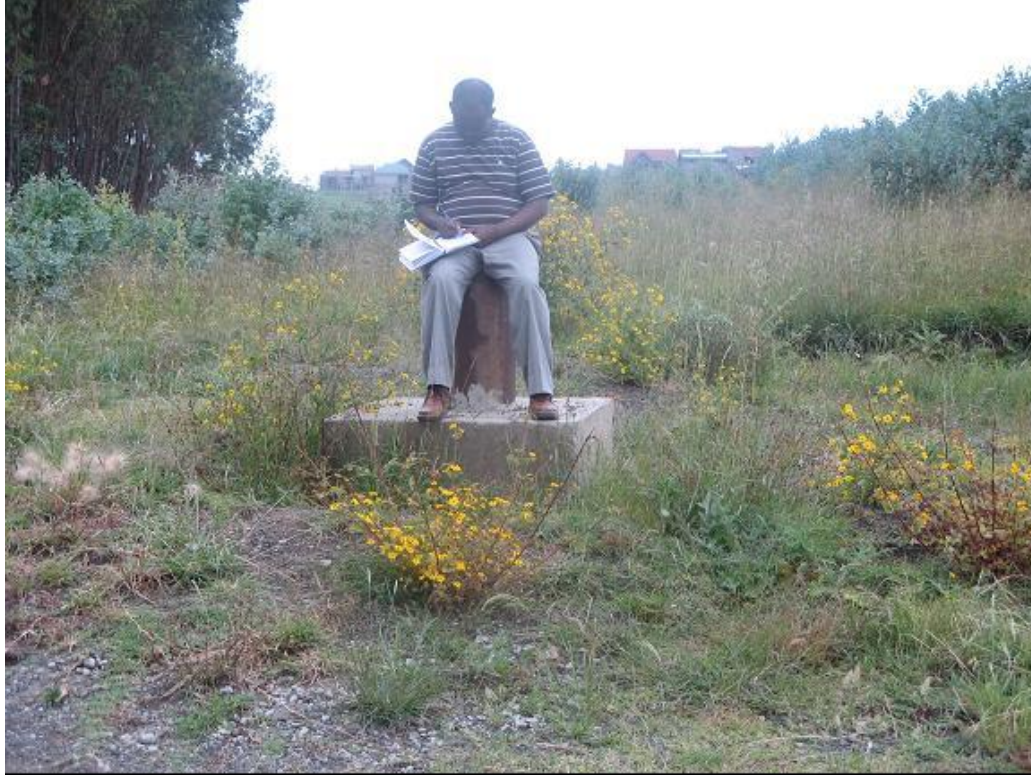
Borehole SUMTV3

This borehole is constructed very close to Medhanialem Church at the bank of the river that originates from Kotebe area. The Borehole site is covered with tall grass and flowers locally known as “Gelegele Meskel”. The transmission pipe route proposed to convey water from this borehole to SA Reservoir has not yet been decided.

- Due to the construction of the borehole, the community has lost about 400 m² of grazing land /grassland and compensation for such losses will need to be paid to the community.
- The site has been satisfactorily rehabilitated and there is no left over from the construction of the borehole that adversely affects the social and biophysical environment
- The route of the transmission pipe that will convey the water to the summit reservoir is not yet marked on the ground thus difficult to quantify the type and extent of the impact of the transmission pipe at this stage

- The transmission route will need to be marked on the ground to be able to assess social and biophysical impact of the transmission pipe

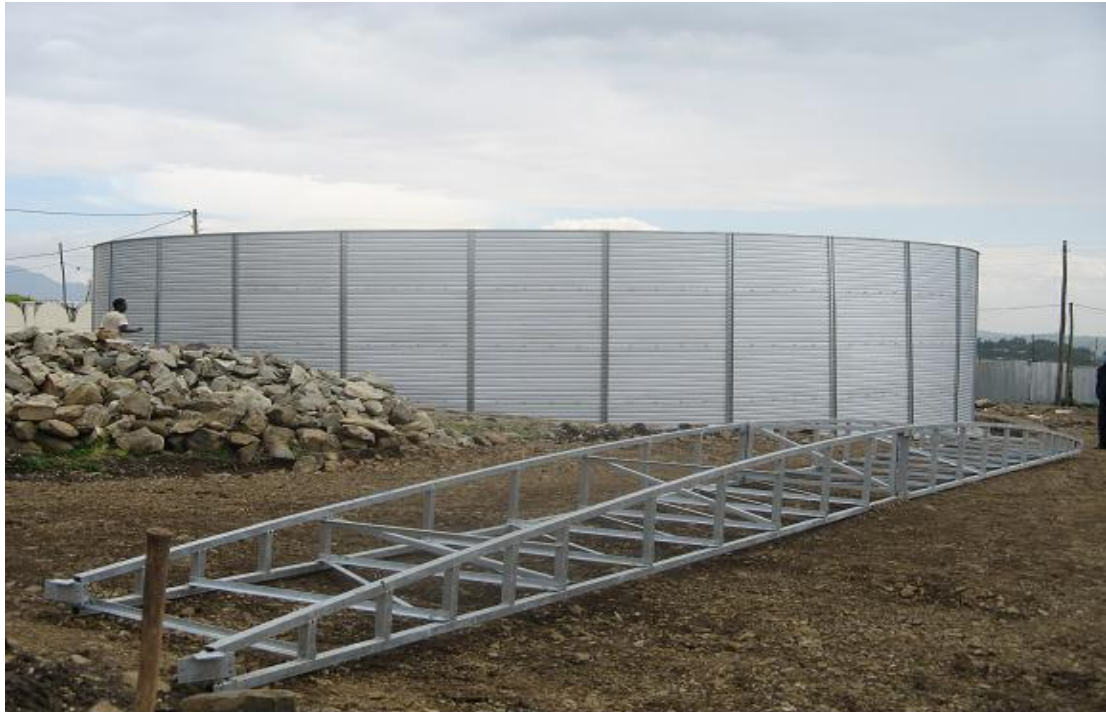
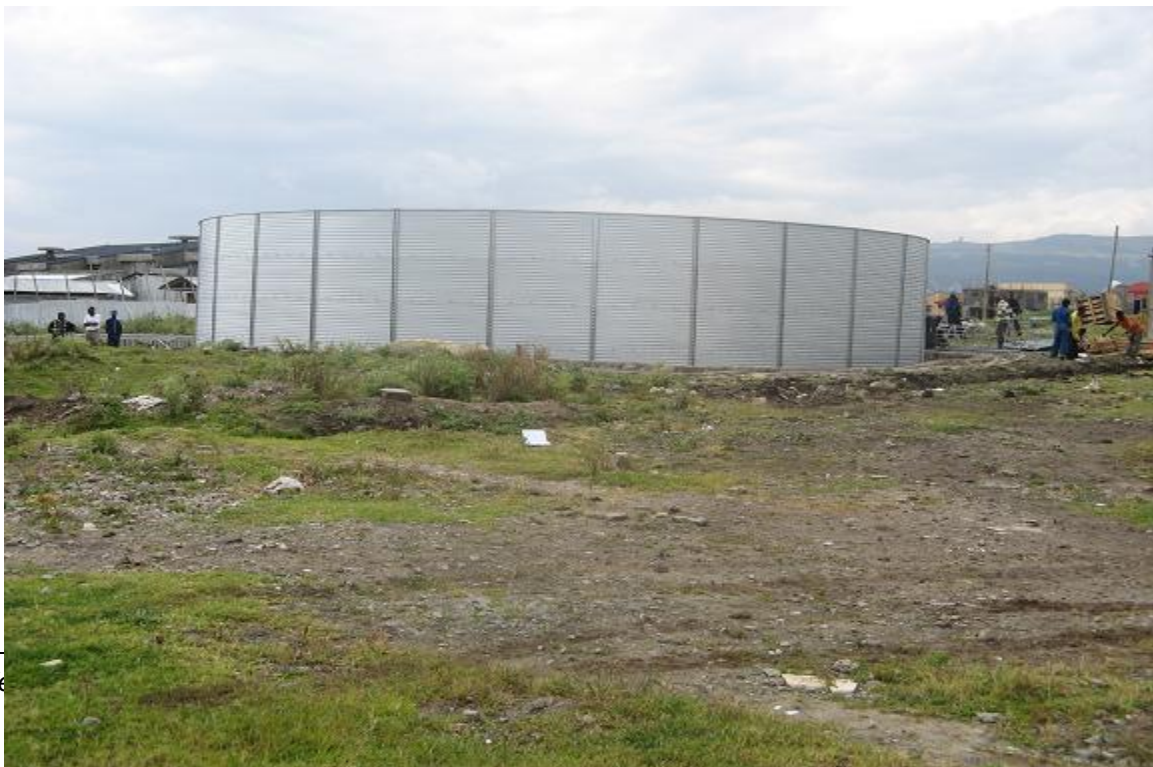
SA Reservoir

This reservoir is constructed on 900 square meter of land and has the capacity of 1000 cubic meters. It is designed to store water from boreholes SMV3, SMV10 and SMV19. The reservoir site before construction was reserved as green area for Washington and Selam Housing Associations.

Addis Ababa Master Plan has not been followed when choosing the reservoir site and we have been informed the same location has been chosen by MS Consult as a reservoir site for the additional boreholes proposed to be constructed on the eastern catchments.

- The construction of the reservoir has adversely effected the surrounding environment by reducing the open space that was reserved as a green area for the neighboring housing associations thus denying the children access to their playground.
- About 900 meter square of grassland has been transformed from grassland to reservoir construction site and this change, although localized, has to some extent adversely affected soil fertility and accelerated soil erosion due to the losses due to the losses in grass cover.

- After the construction of the reservoir no improvement in the supply of water to the surrounding communities has been observed.
- After the construction of the reservoir the sight has been adequately rehabilitated and you see no construction leftover that negatively affected the biophysical and social environment.

About 900 square meter of land will need to allocated to serve as a green area to the community in compensation to what they lost

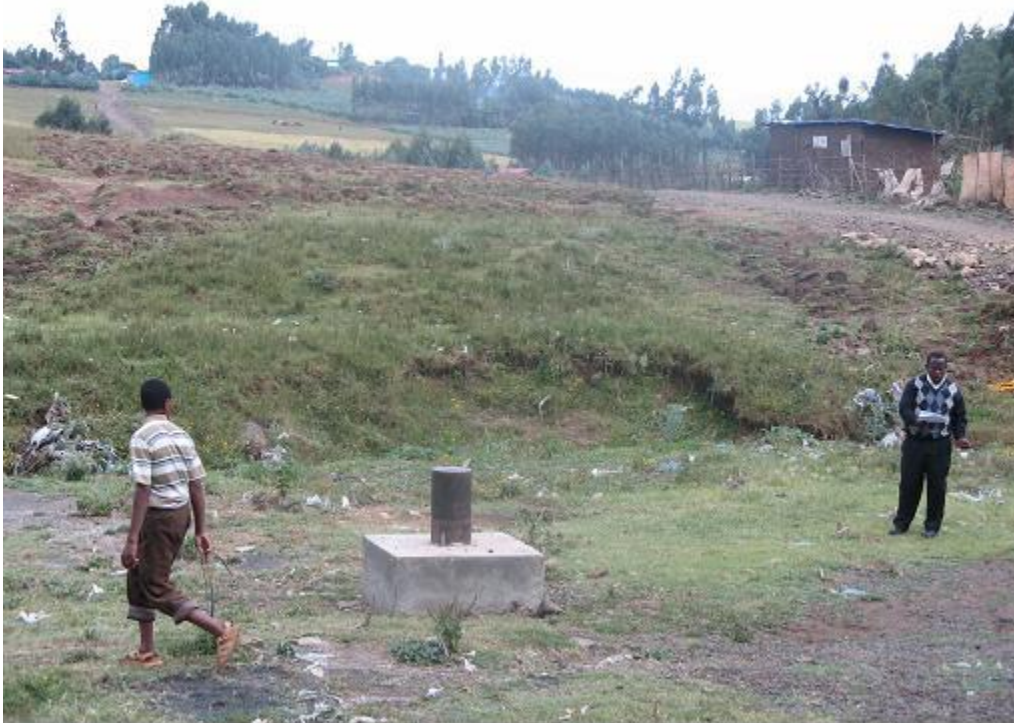
Borehole SUMV10

This borehole is located at the bank of a stream called “Waja” very close to Sellasie Church. This Borehole is constructed on the grazing land owned by Agata Enterprise currently engaged in animal breeding near the borehole site.

- The Enterprise has lost about 400 m² of grazing land thus compensation need to be paid to the Enterprise for the land it has lost due to the bore hole construction
- The borehole water is planned to be conveyed to the SA reservoir but the route of the proposed transmission pipe is not defined and the extent and type of impact could not be determined at this stage

- Borehole site is vulnerable to flooding it is therefore important to construct structure around the borehole to protect it from damage due to flood
- The transmission route will need to be marked on the ground to be able to assess social and biophysical impact of the transmission pipe

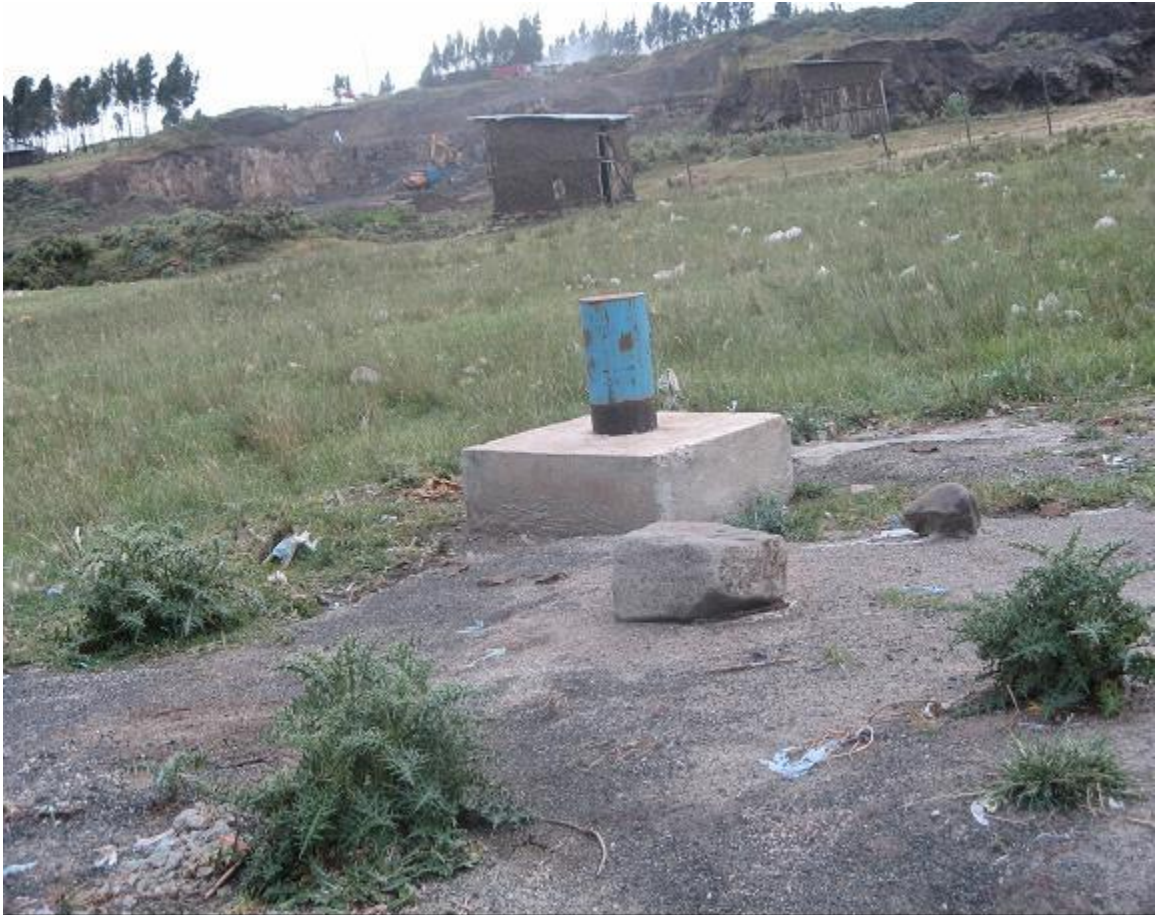
Borehole SMV21

This borehole has been constructed on a grazing land that is also prone to flooding. It is situated at the bank of a nearby stream. The 400 meter square of grazing land that has been lost due to the construction of the borehole belong to the community

- The community has lost about 400 m² of grazing land due to bore hole construction and compensation need to be paid to the community for such losses

- Crushed stone that has been excavated from borehole during construction is observed to have been dumped around the borehole covering the fertile soil underneath and reducing soil fertility for plant growth
- Water from this borehole will be conveyed to SA reservoir but, at this stage the route of the transmission line has not been marked on the ground and it is difficult to assess the type and extent of impact

The transmission route will need to be clearly marked on the ground to be able to assess social and biophysical impact of the transmission pipe

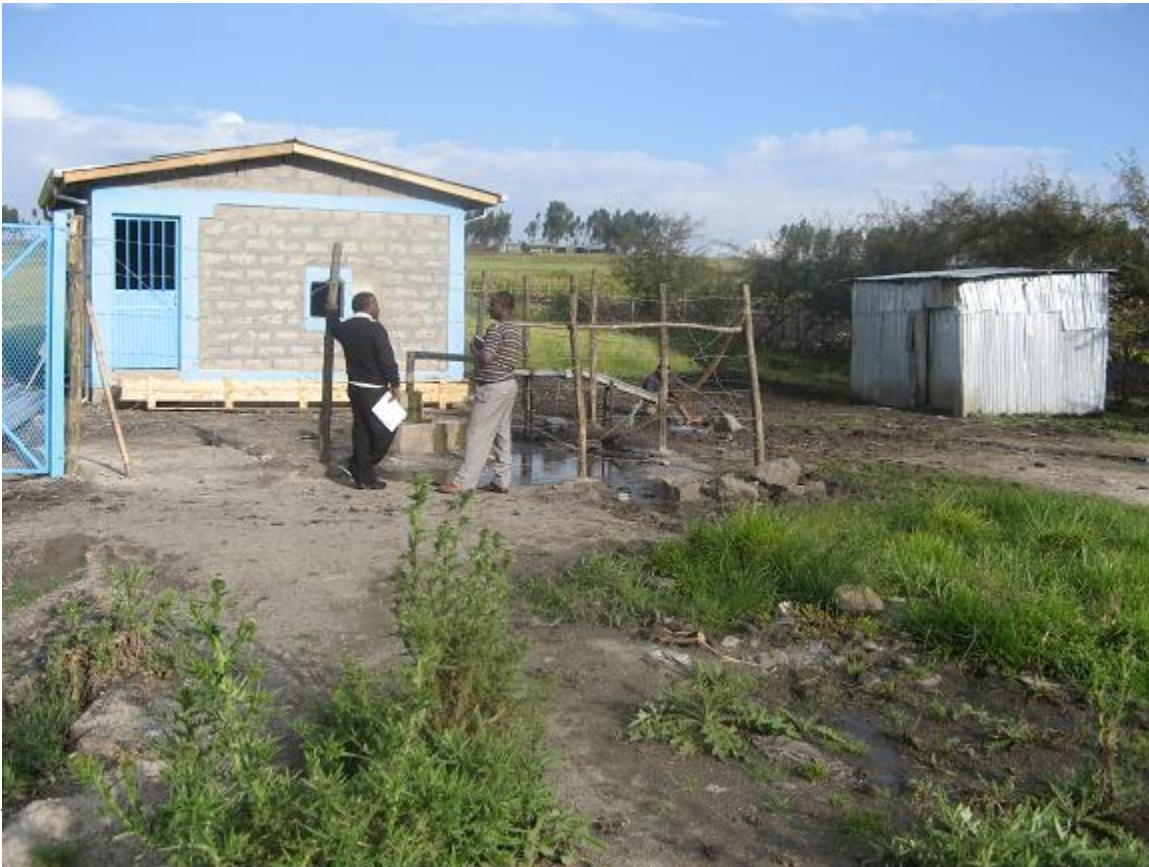
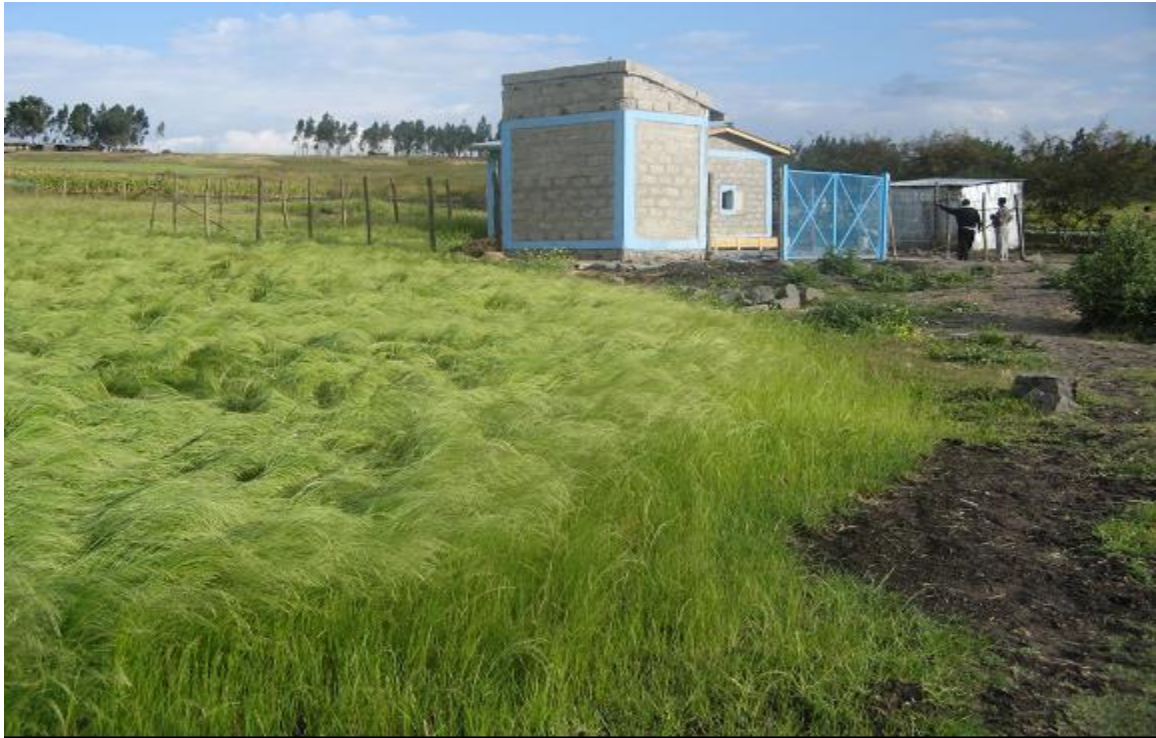
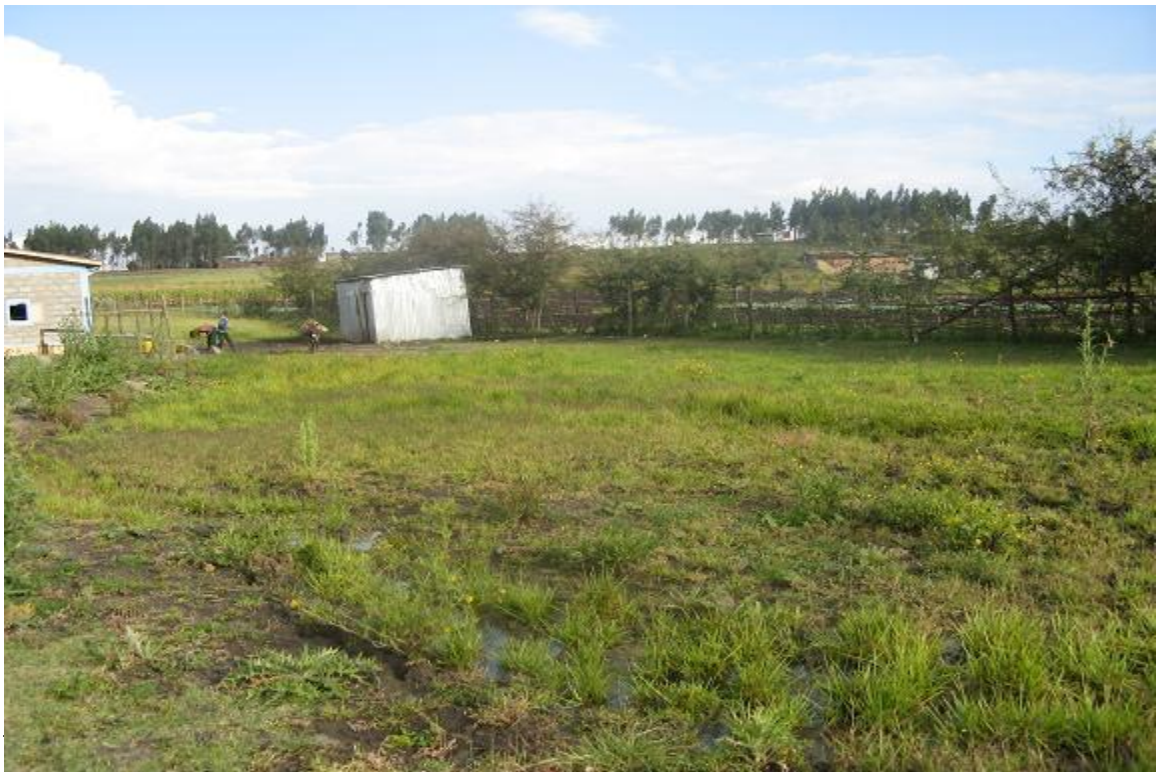
Borehole SMV19

This is artesian borehole constructed on an agricultural land. A person by the name Dr Regassa is currently using this water to irrigate vegetables around the borehole. The owner of the land of the bore hole site has not been identified.

- A person whose name has not been identified at this stage has lost about 400 m² of agricultural due to the construction of the borehole.
- The route of the transmission line is not marked on the ground but is expected to follow the Yarer summit highway in most of its routes.

- The owner of the borehole site has not been identified thus further consultation will need to be done to confirm if compensation is paid for the land he has lost.
- The transmission route will need to be clearly marked on the ground to be able to assess social and biophysical impact of the transmission pipe.

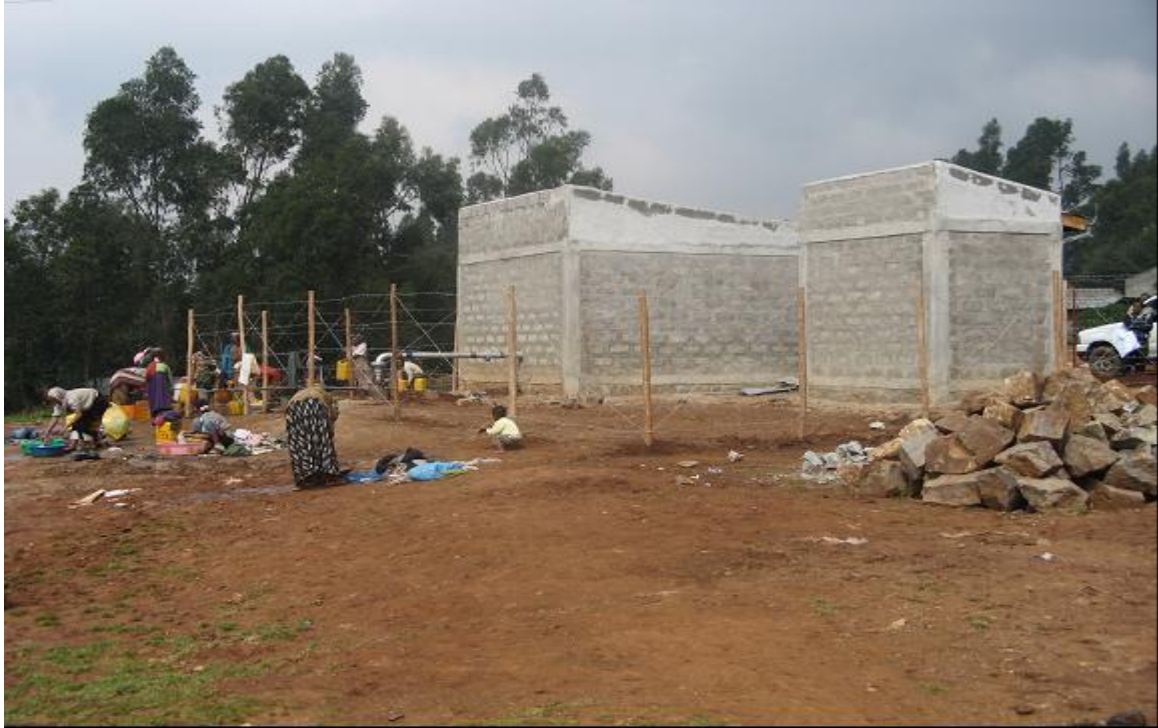
Borehole TOTV2

This is artesian borehole located on grassland at the bank of a river and it is owned by kebele. This site has been handed over to AAWSA by the kebele for the purpose of borehole construction.

The borehole site occupied about 400 m² of marginal land. The community around the site is using water from the artesian well for various domestic uses including bathing and washing. The transmission pipe to Shegole has already been installed and in the future the water from the artesian well will be conveyed to this reservoir.

- The community before the construction of the borehole were using water from the nearby rivers but now they are using clean water from the artesian well for free
- The borehole site has been marginal land owned by the kebele therefore, there is no need of compensation any one for the land that has been lost as a result of bore hole construction
- Installation of the 600 meter long transmission pipe has followed the existing road and there is no loss of property or land that is owned by individuals requiring compensation
- The construction of this reservoir took out about 900 m² of the grassland reserved for environmental rehabilitation.
- The construction of the reservoir foundation have aggravated soil erosion
- The loss of grass land reserved for environmental rehabilitation will need to be compensated by allocating equivalent land for environmental rehabilitation to preserve nature

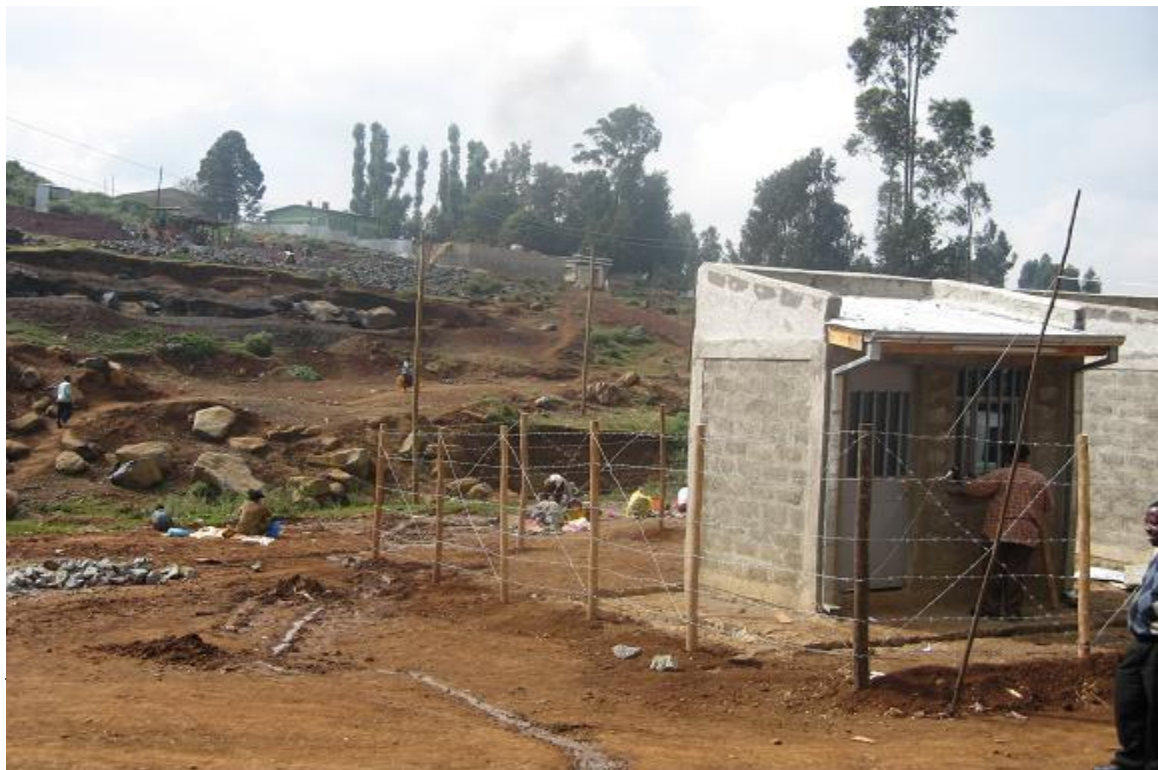
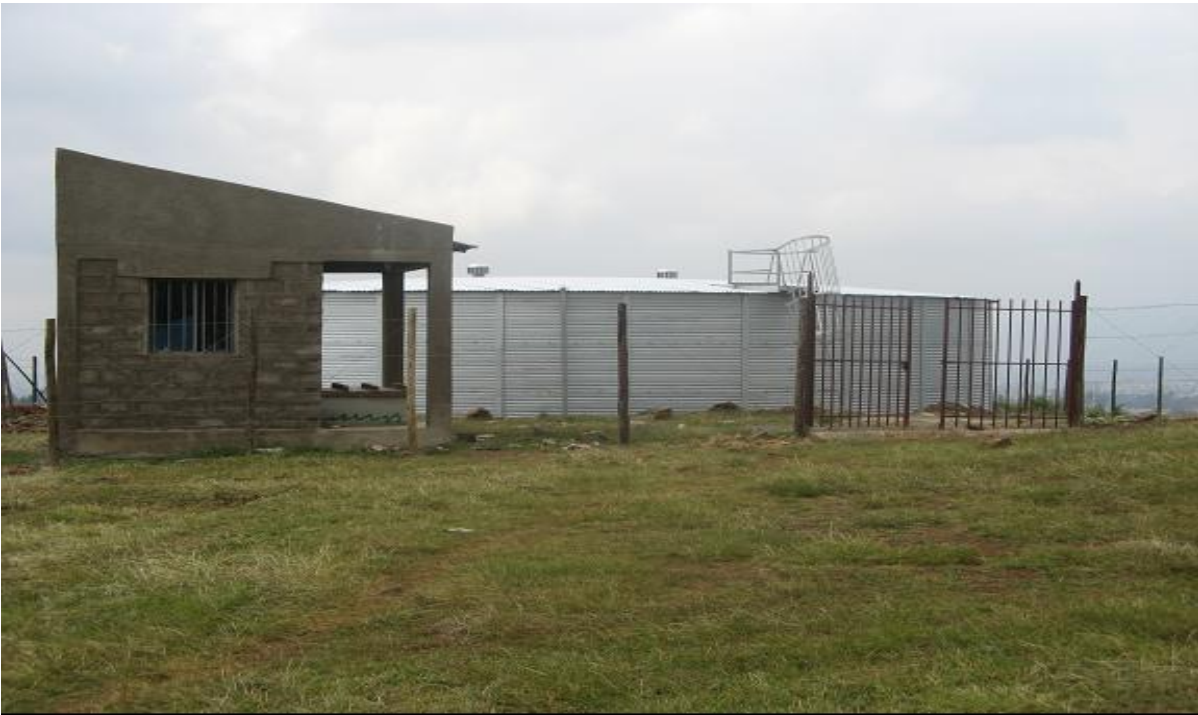
Shegole Reservoir

The capacity of Shegole reservoir is about 700 m³ and it will serve to store water from the artesian well (TOTV2). The reservoir is constructed very near to the cemetery of the kidanameheret church.

Reservoir site has been owned by the kefeleketema Environment Office for the purpose of environmental rehabilitation and has been handed over to the AAWSS Authority for the purpose of reservoir construction

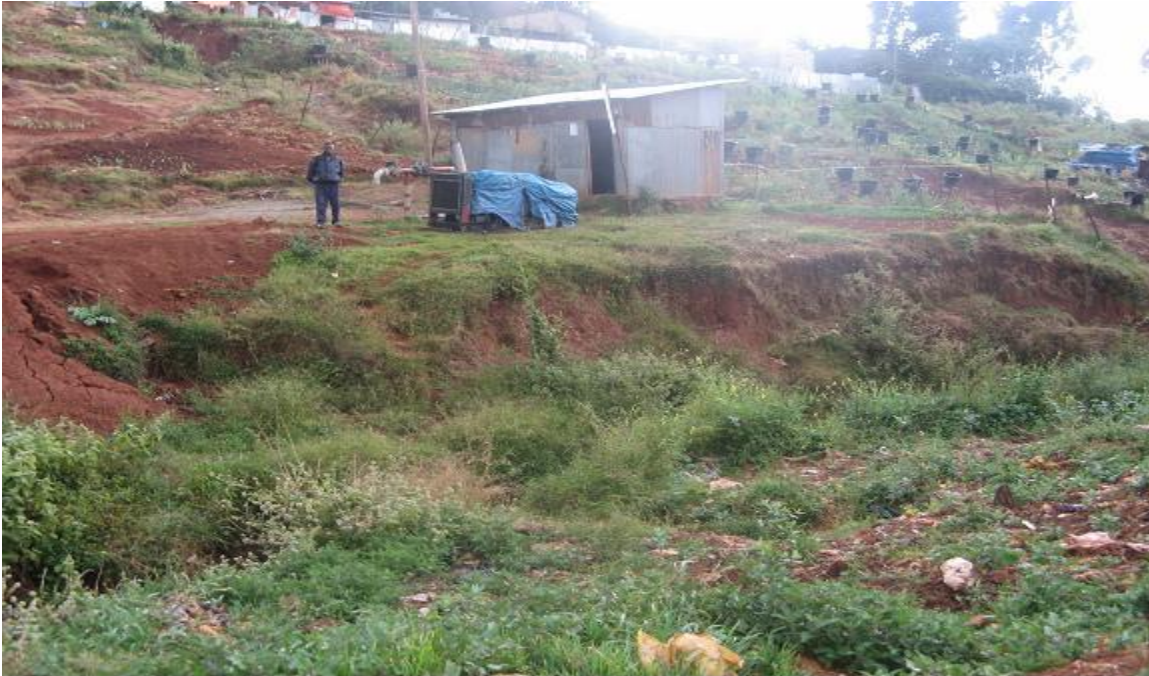
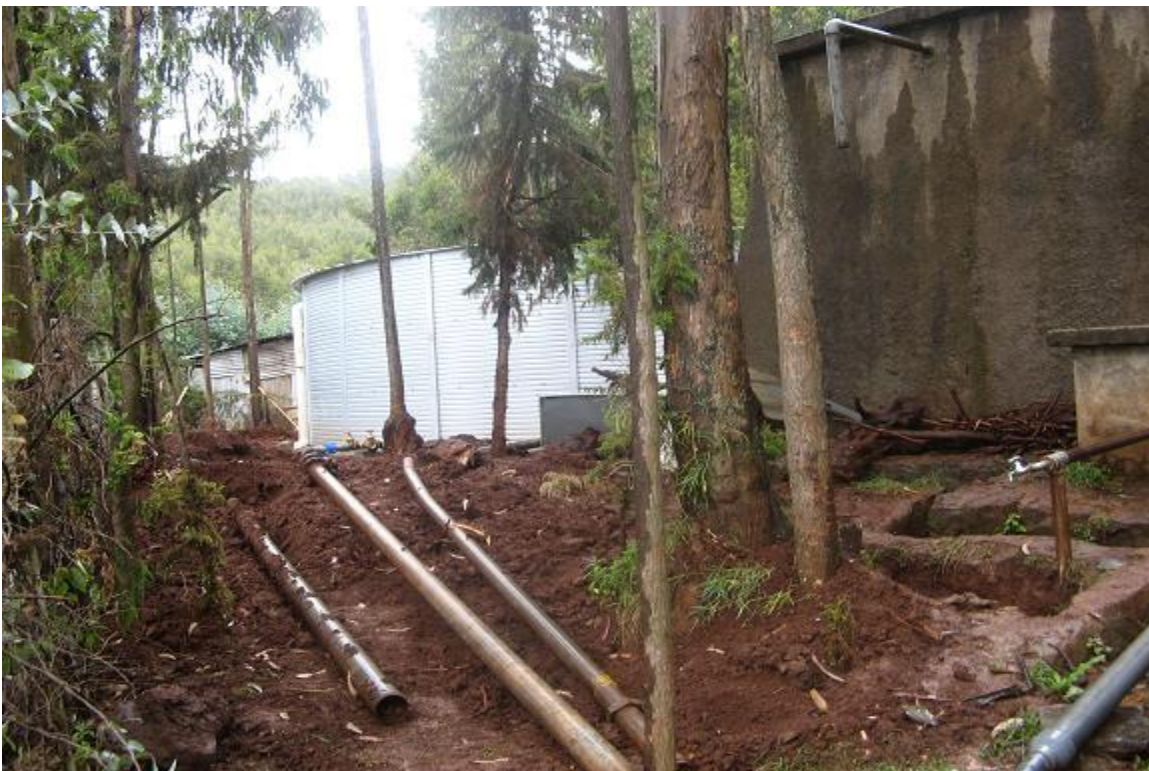
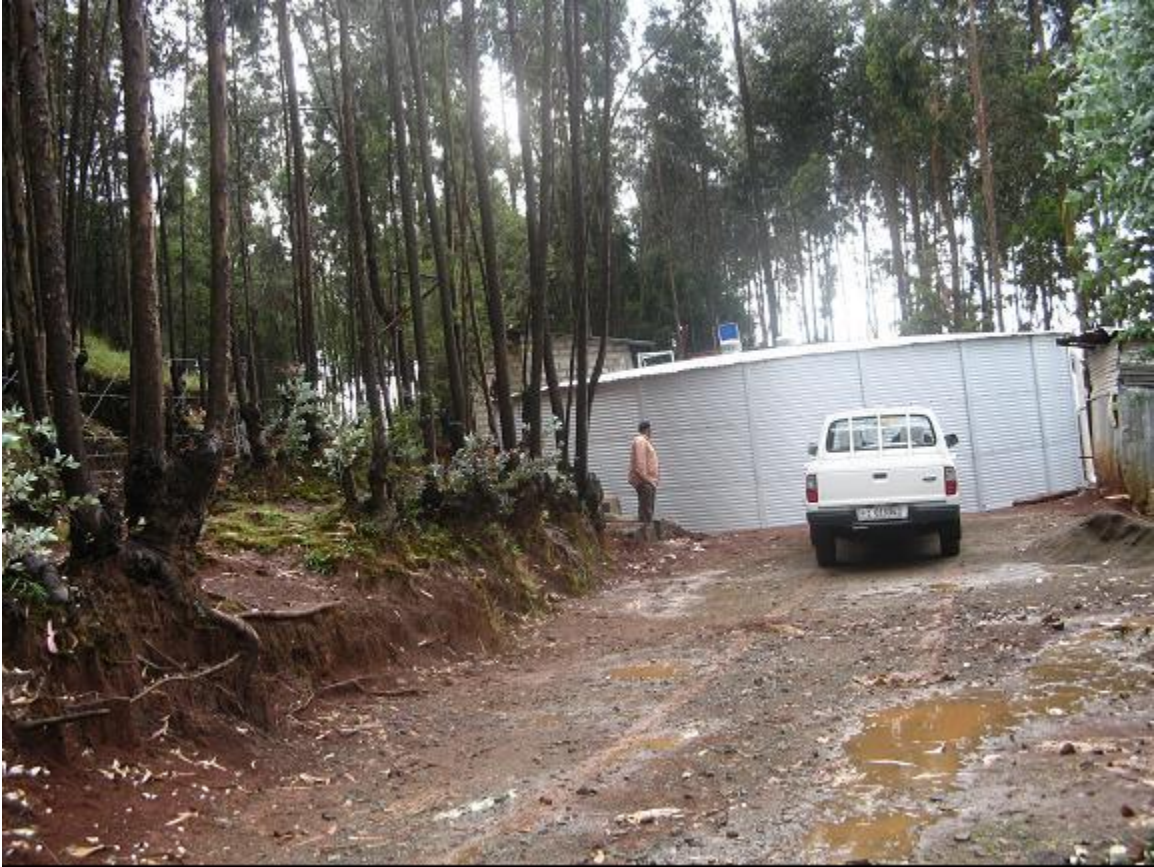
Borehole BLGZV2

The borehole is situated on a marginal land/grass land very close to the bank of a river. The site before borehole construction was owned by kebele. Very close to the borehole there is a spring the community considered as a holy water that is believed to cure various diseases.

Currently, water from the borehole is utilized to irrigate vegetables by the help of drip irrigation system owned by some members of the community. The transmission pipe that will convey water from the borehole to the Gojam Ber reservoir has already been constructed. The route of the transmission pipe to Gojam Ber reservoir has followed the existing road.

Water from the BLGZV2 Bore hole is conveyed by the help of transmission pipes to the reservoir located at the Gojam Ber. This reservoir has been constructed on an area closure designated for rehabilitation. The area protected area (not officially not gazette area closure) is owned by the AA Environmental Protection Authority

- 400 square meter of marginal land has been lost as a result of the borehole construction. The land is owned by the government and thus, there is no body claiming compensation for such losses
- Transmission pipes have already been installed to convey water from BLGZV2 borehole to the reservoir at the Gojam Ber. The transmission route followed the existing road and there was no serious impact on the socio-economic and biophysical environment.

- In the future exploitation of water from the borehole may adversely affect the water yield of the spring and this needs to be monitored from time to time
- This Reservoir has been constructed by clearing “Ted” and eucalyptus trees within the protected area. This has resulted in the loss of about 2500 m² of the protected area and about 30 Ted and eucalyptus trees. The same number of trees has to be planted about the same size of land has to be put under protection to compensate nature.

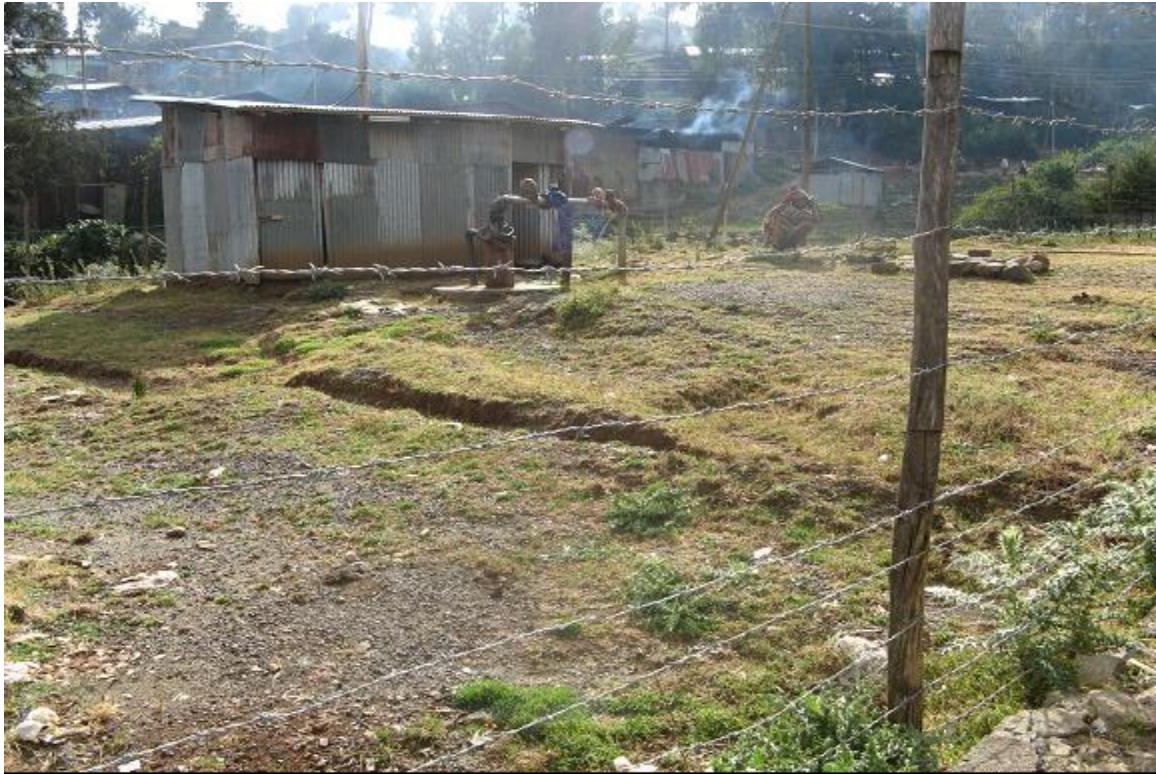
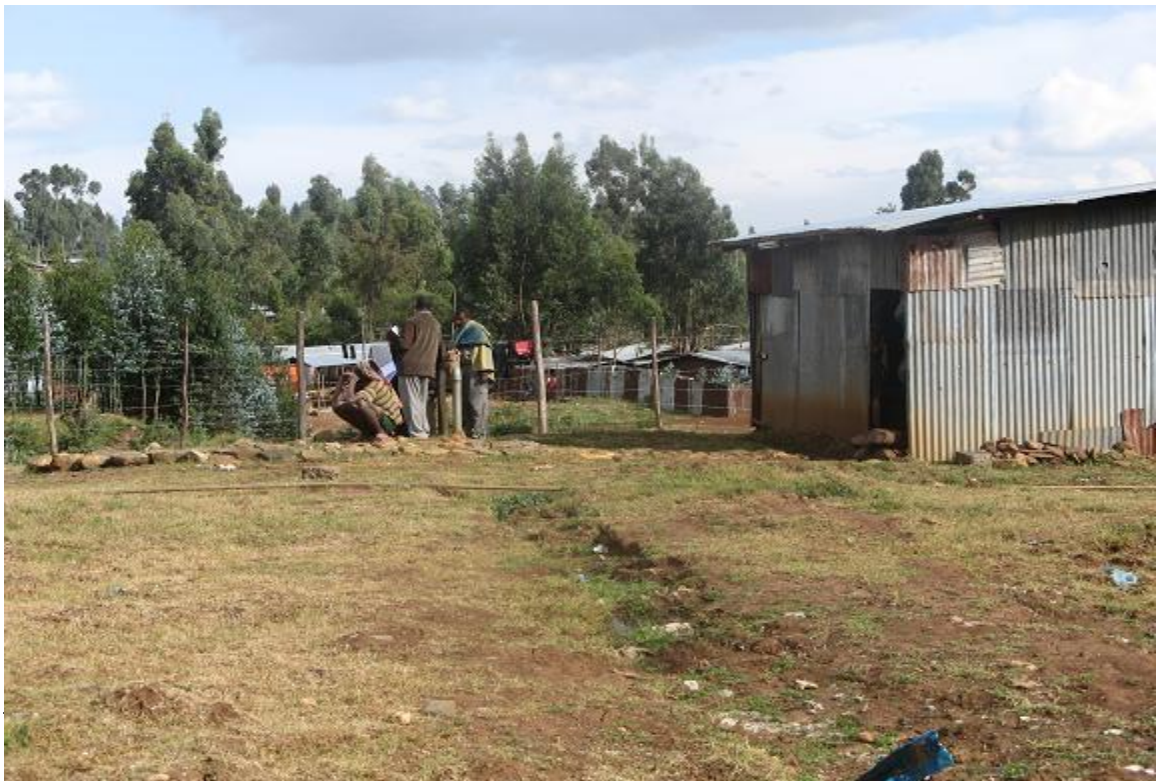
BOREHOLE KECHV1

The borehole site is located on marginal land very close to the bank of the river. The site was previously occupied by six aids patients' four of whom are women. They were using the land for growing vegetables using water from the nearby river. Through 800 meters long transmission pipe the borehole is currently supplying water to existing plastic reservoir (Roto). The community around the borehole was getting water from the Entoto Spring and had critical shortage of water during the dry season.

The situation of the water supply provision to the community around the borehole has very much improved after the borehole has been made operational.

- The marginal land where the bore hole has been constructed has been owned by the aids patients thus need to be compensated by providing them equivalent size of land to support their living
- Provision of water supply to the communities after the borehole is made operational has significantly improved
- The transmission pipe followed the existing road and its impact on the biophysical environment has been minimum
- The existing reservoir (roto) has been installed in the middle of the Entoto protected forest and this has resulted in the clearance of some trees within the forest area (The construction of this Roto reservoir has not been financed by the WB)

The six aids patients need to be given land of equivalent size to earn their living.

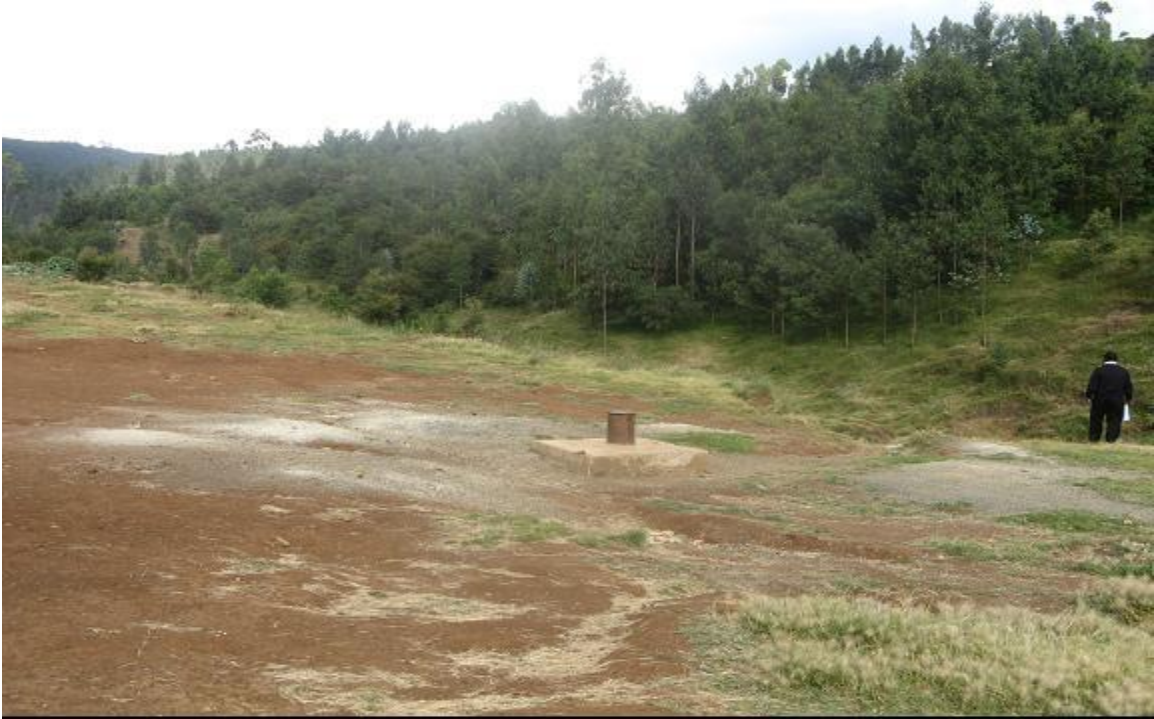
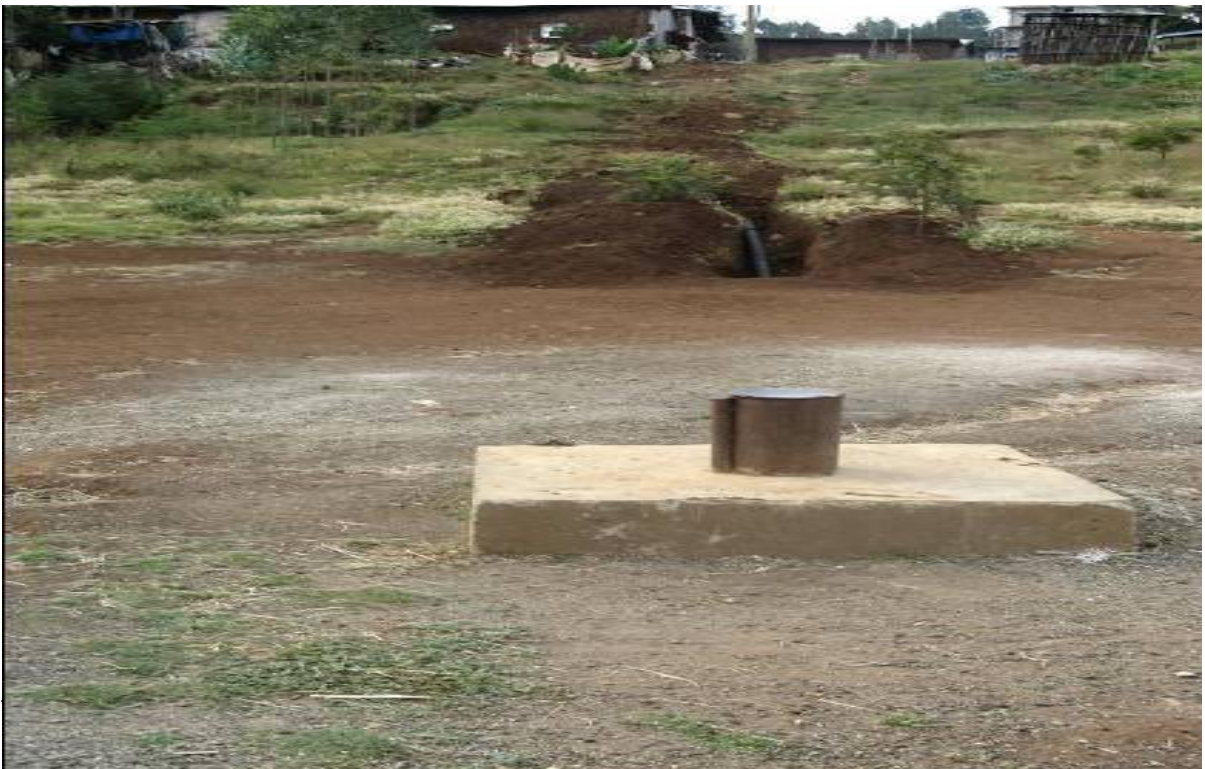
Borehole KMHEV1

The borehole is located on grassland designated as protected area by the Environmental Protection Authority. Some trees have been planted on the borehole site to commemorate the Ethiopian millennium.

Currently, water provision to the community around the borehole is very poor and they get water from the existing reservoir(R1) once every three days. The water from this borehole is proposed to supply water to the reservoir designated as EN on the map.

- The borehole site will take about 400 square meter of the area designated for environmental protection. The environment has to be protected by persevering the same size of land and planting trees on that land
- The route for the transmission pipe is not marked on the ground and the type and extent of impact could not be determined at this stage

The transmission pipe route will need to be marked on the ground to assess the type and extent of biophysical and socio-economic impact of installing the transmission pipe.

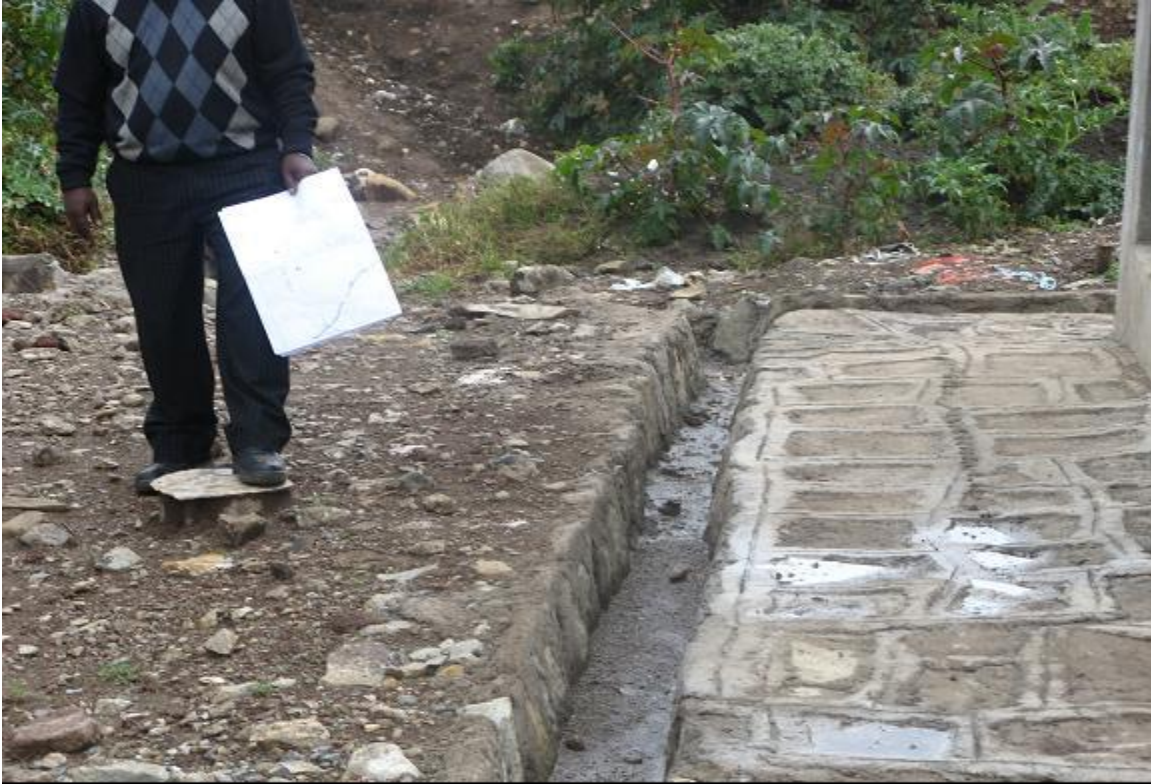
Borehole WNDV2

This borehole is located very close to Gelisa River and it was once part of the river course where waste is dumped. The water from the borehole is planned to be conveyed to the existing reservoir designated as AN on the map close to Yeka Micheal church. The borehole site is prone to flooding.

- The borehole is sited on a place where it was once river course and no compensation has been required during the construction of the borehole

- The route of the proposed transmission pipe will follow the existing road until it reaches the existing reservoir and the impact as a result of the transmission line construction is expected to be minimal

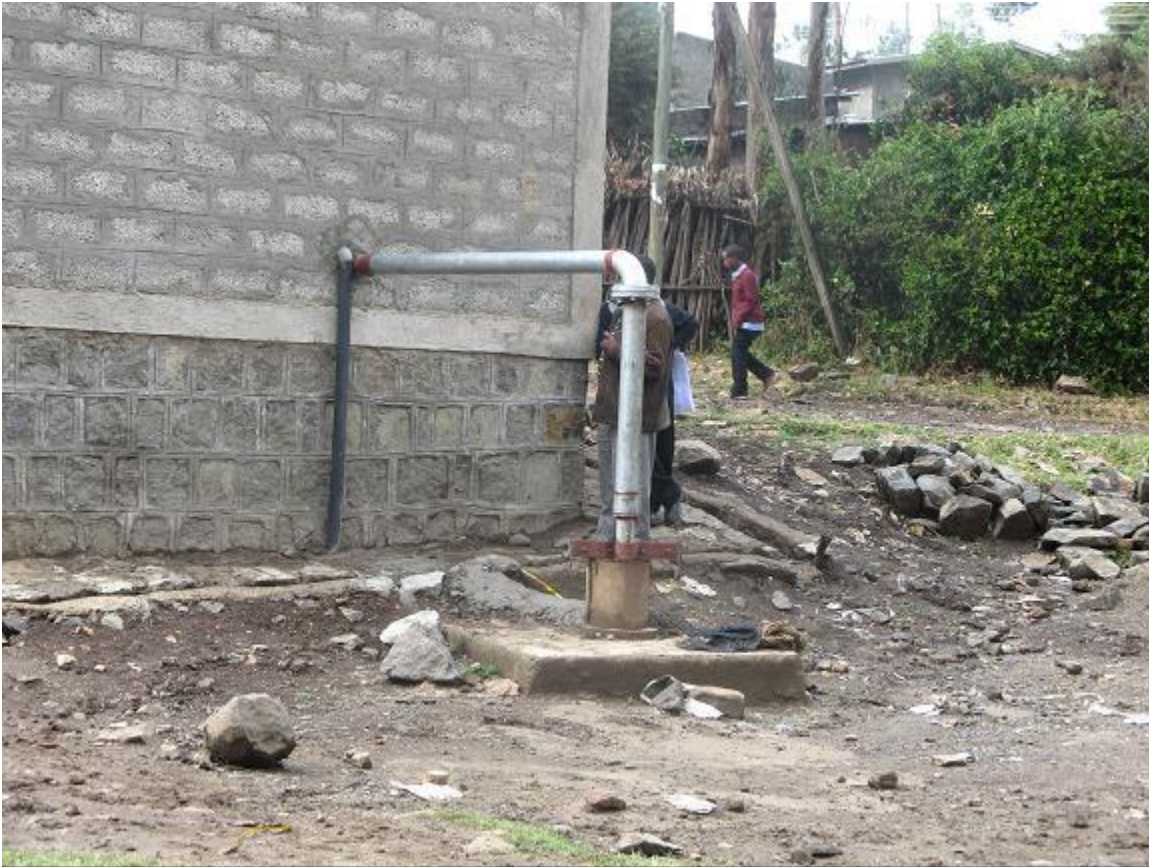
Borehole ANK-2

The borehole site is located on a grass land very close to the kidanameheret wooden bridge .The site was previously playing ground for those kids living around that area

The water from the borehole will join the existing transmission line until it reaches the existing booster reservoir very close to the security office

- The borehole is constructed on a play ground and the community will need to receive equivalent land (400 square meter of land) to compensate what has been lost
- The route for the transmission pipe is not yet marked on the ground. However, it is expected to follow the exiting road and the impact on the social and biophysical environment is expected to be minimal.
