Irrigation and Land Market Development Project

Rehabilitation of Zeda Ru Irrigation System

Section 1: Project design and specifications

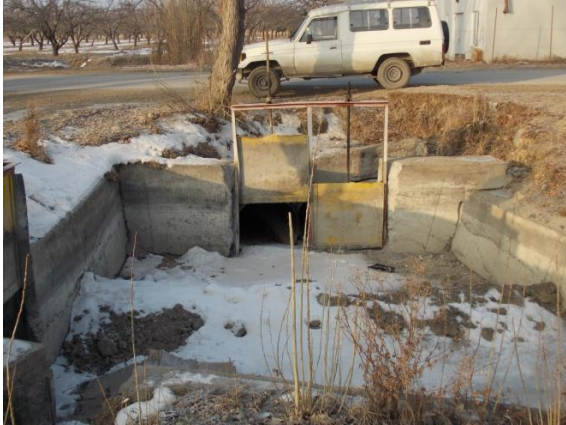
- Bushes and herbaceous plants are presented on the slopes of the canal. In order to raise the water level stone-rock is laid in some sections;
- Pk0+00. Concrete lining of the distribution well is damaged. The slopes are heavily eroded. Significant amount of stones and rocks is accumulated on the bottom. The lock gates of Dzlevijvari and Zeda Ru irrigation system are amortized and inactive;

Distribution well. pk0+00

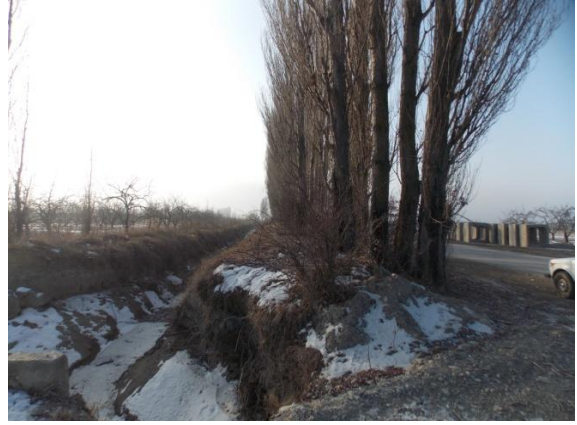
Main canal. From pk0+00

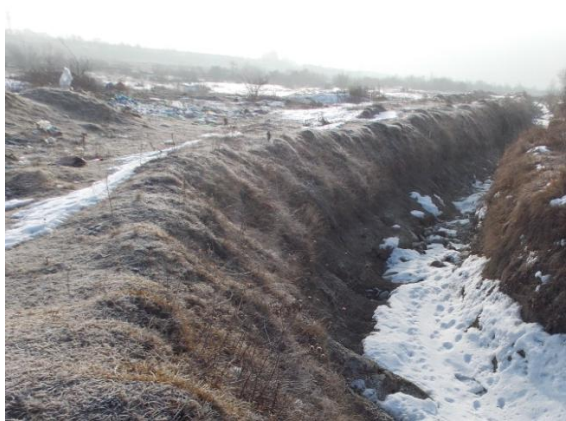
Main canal and landfill to its left. pk12+20

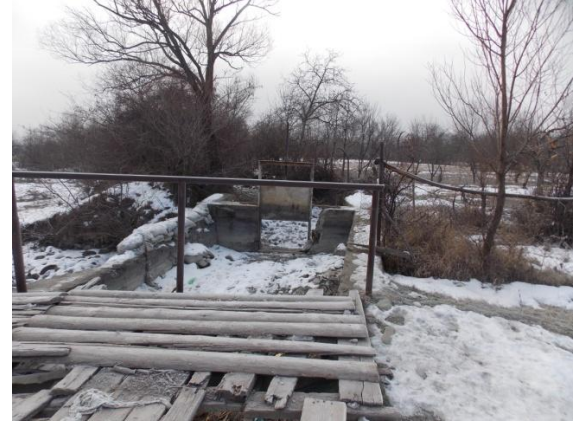
Distribution well. pk28+00

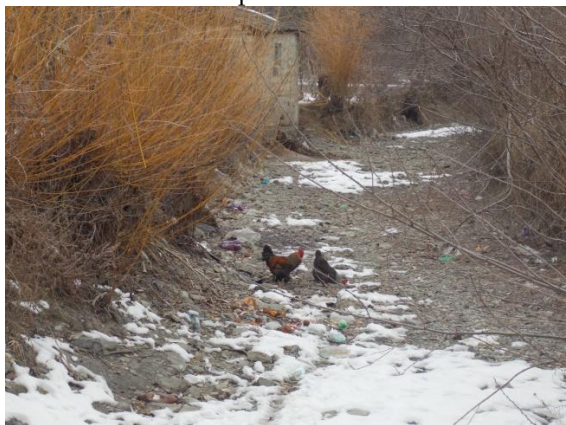
Animal shed on the berm of the canal pk37+00

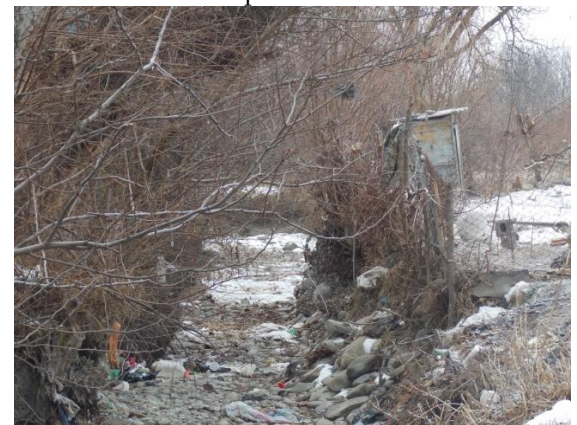
Toilet on the berm of the canal. pk37+30

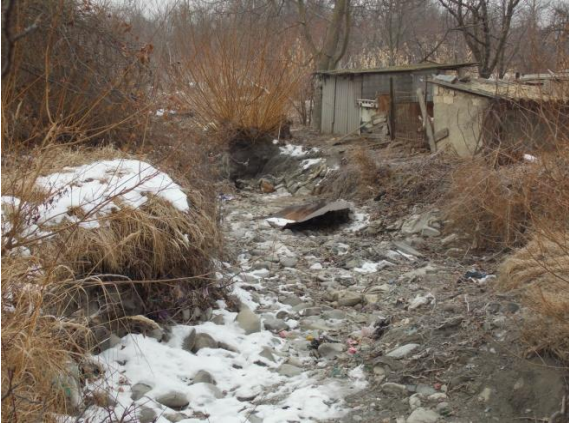
Shed of domestic animals. pk37+80-pk38+00

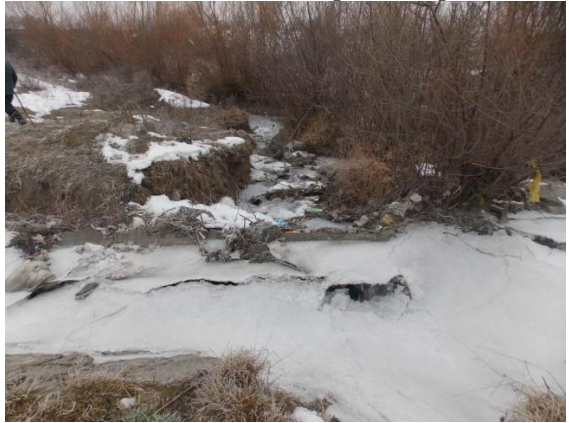
Distributor of the v. Variani. pk71+20

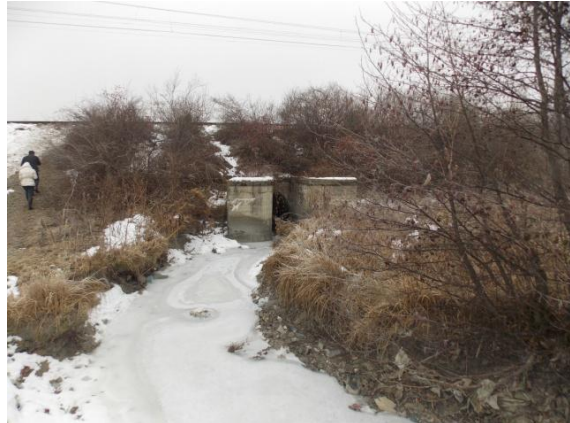
- Pk71+20. Household waste with the amount of $\approx 4 \text{ m}^3$ is observed on the left side of the canal;
- Pk71+20-pk72+00. Ground road runs along the canal from the left. The road subgrade is damaged;
- Pk72+00. The canal crosses the railway via tunnel. The tunnel is filled with stone-gravel.

Crossing with the railway. pk72+00

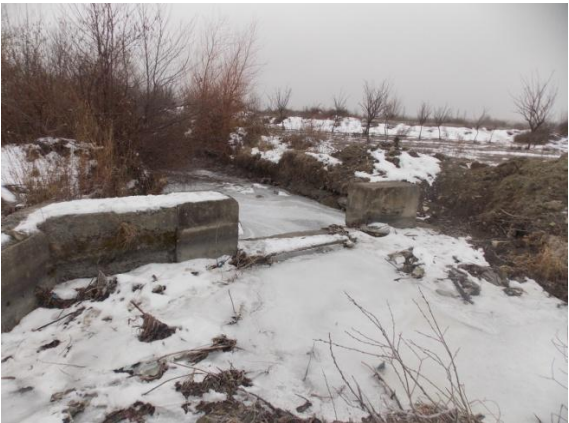
- Pk72+50. Variani distribution well. The concrete lining of the well is damaged. Lock shields are not present. It is filled with vegetation waste, breakstone and material collapsed from the railway subgrade;

Variani distribution well. pk72+50

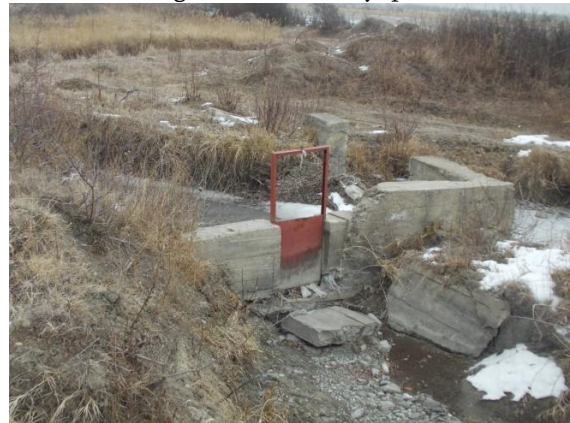
- Pk99+70. Recently arranged distribution canal purpose of which is to supply refugee settlement with irrigation water. Currently inactive;
- Pk99+80 and pk102+10. Distribution wells. Concrete lining of the wells is damaged. They are filled with sediments. Locking shields are amortized and looted. The surroundings represent agricultural lands (mainly corn fields);

Distribution well. pk102+10

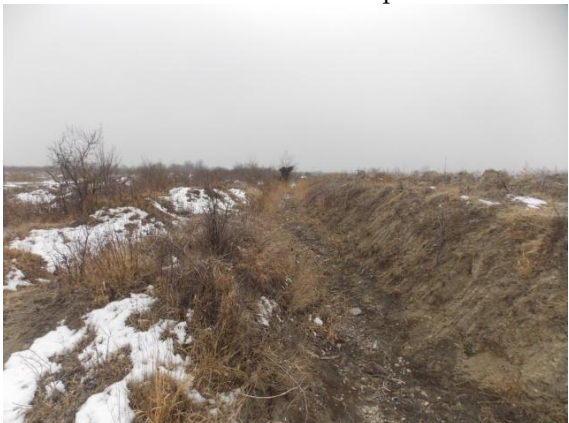
Main canal. pk104+00

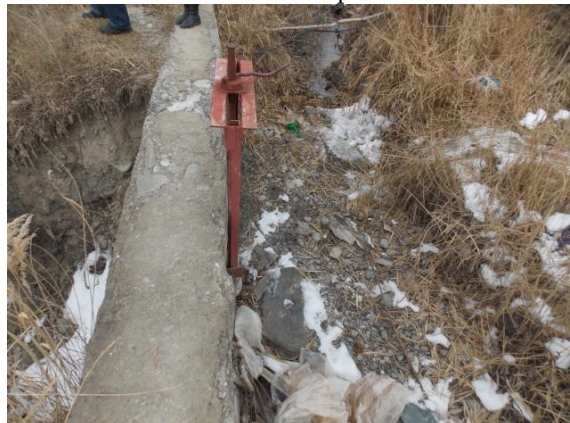
Distribution well. pk115+80

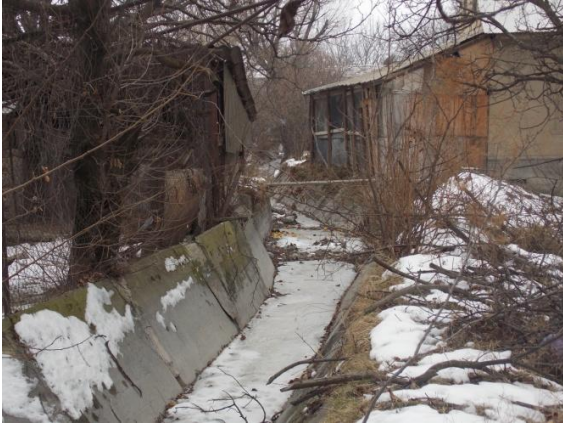
Main canal. pk120+00

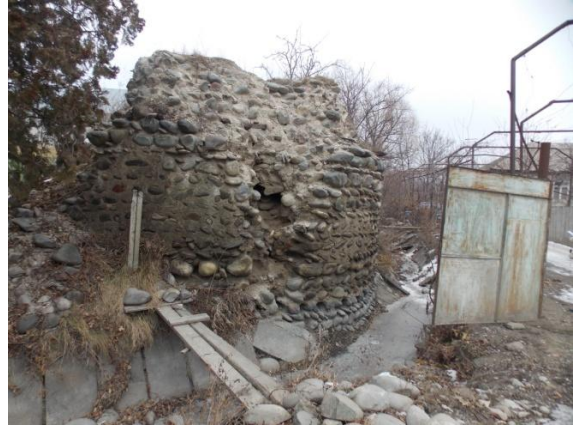
Ruins of church on the right berm. pk121+20

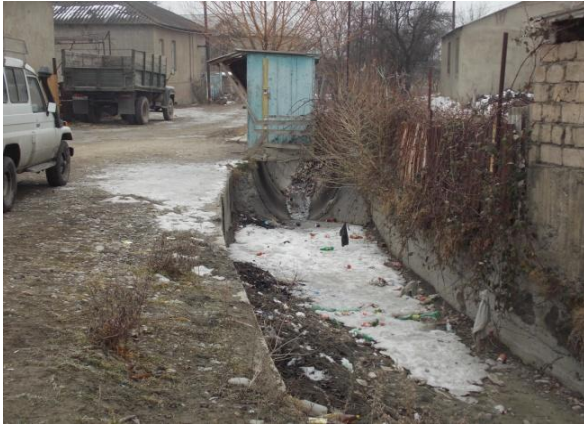
Main canal. pk122+00

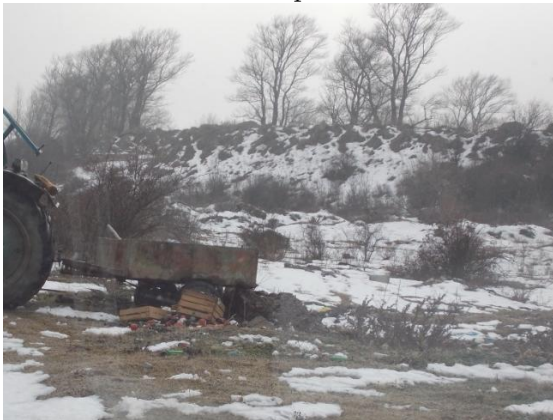
- Pk131+00. Household wastes with the amount of $\approx 1,5-2,0 \text{ m}^3$ are recorded on the left side of the canal;
- Pk144+00. Left side of the emergency discharge canal. The discharge canal feeds the Sasireti Lake. The locking shield is in working condition, the technical condition of the canal is satisfactory.

Landfill. pk131+00

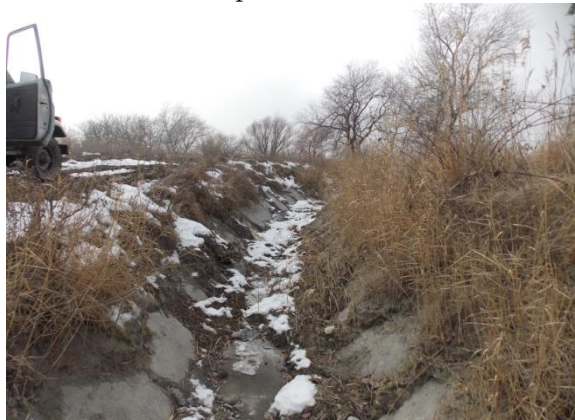
Main canal. pk140+00

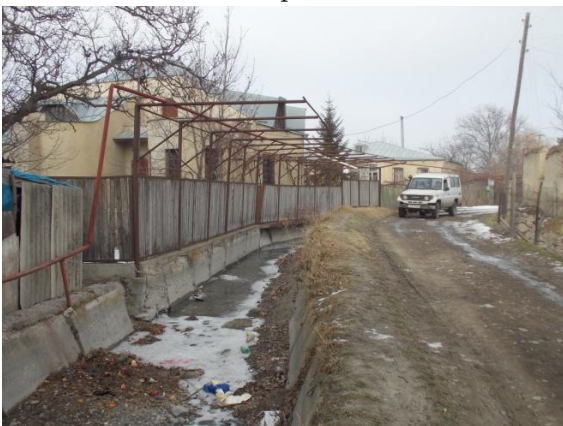
Main canal. pk153+40

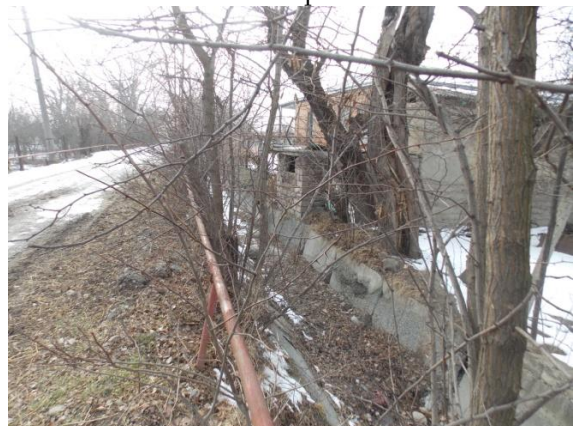
Main canal. pk154+20

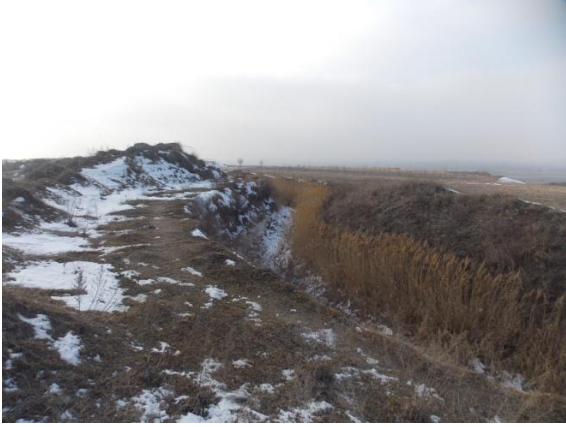
Main canal. pk176+00

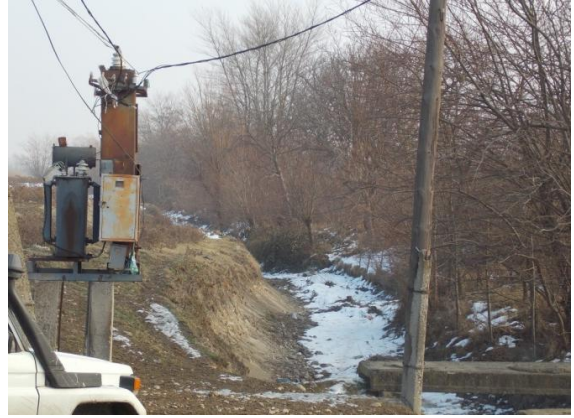
Main canal. pk199+70

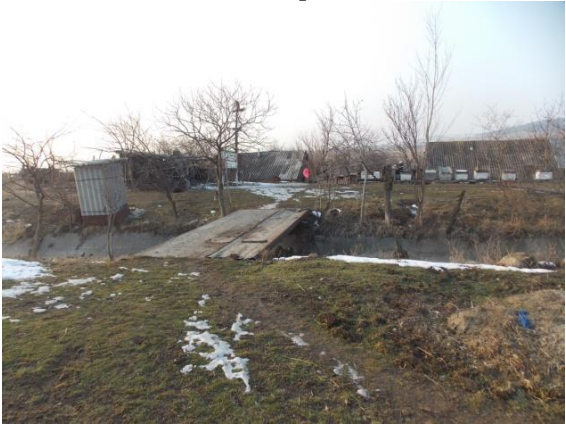
Toilet on the berm of the main canal. pk252+30

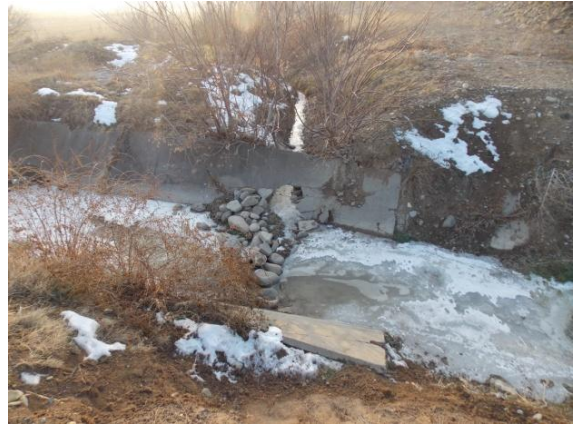
Main canal. pk257+00
