Georgia Irrigation and Land Market Development Project

### Rehabilitation of the Right Main Canal (pk0+00 to pk244+20) of Kvemo Samgori Irrigation System

February 2015

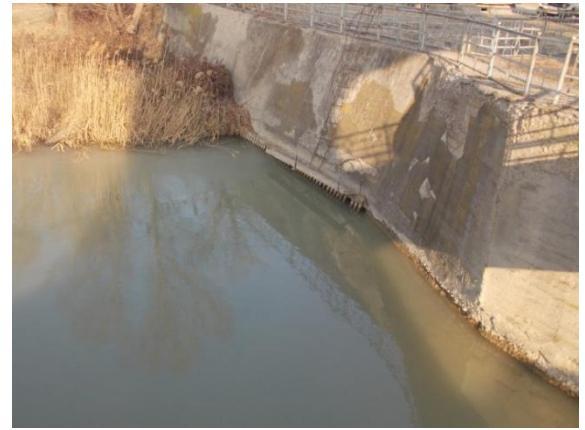
Inlet of water intake of the right main canal

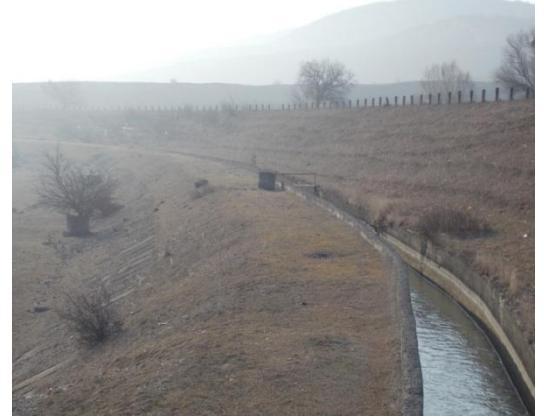
Open rectangular canal

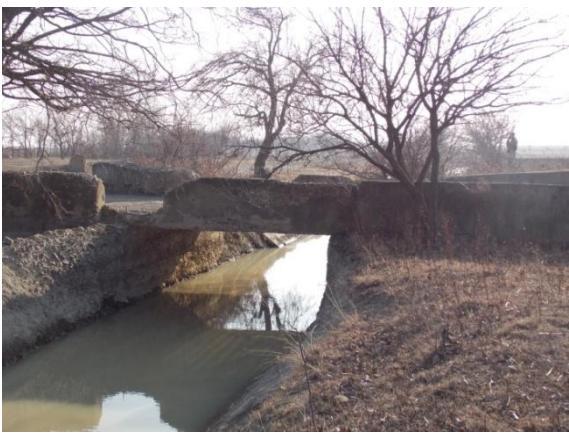
Drainage bridge over the canal

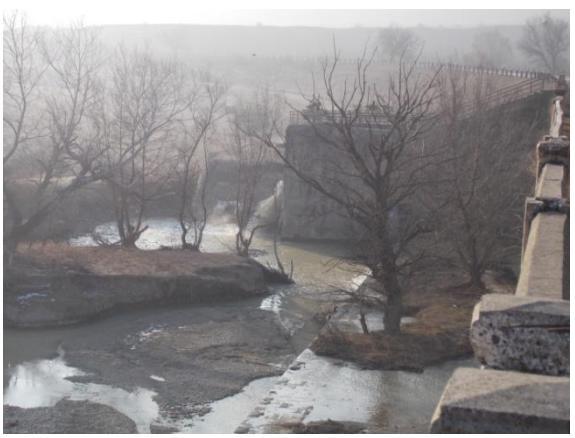
Tailrace, idle spillway

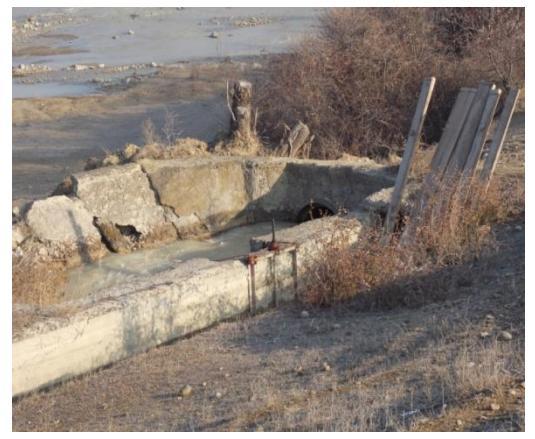
Water discharge well

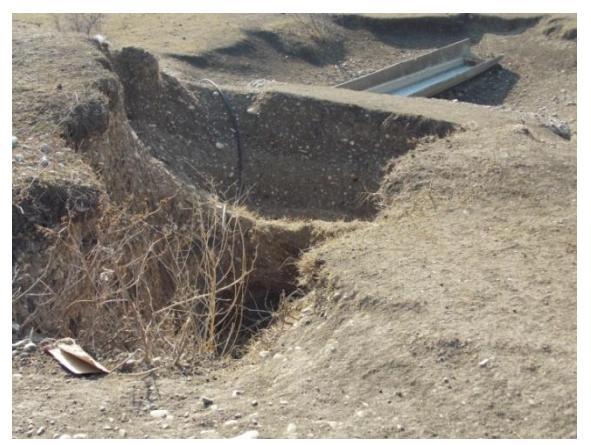
Erosion developed within artificially arranged pond

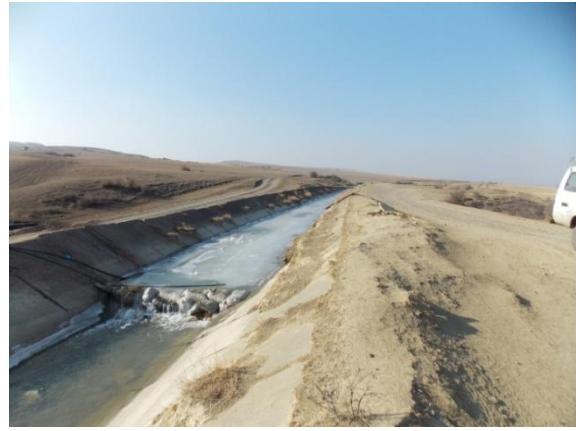
Raising water level by using material placed on the bottom of the canal

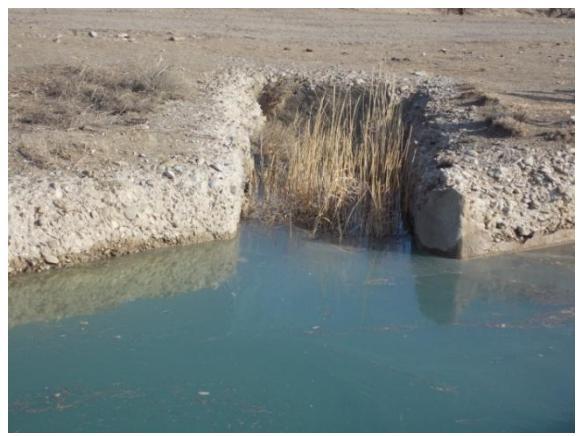
Spillway

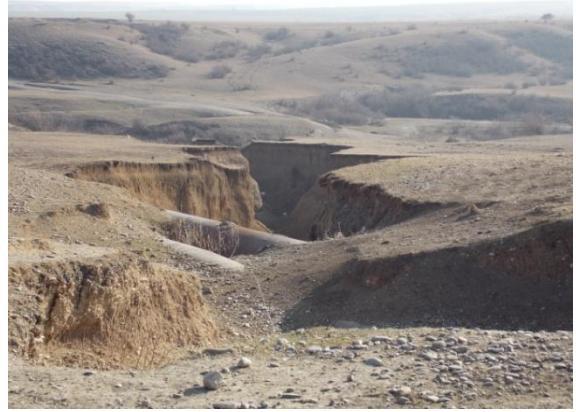
III inverted siphon corridor

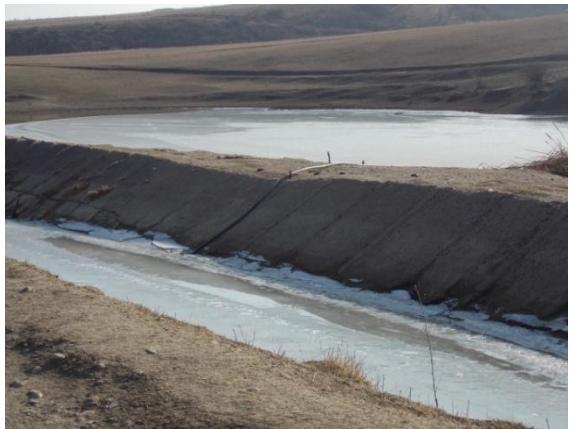
Unauthorized water abstraction and artificially arranged pond

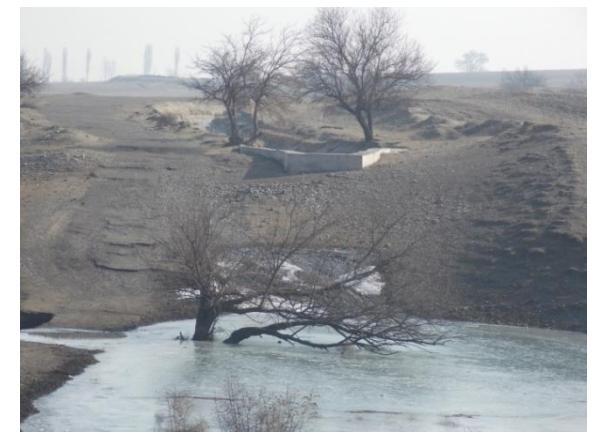
I inverted siphon corridor

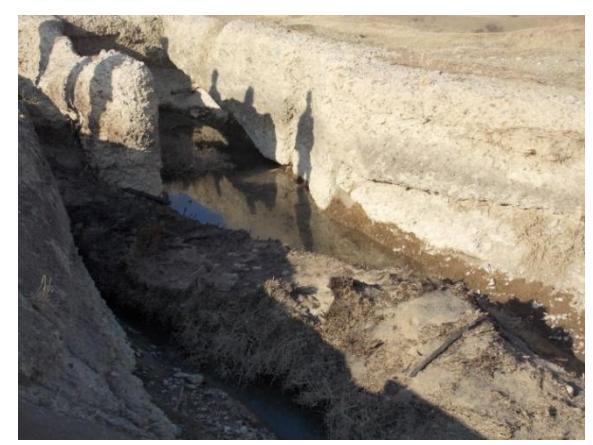
III inverted siphon outlet
