Georgia Irrigation and Land Market Development Project

**Restoration of Instrumental Monitoring System of Algeti Reservoir and Weir and Hydraulic Structures of Tbisi-Kumisi Irrigation System, and Rehabilitation of the Main Canal and Headrace Pipeline on Khaishi and Marabda Massifs**

February 2015

## Section 1: Sub-project design and specifications

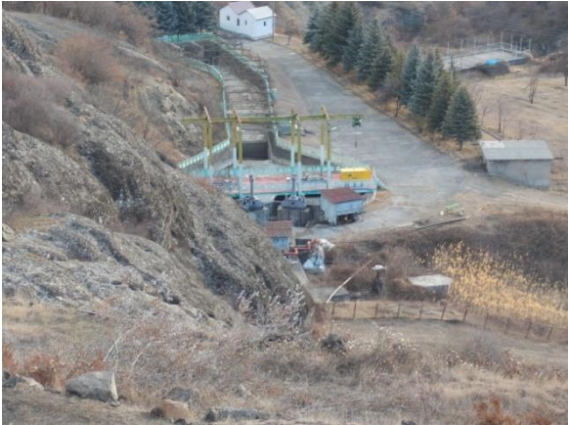
Flat shields of the water discharge and left break lock are damaged. Bridge crane is not working. Internal roads of the territory are asphalted and in a satisfactory condition. Plants are cultivated on

Discharge territory

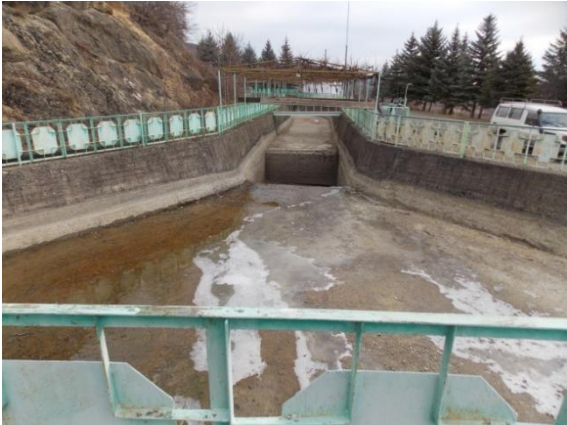
Discharge of the main canal

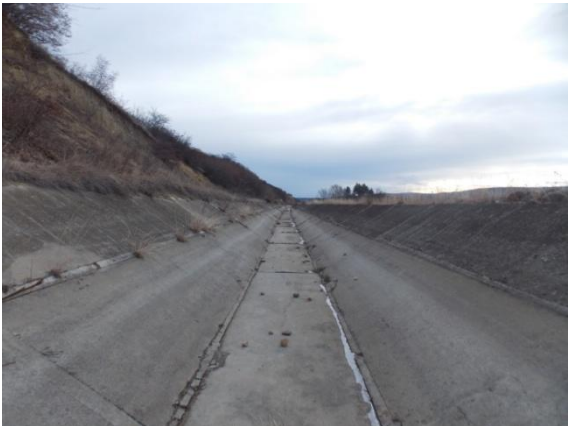
Open canal of Partsikhe mainly runs on the free territories, on 735-738 m asl. The bottom and slopes of the canal are clean from vegetation and sediment material. Ground road is located on the both sides. The technical condition of the road is satisfactory. A small metal pedestrian bridge is arranged across the canal, which is used by the population of the village Partsikhe for crossing to the forest located on the left side of the canal, where they gather fruit and berries. Transmission line is located along the right side of the canal. A pile of concrete waste with a total amount of  $\approx 2.3 \text{ m}^3$  is recorded on the right side of the canal.

Partskhisicanal

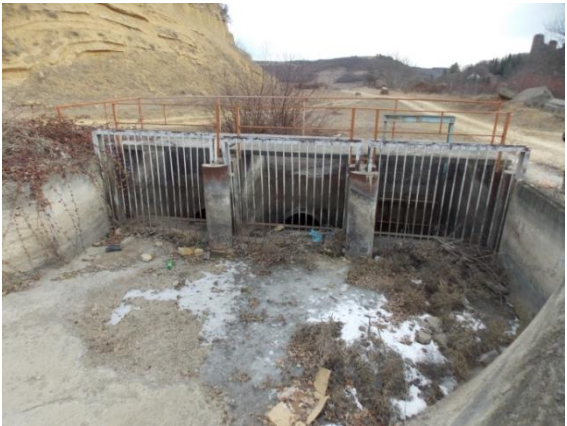
A small amount of tree-plant waste is accumulated on the inlet of Partskhisi inverted siphon. The concrete lining of inverted siphon entrance is damaged. The main canal crosses the Partskhisi ravine with the means of inverted siphon. No buildings were observed in the corridor of the inverted siphon.

Partskhisiinverted siphon inlet

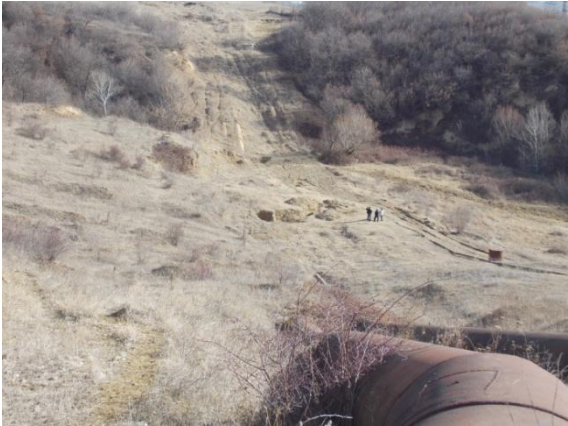
Small amount of tree-plant waste is accumulated on the inlet of Bogvi inverted siphon. Eroded slopes are observed on some section of the inverted siphon corridor. Due to erosion the pipeline is exposed creating a high risk of inverted siphon damage (this section was rehabilitated in 2012).

Bogviinverted siphon corridor

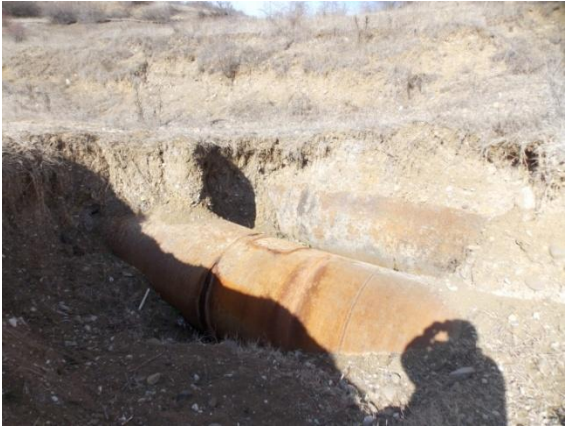
Damaged section of Bogvi inverted siphon

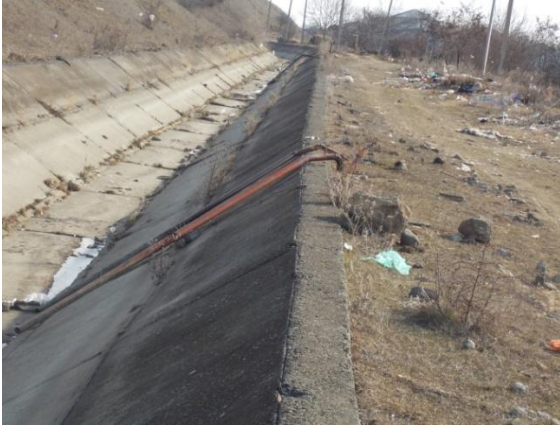
Technical condition on the right side of the canal is satisfactory, while the subgrade of the road to the left is damaged in some places. Transmission line runs in vicinity of the canal. The canal was recently cleaned and trees and plants are poorly present on the berms. Due to damage of the concrete filters and hi filtration the filters leak from the right side into the household plots located on relatively low elevation. Dissatisfaction from the damage of the property (basements of the residential houses, fence, etc.) is high among the local population (in total 5 cases were recorded). Six unauthorized water abstractions were recorded within the canal using siphons. A pedestrian bridge is arranged across the canal which connects local population with the agricultural lands located on the left side of the canal. Household waste with the total amount of 4-5 m<sup>3</sup> was observed on the right side of the canal. Facts of household waste incineration were observed in vicinity. Before connecting with the inverted siphon the canal turns north.

Jorjiashvilicanal

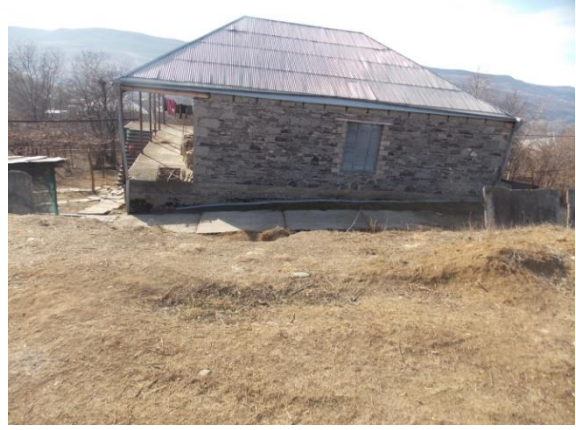
Damaged fence as a result of Jorjiashvili canal filtration

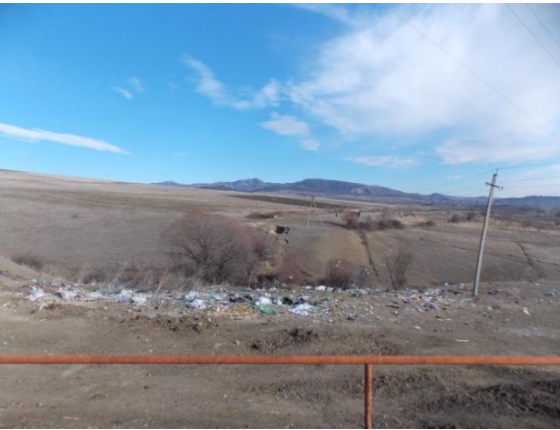
Small amount of tree-plant waste is accumulated on the inlet of Jorjiashvili inverted siphon. 1,5-2,0 m<sup>3</sup> household waste is observed on the left side of the inverted siphon inlet. Ground on the surface of the beginning section of the inverted siphon (pk59+74-pk74+39) is failed and eroded, route stability is violated. Third line does not exist on this siphon. In order to restore capacity of the canal in accordance with the sub-project a third line must be arranged. Transmission line passes on the right side of the inverted siphon. Separate sections may be approached via ground motorway.

Jorjiashvili inverted siphon corridor

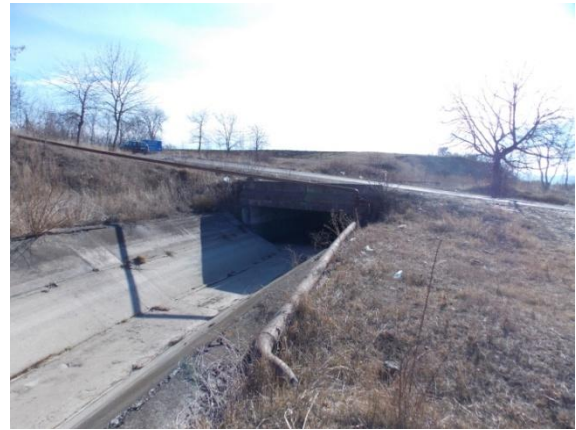
Shavsakdrisi open canal passes on the agricultural lands located between the villages Jorjiashvili, Enageti and Asureti, away from the populated areas. At Pk104+50, the canal crosses the main road of Tbilisi-Tsalka-Ninotsminda and the gas pipeline. After this it turns east. On pk109+70 it crosses the road connecting with the village Shavsakdrisi and connects with Shavsakdrisi inverted siphon. A ground road under satisfactory condition runs along the right side of the canal. The road on the left side is covered with vegetation. A few trees and bushes grow on the berm of the canal. Talus from the eroded slope located on the left side of the canal accumulates on the bottom on the section before crossing Tbilisi-Tsalka-Ninotsminda main highway. Eroded sections within the canal were not recorded. Small amount of vegetation waste and stone-gravel is accumulated on the bottom of the canal and discharge gates of the 9<sup>th</sup> pumping station located on the crossing of the access road leading to the village Shavsakdrisi. A pedestrian bridge is arranged across the canal which was supposed to be used for flow measurement.

Shavsakdrisi canal crossing the motorway

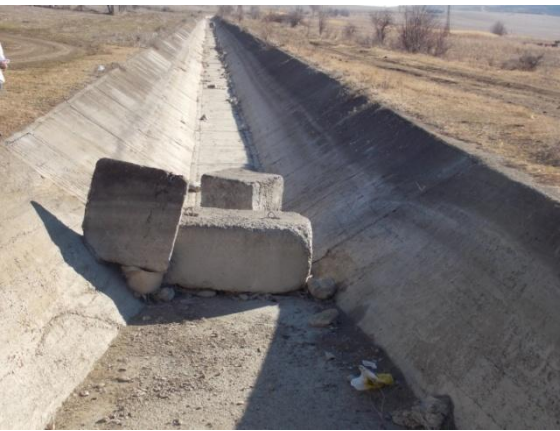
Asureti open canal #2 passes south to the vil. Asureti, mainly through the pasture, far from the settlements. The canal is followed by the gravel road from both sides. The road is in good condition. Vegetation cover on the slopes and berms of the canal is negligible (only herbaceous plants are observed). Concrete tiles (total volume  $\approx 2 \text{ m}^3$ ) are thrown into the canal for impoundment. At the final section the canal turns east and connects with the Asureti underground water pipeline #2.

Asureticanal№2

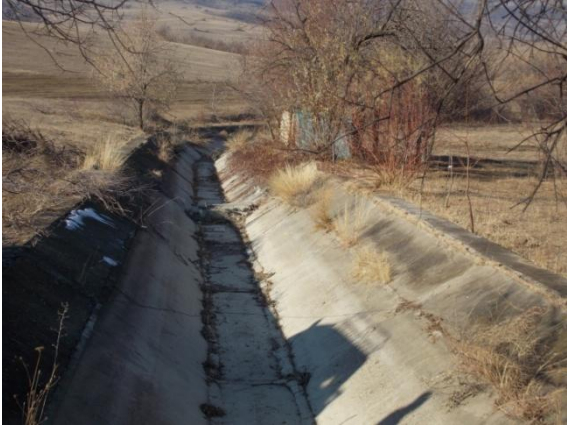
Borbalo open canal passes through the pasture, far from the settlements. The gravel road in satisfying conditions (some sections of it still require aligning of the subgrade) follows the canal from the left. From the right it is bordered by private land plots. On the right berm of the initial canal section there are 2 facilities (built with wooden and steel materials). To the right of the last section (near the emptier of excessive water) public food facility is arranged. Two wooden structures of this facility is located on the canal berm. Vegetation cover on both berms is intense (in total there are 30 units of apricot, poplar and other low-value trees and bushes). The canal connects with Borbalo underground water pipeline.

Borbalocanal

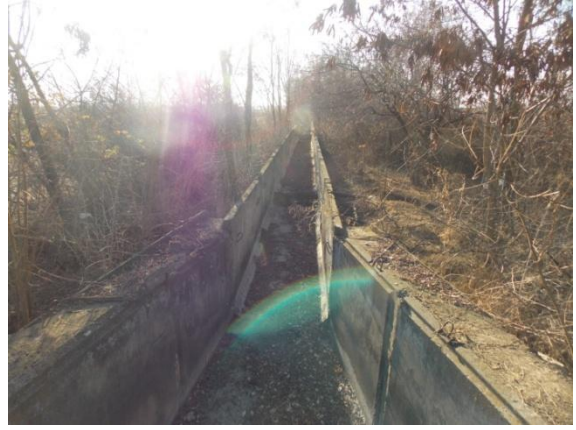
Rectangular canal passes south-east to the vil. Borbalo, through the agricultural lands. . The gravel road in unsatisfying conditions (the subgrade is damaged or covered with plants at some sections) follows the canal from the right. Vegetation cover on both berms is intense – up to 80 units of trees and bushes are represented. On some sections of the canal concrete lining is damaged and water is being taken illegally using pipelines. Rectangular canal connects with the Vashlovani underground water pipeline.

Rectangular canal

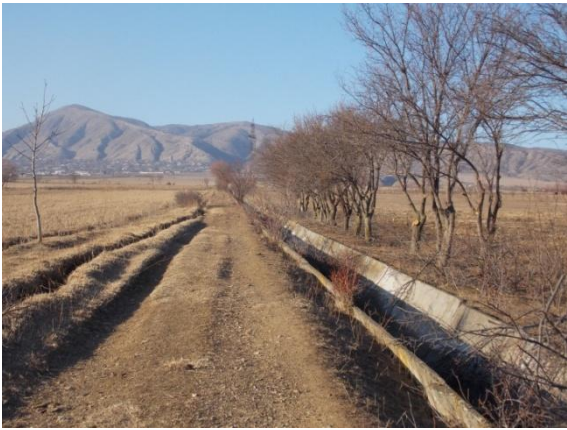
Parabolic inclined canal lies north to the vil. Koda, through the agricultural lands. The canal is followed by the gravel road from the both sides. The road is in unsatisfactory conditions (the road subgrade is eroded by the artificial ground canals). On the slopes of the canal several large trees blossom (mainly apricot trees). At some sections concrete surfacing of the canal is seriously damaged, concrete tiles are broken by the local population. Water is stolen illegally using pipelines and ground canals (up to 10 illegal water users were detected). The bottom of the canal is filled with large volume of vegetation waste, rocks and slime. The canal ends at regulating basin. The concrete surfacing of the basin is damaged, it is filled with rocks, slime and vegetation waste.

Parabolic inclined canal

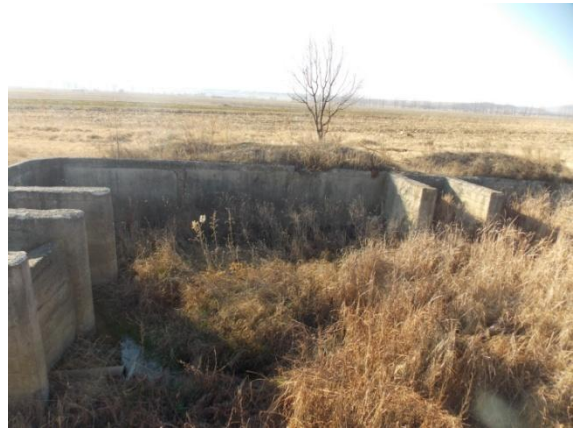
Reservoir adjacent to Koda-Marneuli motorway
