The Gambia Essential Health Services Strengthening Project (P173287)

ASBESTOS ABATEMENT REMEDIAL ACTION PLAN For Health Care Facilities Renovation and Installation

September 9, 2022

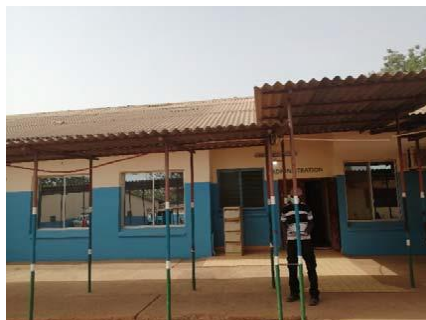
Figure 1. Waiting shed

The survey found a significant number of HCFs where asbestos is found, and they are in a very poor state, badly damaged. In Basse District Hospital, the maternity ward, chest/tuberculosis clinic and waiting sheds, the asbestos fibers in the roofing are exposed. In Mansakonko, all the roofing sheets in the staff quarters had holes and cracks with exposure to fibers. In other areas, asbestos was found in the kitchens, offices, fencing and drainage pipes of toilets.

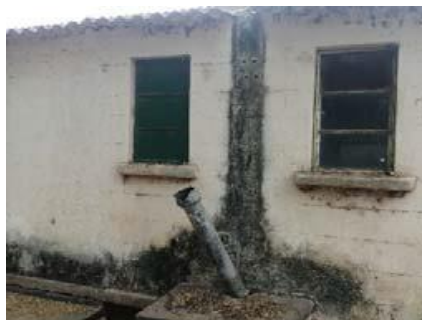
Figure 2. Asbestos in plumbing pipework

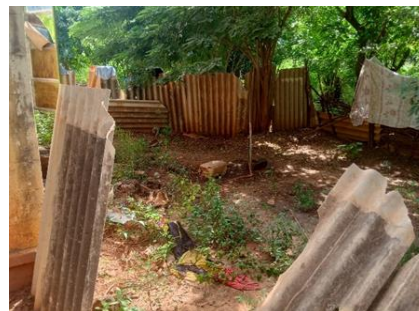
Figure 3. Old asbestos roofing sheet for fencing

According to the *NEA report* some of the asbestos removed from buildings were found to be reused for fencing for gardens or outdoor bathing areas while others are left lying abandoned which poses more health risks.
