KOMATI POWER STATION SOLAR PHOTOVOLTAIC, BATTERY ENERGY STORAGE SYSTEM, WIND ENERGY FACILITIES AND ANCILLARY INFRASTRUCTURE

DRAFT ENVIRONMENTAL AND SOCIAL IMPACT ASSESSMENT REPORT
PART IV – APPENDICES E8 – E14

22 AUGUST 2022

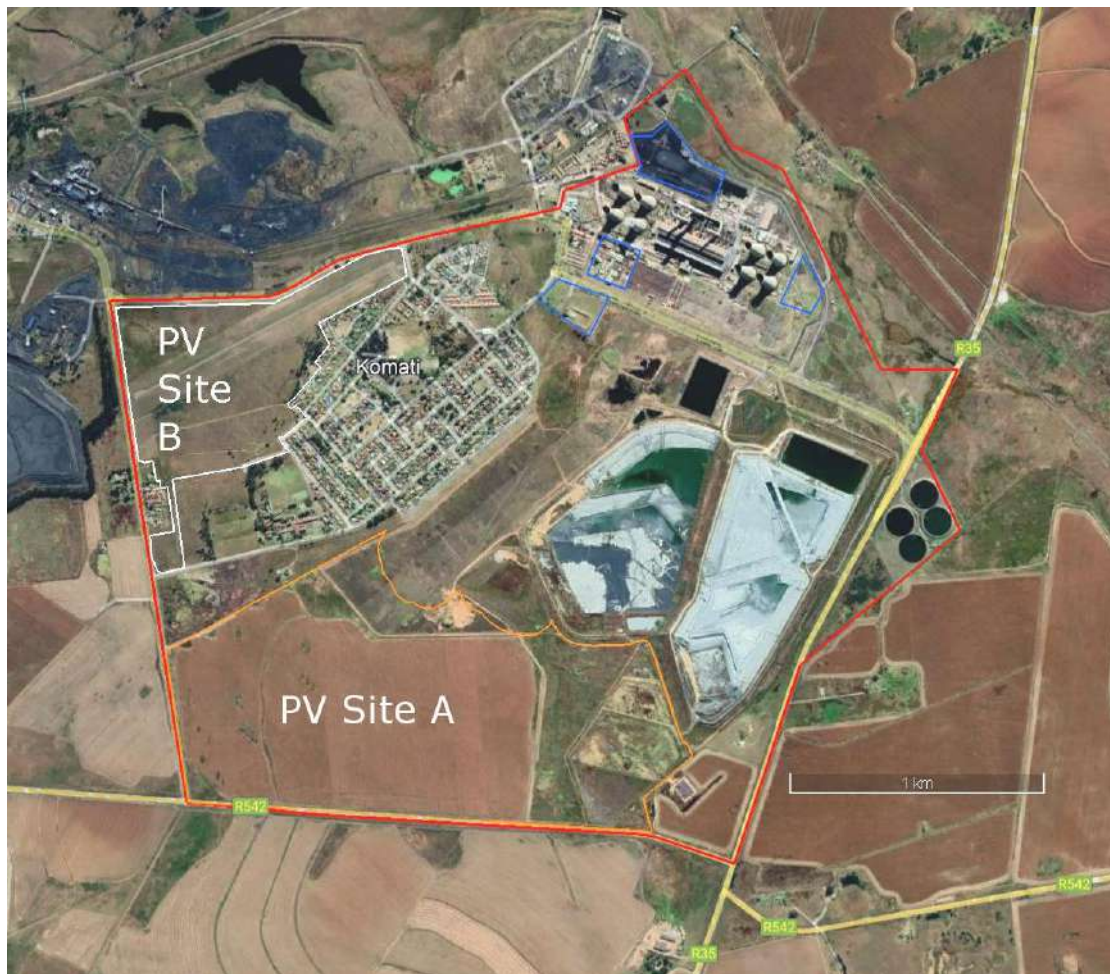
Figure 6: Aerial view of the proposed Solar PV Energy Facility Development Footprints (orange PV Site A and white PV Site B) and BESS (blue).

The BESS development sites are located within the power station property; in very close proximity to the existing power station infrastructure i.e. the core power plant, cooling towers and substations.

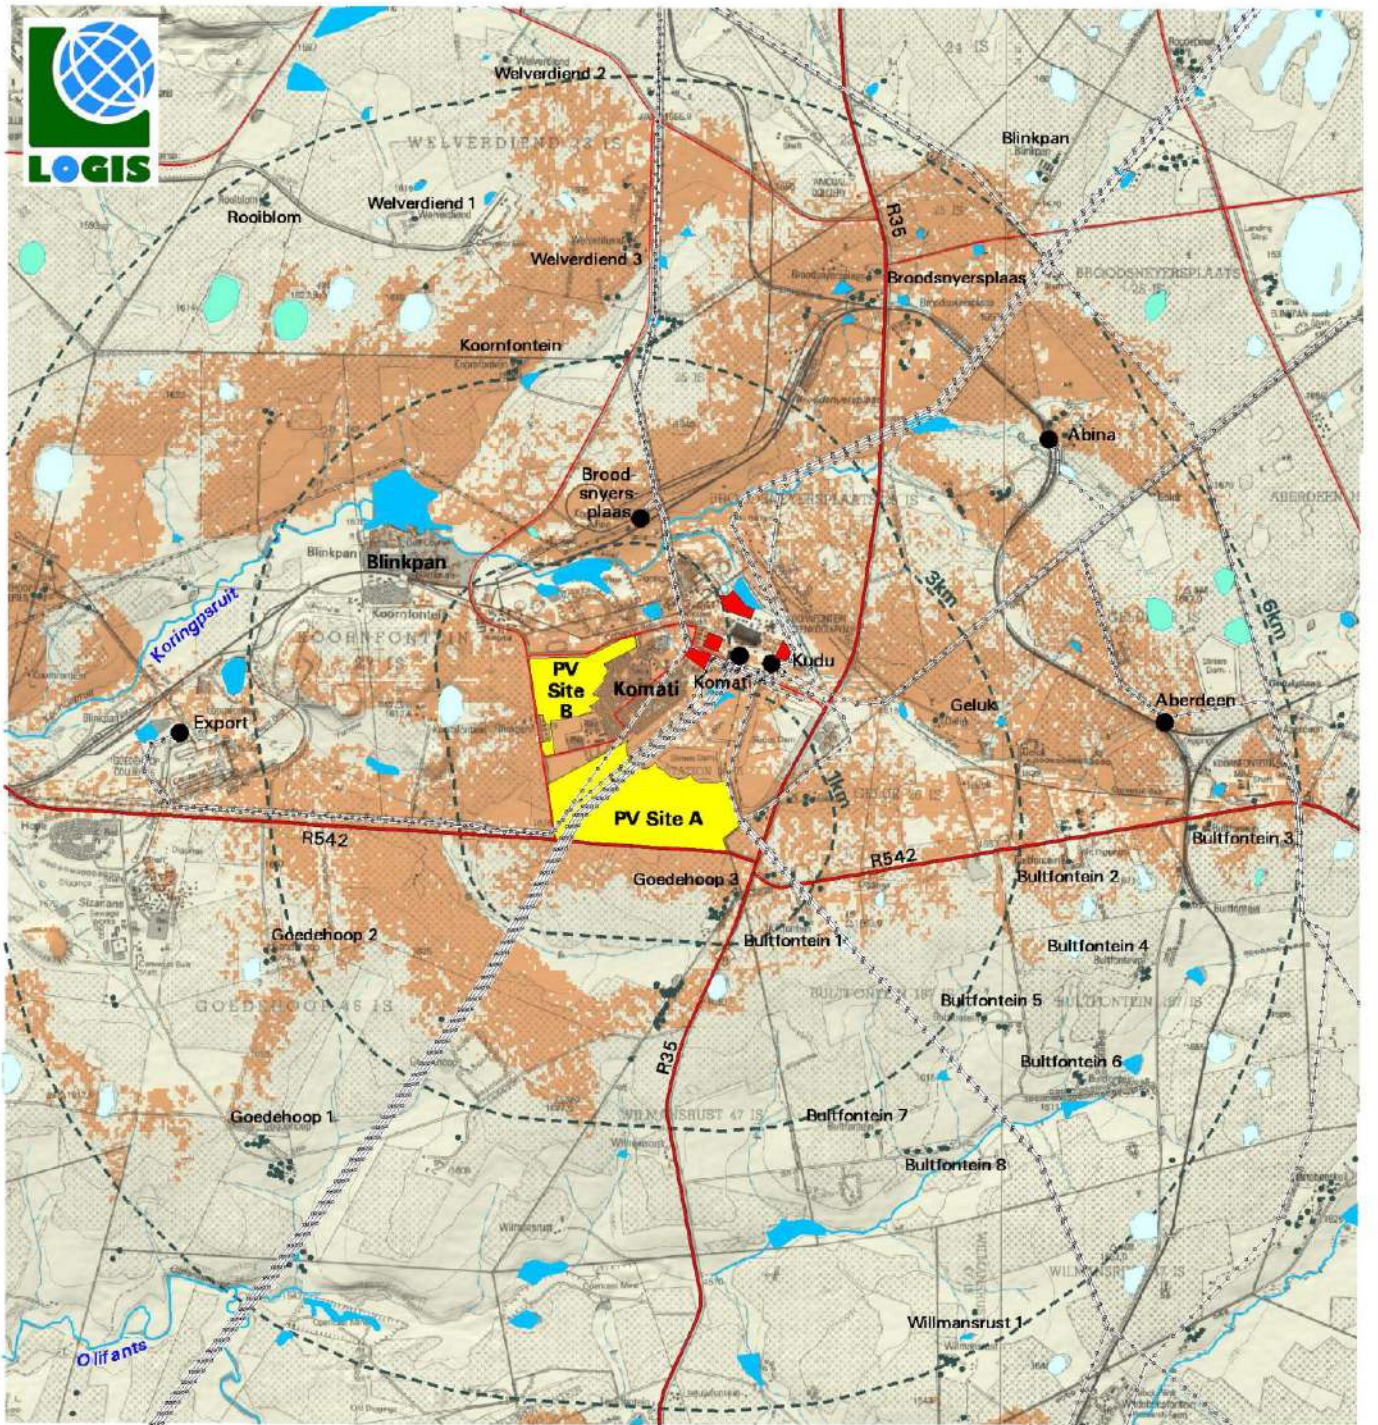
Map 3: Map indicating the potential (preliminary) visual exposure of the proposed Komati Power Station Solar PV Energy Facility.

The PV facility (both sites) is expected to be visible for up to 6km from the development sites. The visual exposure is relatively scattered due to the undulating nature of the topography, with lower-lying land (e.g. along the Koringspruit and Olifants Rivers) shielded from the infrastructure, and only higher-lying terrain being exposed. It should be noted that the potential visual exposure will not occur in isolation, but rather in conjunction with the existing mining, power line and power station infrastructure in closer proximity to the sites.

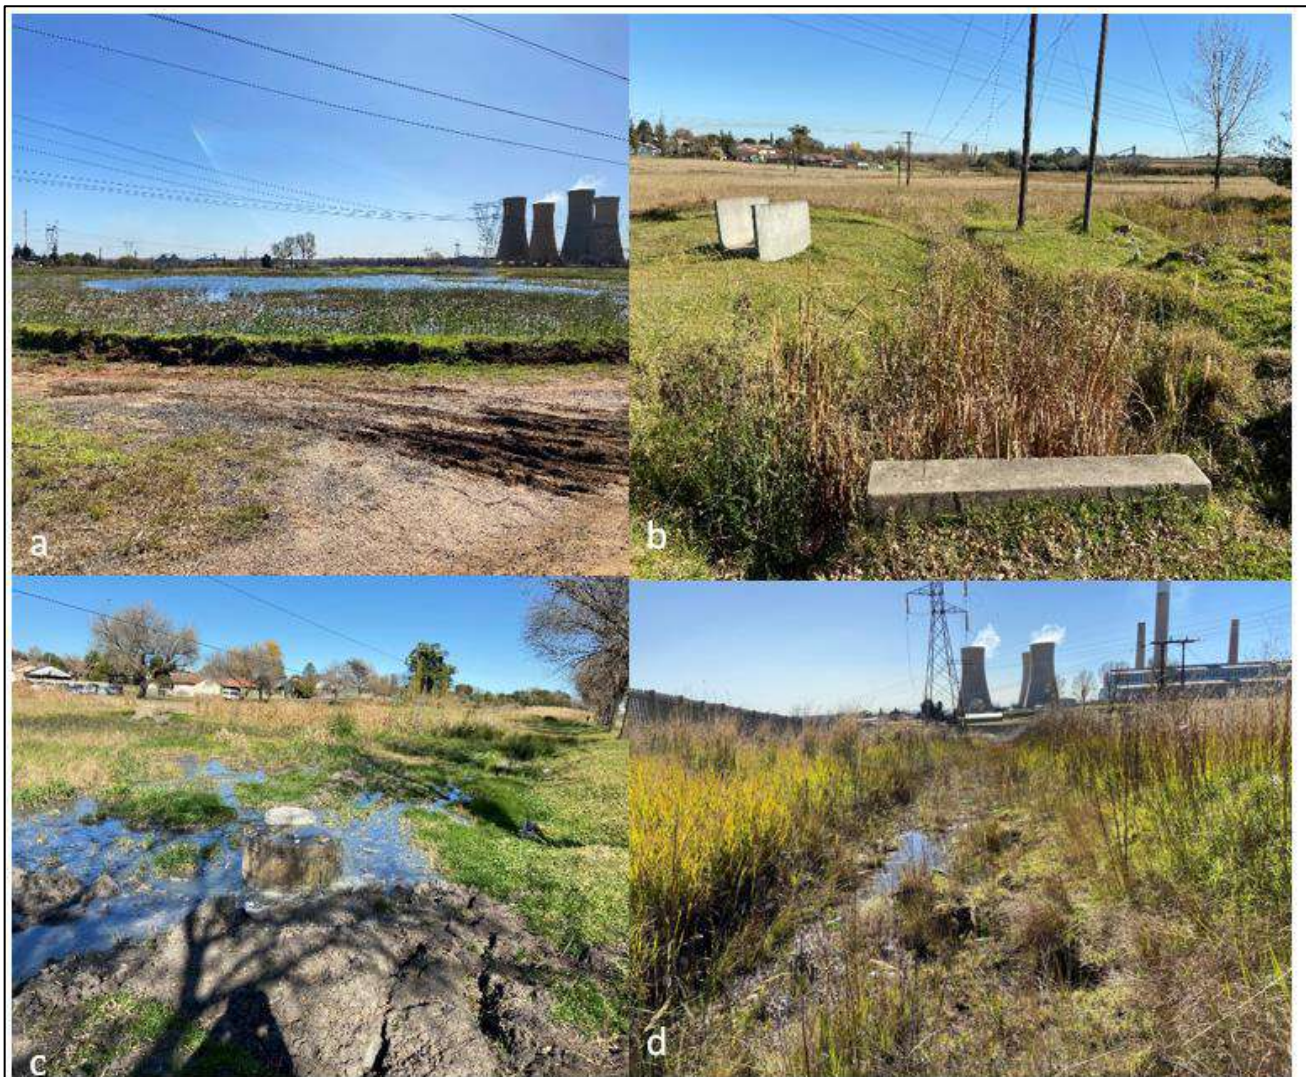
Figure 18: Impacts: a) pooling of water at dam; b) trenches and berms in wetland; c) effluent discharge into the wetland from a leaking pipe; d) impoundment of water at roads in wetland

Major impacts identified in the Seep 2 wetland include increased water inputs into the wetland system from the PCD, spread of alien invasive species, impoundment of flow along roads and dams, and the presence of drains and trenches. These disturbances, together with the likely impact on water quality as a result of seepage from the PCDs, have contributed to the Largely Modified state (PES Category D) of the wetland.

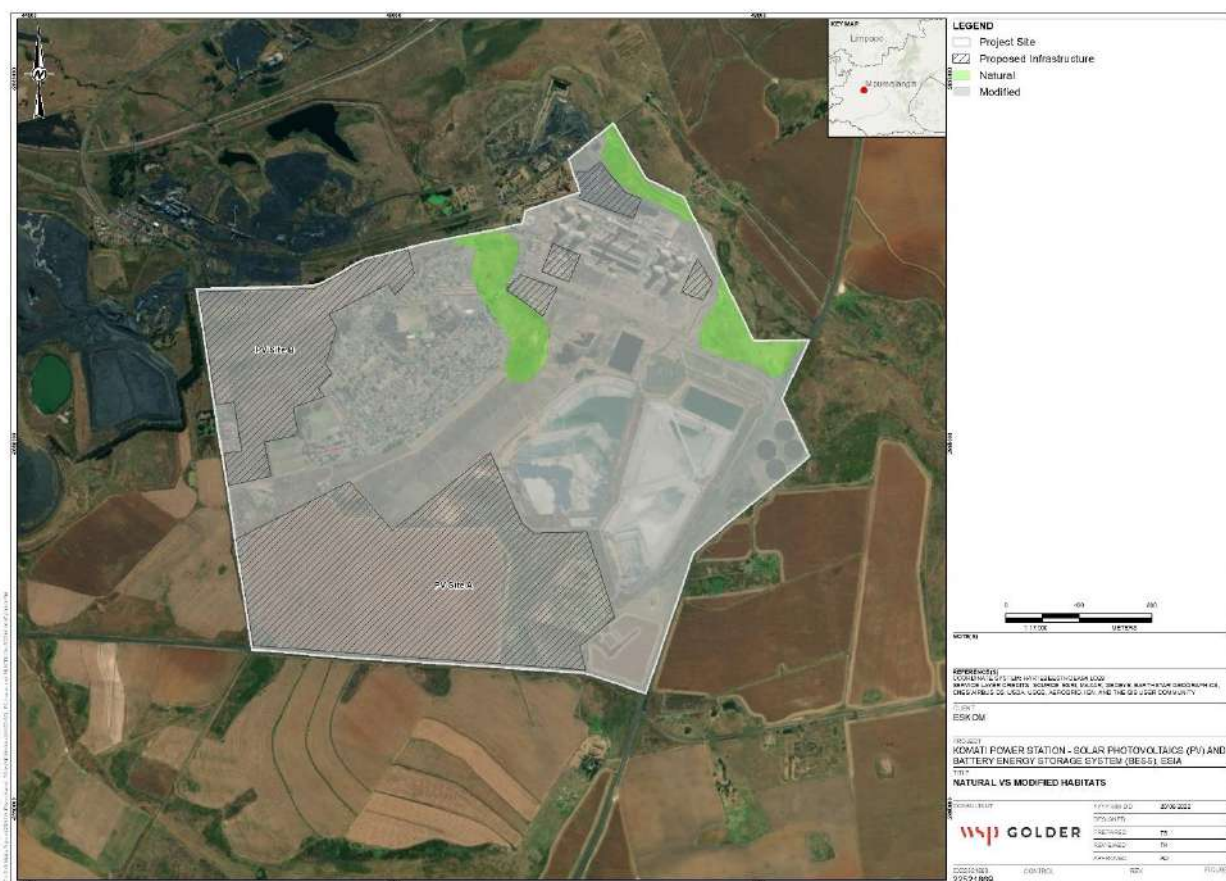
Figure 22: Natural, modified and critical habitat

The study area is dominated by agricultural cultivation, power station infrastructure and residential/industrial areas, interspersed with some remnant wetland habitat. While some very disturbed wetland habitat has been identified in the eastern extent of PV Site A, it is no longer considered to constitute 'Natural' habitat as defined by WB ESS6 or IFC PS6, due to its heavily degraded state and loss of ecological function. The channelled valley bottom wetland to the north east of the site, and the seep wetland that crosses the northern boundary of the site, while moderately modified/disturbed, still support biodiversity and deliver ecological services to an extent that enables them both to be considered 'Natural' habitat (Figure 22) as defined by the lender standards.
