East African Public Health Laboratory Networking Project (EAPHLNP)

Initial Environmental & Social Audit Study Report

**Regional Public Health
Laboratory**

Located in Busia Town

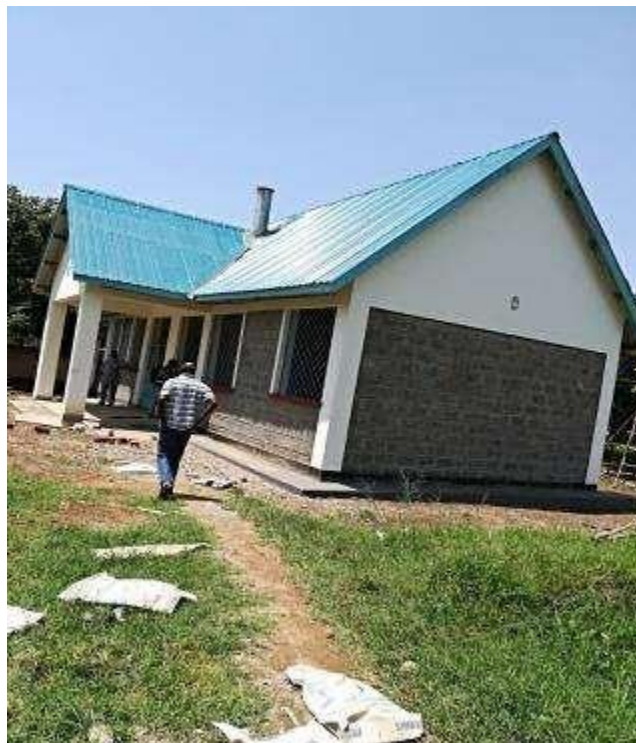
Plate 1: The New Incineration Facility

The new incinerator is located in a green field within the Busia District Referral hospital compound, on the North western side of the hospital. During the Environmental Audit process, it was observed that the facility housing the new incinerator had been completed and minor installation works of the incinerator were being finalized. These activities have minor impacts on the environment. Thus, these impacts are as well addressed in chapter seven of this report under mitigation and corrective action plans. The incinerator shown below was awaiting commissioning at the time of the Environmental Audit.

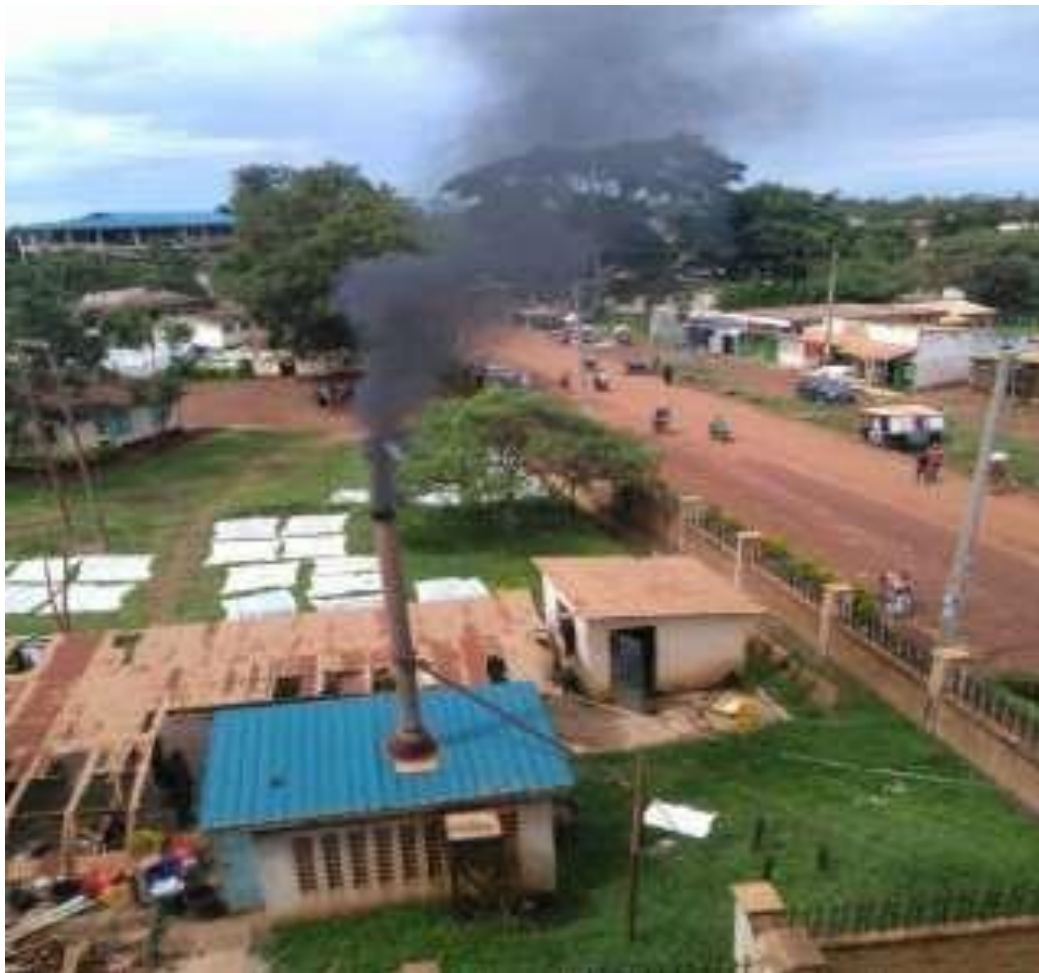
Plate 2: Chimney Emissions from the old incinerator

- It was observed that during the operation phase of the laboratory, the facility was still using an old incinerator for the disposal of medical waste whose opacity was high.
- The new incinerator had been installed at the time of the Audit and was scheduled for commissioning.

The particulate matter assessment method involves inserting a probe nozzle made from stainless steel into the stack, through a pittot tube and the particulate matter were trapped on a pre-weighed glass microfiber filter. The stainless steel filter holder was fitted with heat resistant seals to avoid any leaks. Suction pressure was maintained using isokinetic sampling pump. The particulate matter emissions was calculated from the amount collected on the filter paper, taking into consideration the temperature, volume of exhausted gas sampled, emission velocity through the stack and the pressure drop for the sampling device.

PARAMETER	ARITHMETIC MEAN OF THE READINGS	NEMA AIR QUALITY GUIDELINES	REMARKS
Carbon monoxide (CO)	900ppm	<input type="checkbox"/> Not indicated	
Carbon dioxide (CO ₂)	100µg/m ³ (1000ppm)	<input type="checkbox"/> 500µg/m ³ (5000ppm)	Within the recommended range
Hydrocarbons (C _x H _y)	Not detected	<input type="checkbox"/> 300µg/m ³	Within the recommended limit
Sulphur dioxide (SO ₂)	10.5µg/m ³ (1ppm)	<input type="checkbox"/> 400µg/m ³	SO ₂ Emission is low.
Nitrogen dioxide	Not detected	<input type="checkbox"/> 1500mg/m ³	Within the limit
Particulate Matter	Not detected	<input type="checkbox"/> 50µg/m ³	Within the limit
Dioxins & Furans	Not detected

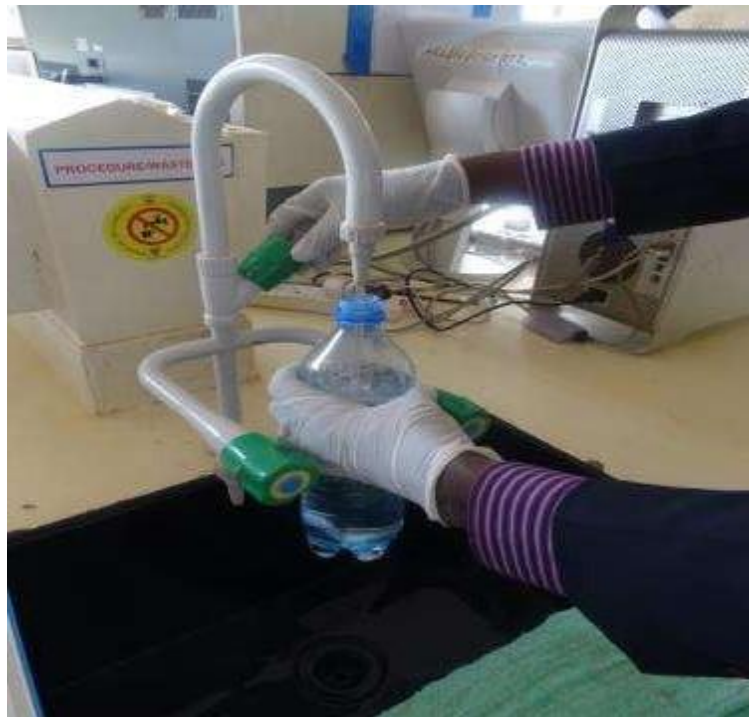
Plate 3: Sampling of Water at the Laboratory

The consultant sampled water at 4 sampling points including within the kitchenette, laboratory, borehole and storage tank. Each sample was collected in one-liter sampling bottle and the samples were transported to the Lake Victoria South Water Services Board laboratory for testing.

The test results were compared to the local water quality standards in and confirmed that all the parameters in the samples were within the recommended physical-chemical and biological standards. The parameters that were considered included; P.H., E-coli, TSS, TDS, among others as required. The results of the water quality testing are presented in Appendix 3 of this report.

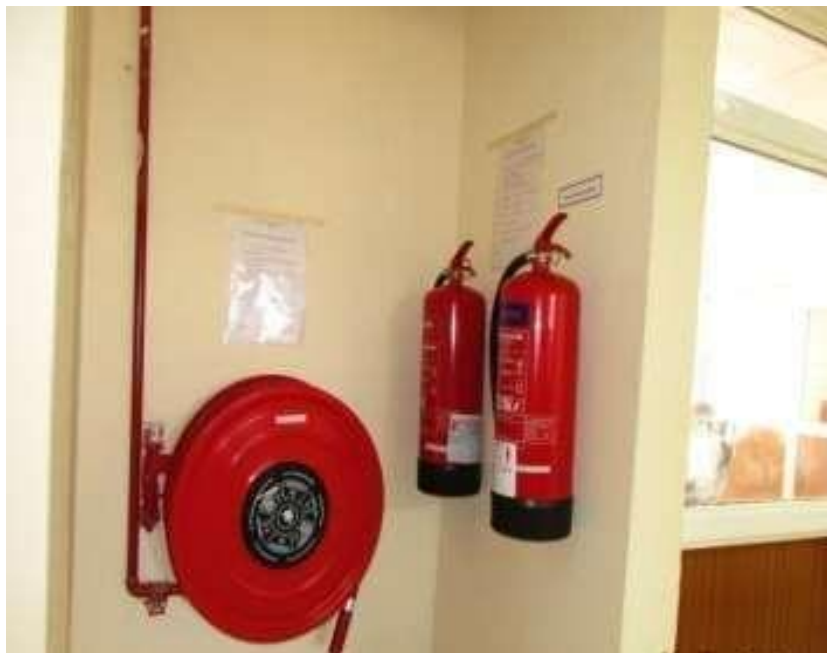
Plate 5: Firefighting equipment at the Laboratory

The emergency procedures in place are designed for handling emergencies likely within the scope of Occupier's business such as fire/explosion, spillages and splashes. The Occupier's fire prevention system comprises of water hydrants, water storage tanks, hose reels, and portable fire extinguishers (CO₂, dry powder, foam) mounted at various points at the facility. These appliances are serviced two times in a year by suppliers.

The occupier had clearly indicated a designated fire assembly point within the compound of the facility. The fire assembly point was clearly marked in green and white signage as required.

The Occupier has first aid kits but under untrained First Aiders and any emergency case that occur at the workplace is immediately attended to while major injuries/cases are referred to the Hospital. It was however observed that the smoke and fire detectors had not been tested and were therefore not working, thereby exposing the facility to fire risk.

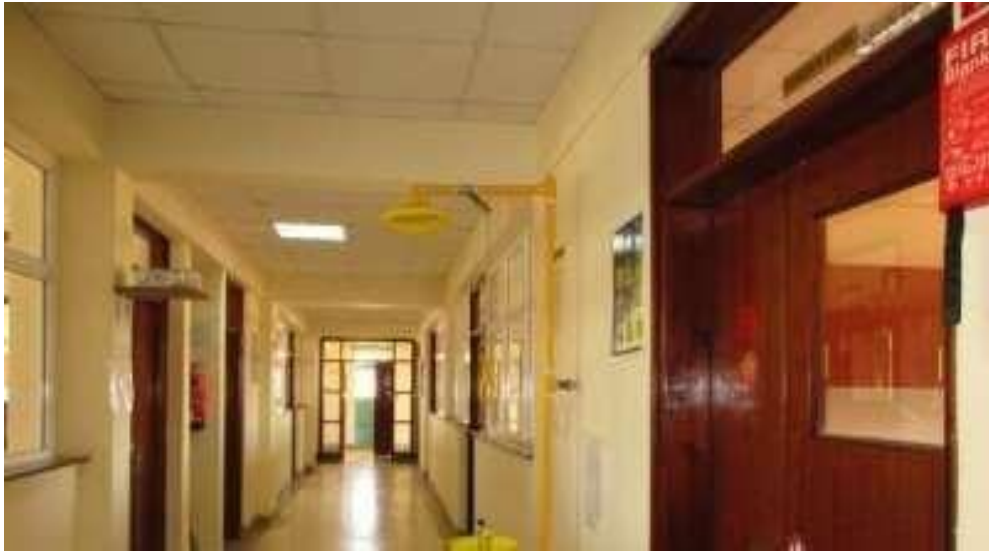
Plate 6: Face/Eye wash unit

There was no evidence of fire drill and training among the laboratory staff which also compromises the preparedness and response status. Whereas there is provision for emergency eyewash unit at the facility as shown overleaf, the functionality of the same was compromised and none of the staff could operate the same. There is need to service the eyewash unit and train the staff on its use.

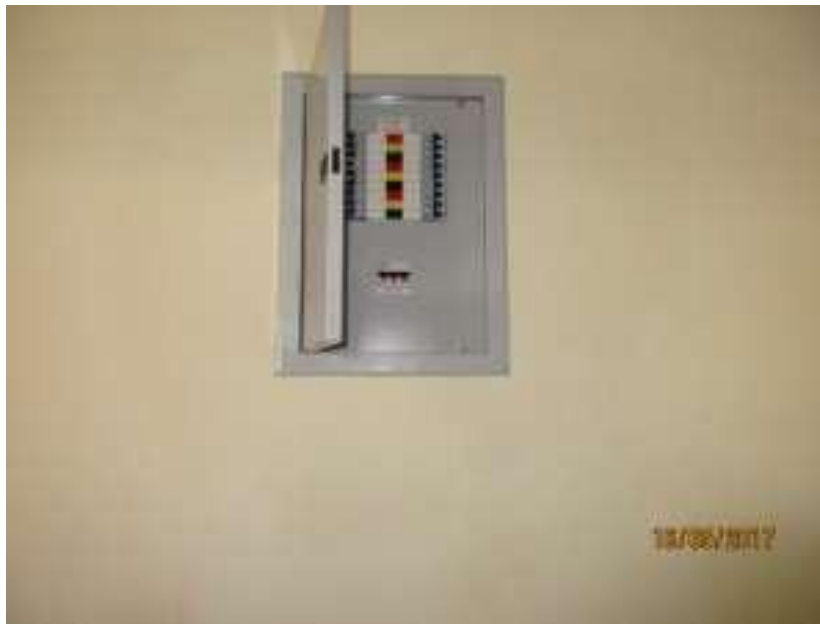
Plate 7: Functional Power Panel

The plants, equipment, appliances and machinery at the Occupiers' premises are in safe electrical conditions. During onsite inspection of the Occupier's workplace, the following were observed with regard to the electrical safety:-

- All the equipment, appliances and machinery did not have worn out or wires and conductors that are not insulated or drawing power directly from the socket without use of plugs or unsuitable plugs;
- The locking devices of power panels were in good condition;
- All equipment are earthed and the earthing tested;
- The workstations did not have overloaded power sockets nor had any electrical plants, equipment, appliances and machinery exposed to wet conditions.

- Underground electric cables are suitably protected; the cables are within appropriate pipes
- Maintenance of electrical installations is done by in house team of trained technicians. The maintenance schedule involves regular checks of the facility and implementing corrective action. The checks are done on a daily basis, on or responding to reports by employees and other equipment users

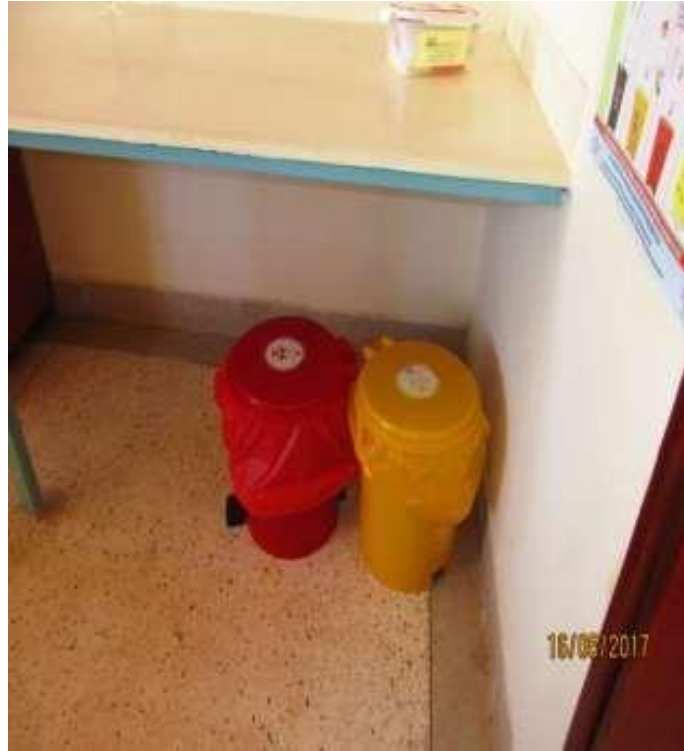
Plate 8: Waste segregation at Source

The laboratory facility generates different types of wastes from the streams of its operations. These wastes include hazardous clinical and general wastes. The wastes were segregated in to black, yellow and red heavy polythene bags as per the waste management regulations and were collected and central point for transportation to

the burning chamber within the hospital facility as the new incinerator was still under construction at the time of the Audit. Plate 8 overleaf shows waste segregation at source as compliance and good practice on waste management.
