IMPLEMENTATION COMPLETION AND RESULTS REPORT
ON A
PURCHASE OF EMISSION REDUCTIONS
FROM THE COMMUNITY DEVELOPMENT CARBON FUND
TO THE
GUODIAN GUANGRUN HYDROPOWER DEVELOPMENT COMPANY
FOR THE
HUBEI GUANGRUN HYDROPOWER DEVELOPMENT PROJECT

October 14, 2020

IMPLEMENTATION COMPLETION AND RESULTS REPORT (ICR)
China-CDCF Hubei Guangrun Hydropower Project

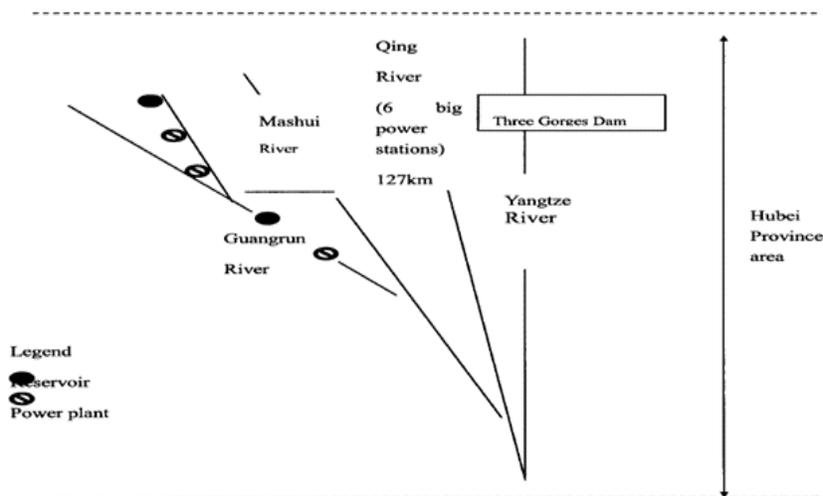
Figure 1. Project Location

8. The two subprojects in the Guangrun component consist of two reservoirs and three power stations, of which Hongwawu phase 2 and phase 1 power stations were commissioned in September 20, 2009, and November 29, 2010, respectively. Zhamushui power station, which is located downstream of the Hongwawu power stations, was commissioned in August 29, 2012. The project subsequently constructed the small 2 × 200 kW Kongzishan power station, which was commissioned on September 25, 2012, to take advantage of the water from the drinking water outlet penstock to compensate for financial losses of the project (see figure 1).

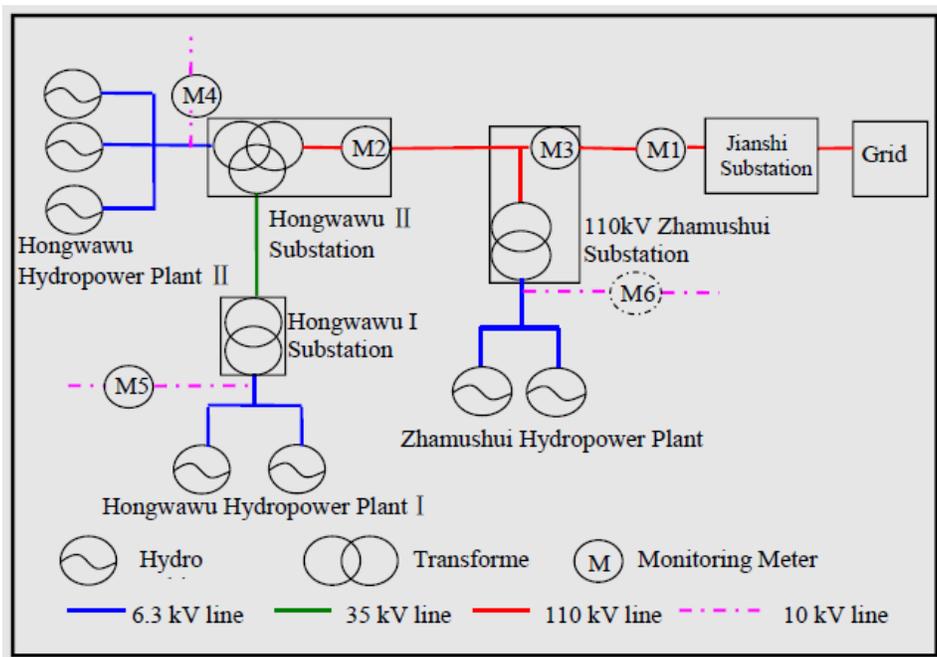
Figure 2. Configuration of the Meters

56. To measure the net electricity supplied to the grid by the project, three meters were installed: (a) a primary meter (M1) is at Jianshi substation with an accuracy of 0.2 s; (b) a backup meter (M2), in case of failure of the primary meter, is at Hongwawu II substation with an accuracy of 0.5 s; and finally, (c) a meter (M3) is installed at Zhamushui substation. The meters measure the electricity supply on a continuous basis, but M2 and M3 are not being used in calculating emission reductions.

57. To supply electricity to the plant in emergency cases when the main power line fails to supply power, a 10 kV backup line at each plant has been installed. Meters M4, M5, and M6 are installed to measure the electricity imported from the grid through these lines. These meters are owned, maintained, and read by the grid company. The accuracy and calibration of M4, M5, and M6 are in compliance with related national standards DL/T448-2000, and calibration reports are supplied to the designated operational entity (DOE) for calculation of CERs. During the monitoring periods, there has been no import of electricity through the backup lines.

58. Electricity supplied to the grid by the project is calculated as electricity exported to the grid by the project minus electricity imported from the grid through the main line and electricity imported from the grid through backup lines. Meter readings of electricity exported to the grid by the project and electricity imported from the grid through the main line are cross-checked by their own corresponding sales receipts to ensure the conservativeness of emission reductions calculation. Values from the sales receipts of electricity imported from the grid through backup lines are used for emission reductions calculation as only the grid company has access to the meters and it is not likely to underestimate the electricity sold to the project company.

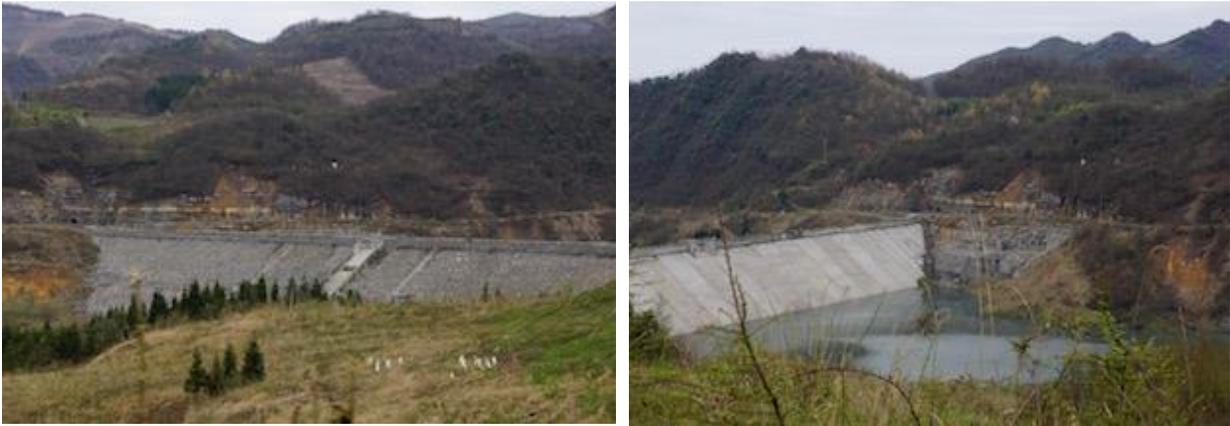
Hongwawu Dam

46. The Hongwawu dam has been operating at the dead water level (low water level). In the regular inspection and checking, the dam and reservoir banks appear in normal condition.

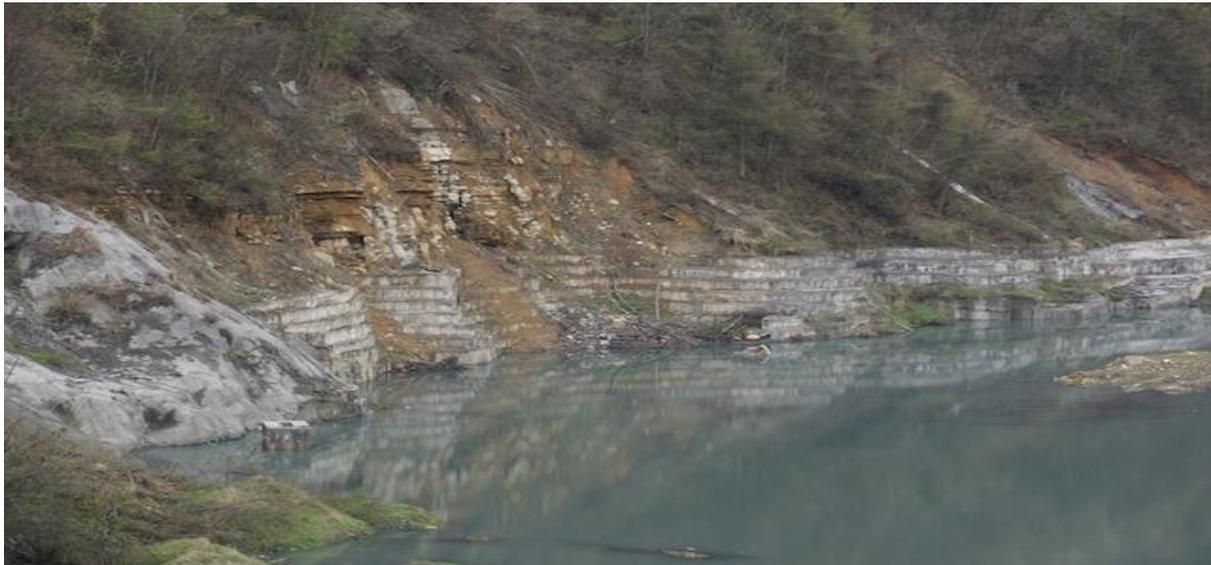
Leakage at Hongwawu - Bottom Treated and Upper Untreated Areas

50. The Hongwawu reservoir and two powerhouses were completed and commissioned in 2009 and 2010, respectively. Soon after that leakage was found in the right abutment and reservoir bed, because of the insufficient prefeasibility stage geological investigation. The leakage has only been partially treated. This increased the shortfall of the water resources caused by the unresolved water dispute with neighboring counties in Chongqing. The Zhamushui dam also faced technical difficulties, with two faults and one fracture zone discovered in the left abutment during excavation and falling rock in the right abutment during operation. The faults and fracture in the left abutment were properly addressed by cement injection, while the decision on falling rock area treatment has been pending since 2017. Although it was partially commissioned in 2012, the construction of two diversion channels for Hongwawu and the installation of flood discharge gates at Zhamushui were not completed. Because of the incomplete construction of these two hydropower stations, their power generation has only reached about half of the design level, resulting in a deteriorating financial position for the Guangrun hydropower company.

- **Leakage at Hongwawu.** During implementation, significant leakage was discovered in the right bank of the Hongwawu dam. Though it was delayed, the first stage of leakage treatment was completed on August 31, 2013. At the time of the ICR, the second stage of leakage treatment had not begun. Due to the high cost of the second stage of leakage treatment, the PE may only consider it when the water resource dispute is properly addressed. Otherwise, the low waterhead may not need the second stage treatment.

- (i) **Environmental.** As mentioned earlier, the second stage of the leakage treatment has not commenced. The PE sees no reason to start this treatment unless the water disputes are resolved as the leakage will not have a significant impact if water levels remain low. The PE plans to commence the second treatment when the water dispute over the Qilibian water diversion tunnels comes out in their favor. It deserves to be mentioned though, that at present during monsoon season, water levels can rise to about 4 m above the current leakage treatment, and the PE has thus been encouraged to continue the leakage treatment as soon as possible. In addition, the issue regarding siltation from the tailings of coal mines upstream at Hongwawu remains and must be resolved so it does not affect dam performance and water quality. The resolution would be the installation of additional retaining walls.

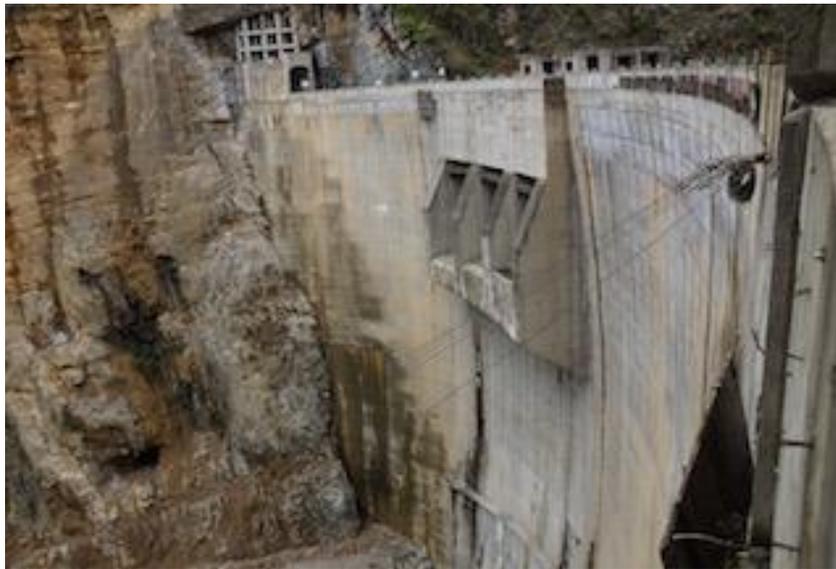
Zhamushui - Missing Sluice Gates

No	Activities in Chinese	Activities	Due Date
To be completed by the given deadline			
1	完成闸木水右岸边坡处理方案和实施	The slope treatment plan and execution for the right bank of the Zhamushui dam	May 31, 2022
2	闸木水大坝右岸边坡处理完成后尽快完成坝顶溢洪道闸门安装	The installation of sluice gates of the crest spillway of Zhamushui dam when the slope treatment for the right bank is completed.	December 31, 2022
3	确定红瓦屋右岸第二阶段渗漏处理方案	Confirm the plan of the second stage leakage treatment of the right bank of Hongwawu reservoir	December 31, 2022
4	红瓦屋大坝监测仪器计划	Updated Dam Monitoring System and Instrumentation Plan	December 31, 2022
5	安全监测系统运行（第一阶段，闸木水大坝）	Dam Monitoring System Functioning (With Zha Mushui)	December 31, 2023
6	安全监测系统运行（第二阶段，红瓦屋大坝）	Dam Monitoring System Functioning (With Hong Wawu)	December 31, 2024
7	项目业主（贷款人）变更需事先得到世行的审查和无反对意见	The Ownership change of the project need to get approval of the Government and no-objection of the World Bank's beforehand and with proper due diligence	Continuously

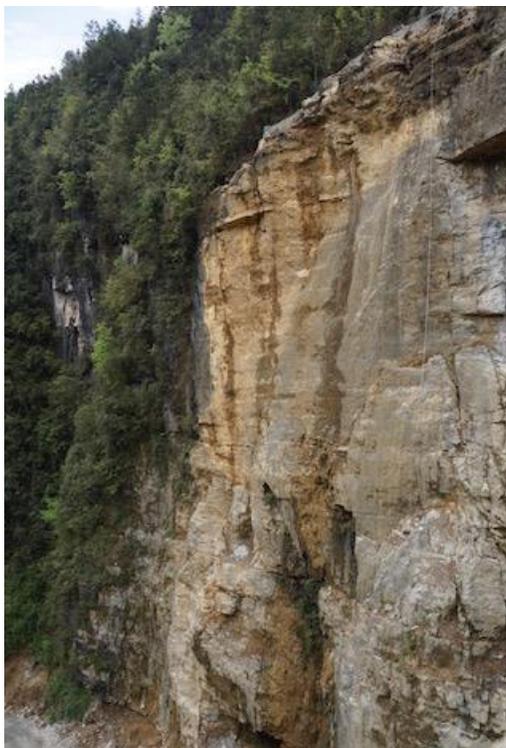
Zhamushui - Untreated Right Bank

76. However, several deadlines regarding the final demands for satisfying the World Bank safeguards related to dam safety were not met at project closure. The decision on whether it is necessary to carry out the treatment of the right abutment at the Zhamushui dam has been pending for four years. In addition, at the time of the ICR there is no time line for the second treatment of leakage at Hongwawu. At the ICR stage, a brief ‘Dam Safety Panel Working’ report was submitted to the World Bank. The World Bank team provided comments for the PE to improve, and the PE is committed to improve the quality of the report in the future accordingly.
