Environmental and Social Screening Report & Environment and Social Management Plan (ESMP)

Rehabilitation of Right Bank Main Canal of Walawe Reservoir

Integrated Watershed and Water Resources Management Project (IWWRMP)

May 2019

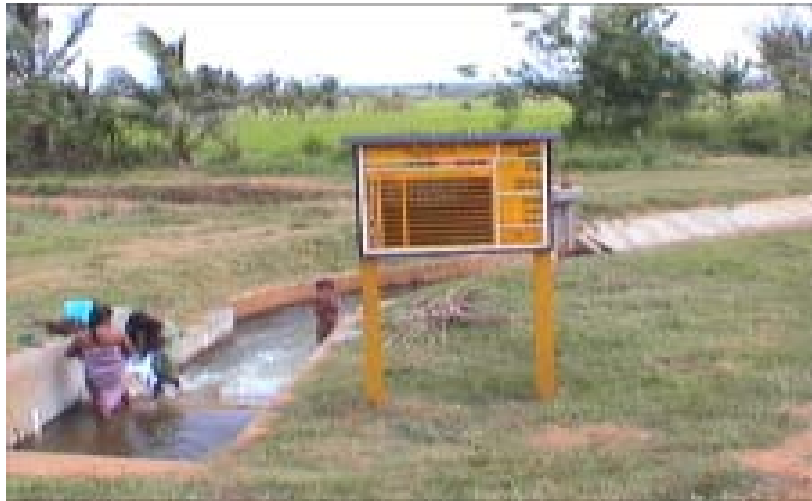
Figure 2: Display Boards fixed at calibrated outlet canal

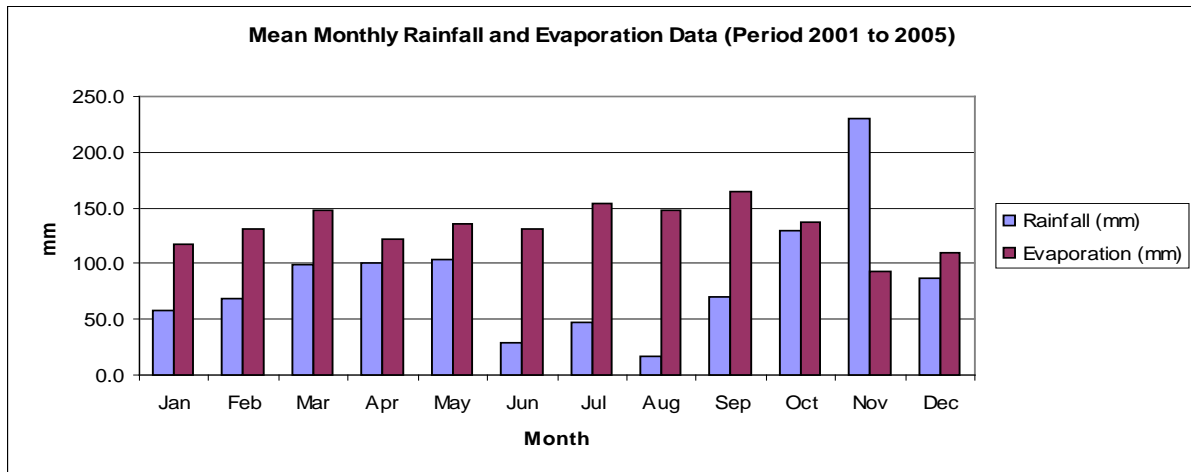
Dry Monsoon forest climate with an annual rainfall of about 1520mm has mean day and night temperature of 29 and 24 degrees centigrade respectively. Variation of monthly rain falls within a year in the RB area is indicated in the following graph

Rainfall and Evaporation data in Udawalawe

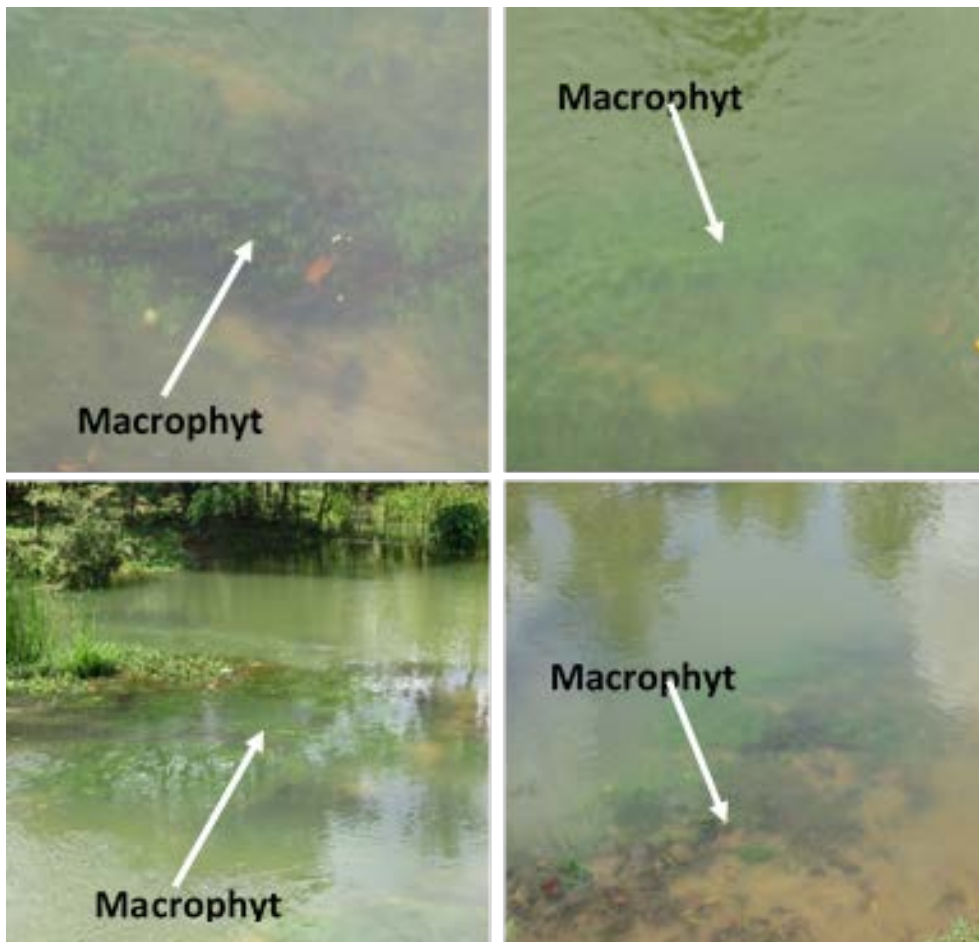
Aquatic macrophyte (plants) beds in the RBMC at the downstream of Chandrika reservoir are provided in the pictures below. Aquatic macrophytes play a crucial role in maintaining the integrity of aquatic ecosystems. Although reed beds hinder the canal flow, it provides good habitat for many avifauna and keeps the water quality in a good condition. Hence, a compromise has to be made when removing this vegetation.

Figure 3. Macrophyte (aquatic plant) beds found in the RBMC

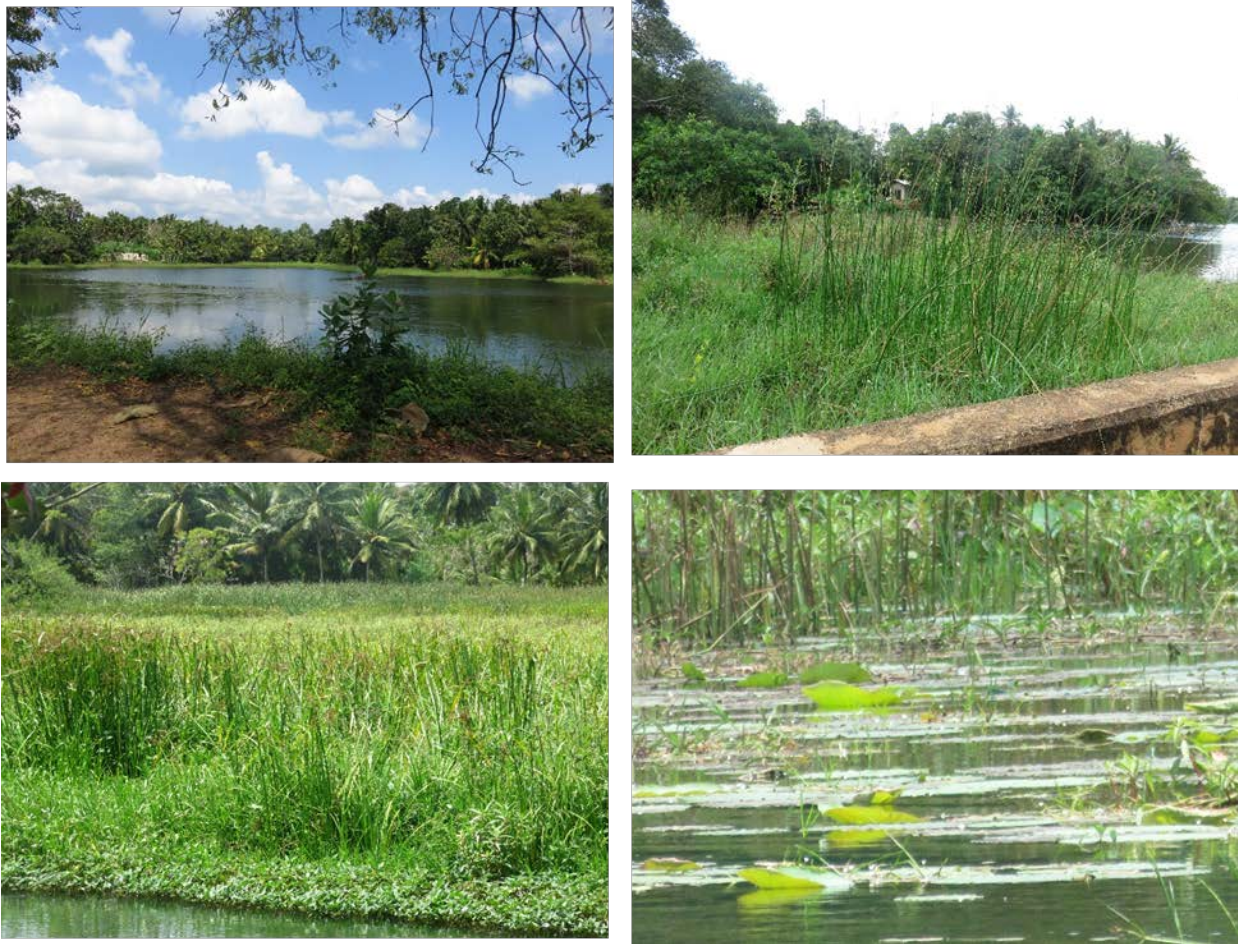
RBMC is a lotic ecosystem (flowing water system) that maintain connectivity between the upstream and downstream. There is large number of village tanks and level crossings (isolated water bodies – around 10) located along the RB main canal. There are 30 village tanks located within the downstream areas below the RBMC. In addition to storing water, those isolated tanks play the role of wetlands in the landscape. The RBMC consists of an array of microhabitats along the canal that supports a diverse group of fauna and flora. Under this context, the level crossings has a significant role to support biodiversity in this system, as there are associated freshwater wetland ecosystems. Wetlands are among the most important ecosystems on earth act as sources, sinks and transformers of multitude of chemical, biological and genetic materials. There are many wetlands closely link with the RBMC via level crossings and are depicted in the pictures below.

Figure 4. Wetlands associated with level crossings of the RBMC .It consist of an array of microhabitats along the canal that supports a diverse group of fauna and flora

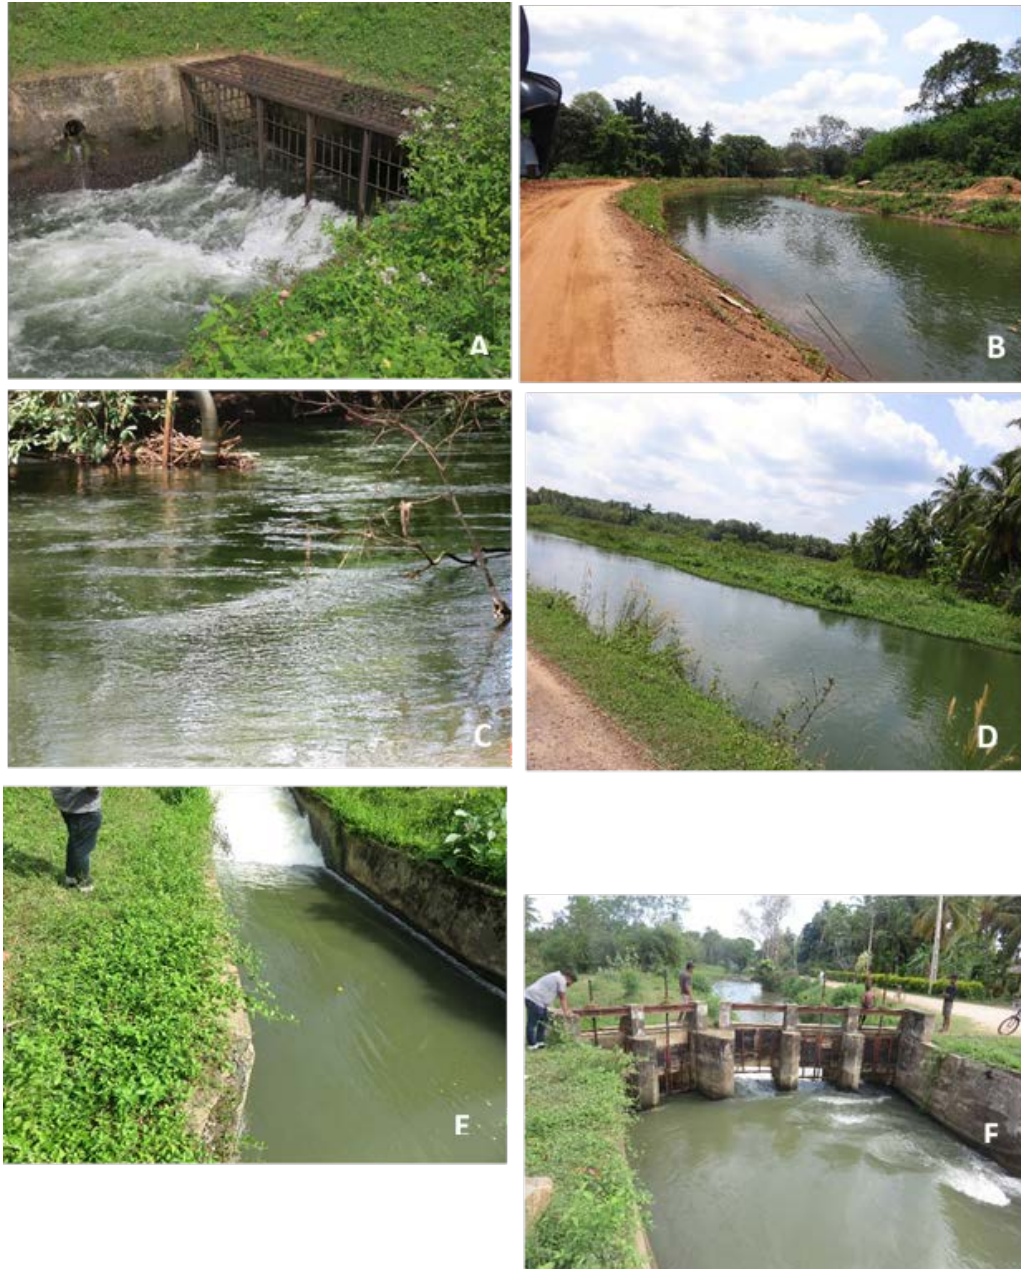
Annex 3: Pictures on Main Issues of the Walawe RBMC

Fig 2. Different locations of the RBMC (A: Outlet of the Uda Walawe reservoir, B: in between Chandrika Reservoir and Embilipitiya Town, C: Close to the Chandrika Reservoir, D & E: Downstream of Chandrika reservoir, F: Main dividing point of the canal)

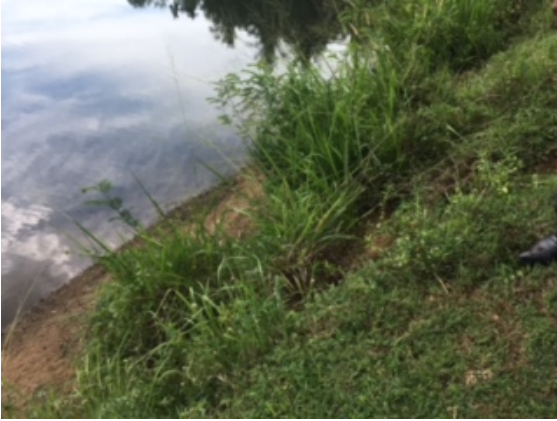
Example of embankment erosion

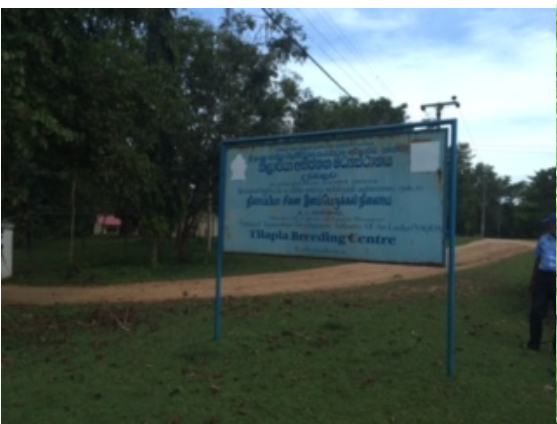
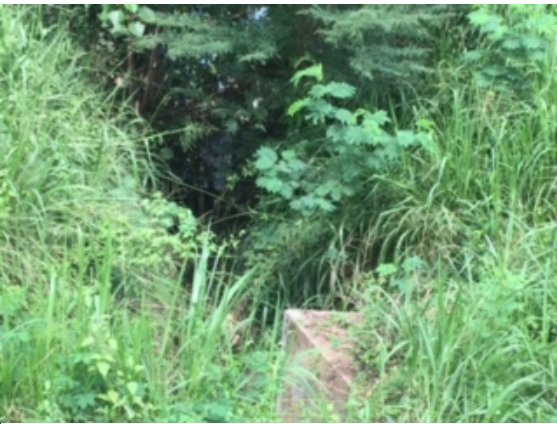
Overgrown intake at the Thilapia Center

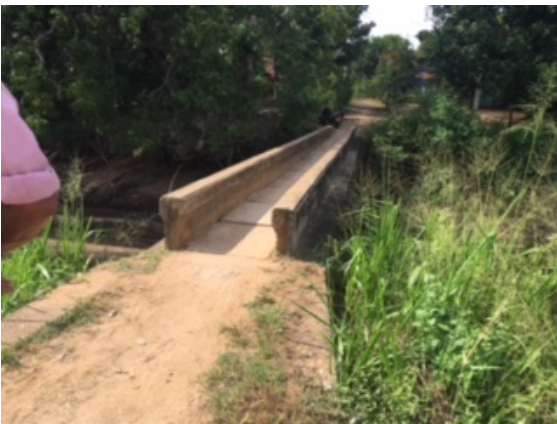
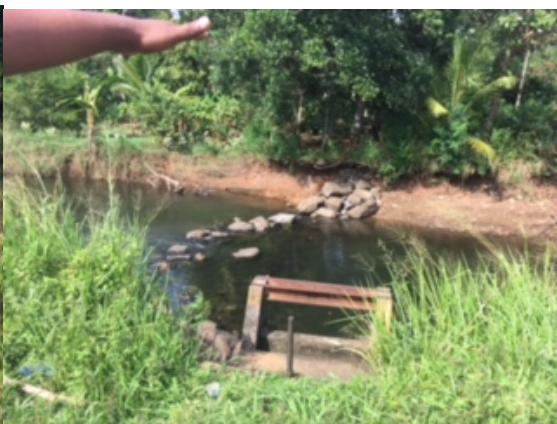
Example of existing bridge that will be widened and example of human interventions of trying to increase the water levels at specific intakes.
