**Nigeria Erosion and Watershed Management Project
(NEWMAP)**

**Environmental and Social Management Plan (ESMP)
For the Amuzukwu Gully Erosion Site
Umuahia North LGA, Abia State**

**Prepared for the Abia State Project Management Unit
Nigeria Erosion and Watershed Management Project**

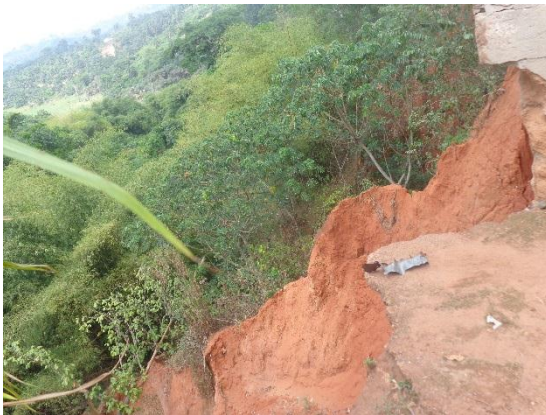
Figure 4 New land slide at the erosion site

Field investigation indicates that the gully erosion developed as a result of excavation of laterites from Amuzukwu, which was put to use in the infrastructural development and road construction works to Umuahia. However typical with most construction works done in Nigeria, the miners failed to neither restore the land nor re-vegetate the area. Many years after, more human activities sprang up in the area; houses were built for their habitation while road infrastructures and other basic amenities were constructed to assist the indigenous populace. These activities were not properly handled and monitored which gradually encouraged the formation of a gully in the area. Figure 8 shows the map of the erosion area and its surrounding environ. As seen in the map there are buildings located around the erosion area and even some that have been swallowed up by the gully erosion. A stretch of water body runs across the erosion site which has even encouraged the further wearing off of the land. Figure 9 indicate the watershed map of the area.

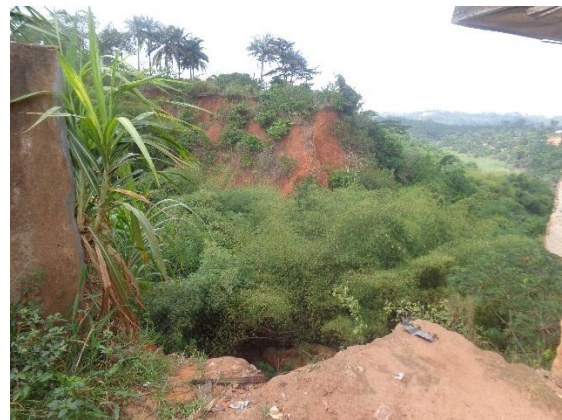
Figure 5 Gully head

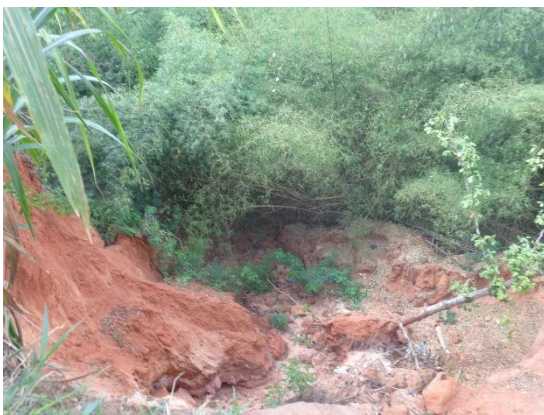
Figure 6 The Erosion site

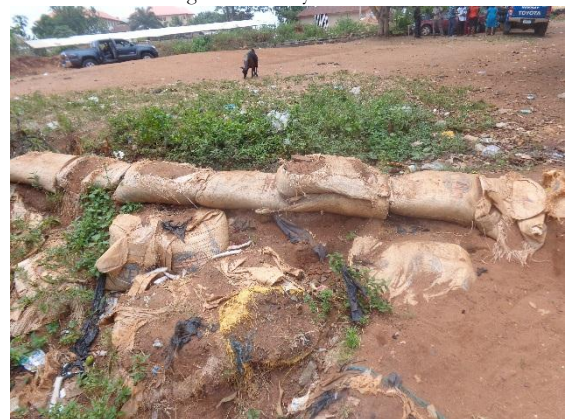
Figure 7 Embankments to control erosion

The community made know their effort in controlling the erosion by building embankments with sand bags, planted bamboo trees at the site and stopped all sand dredging activities in the area to help check the erosion. They explained that most people built up their entire land with no space or consideration for drains to be built later. Presently, the residents use the erosion site as dumpsite for waste as seen in fig.....The community also has been appealing to the government for help before the situation deteriorates.

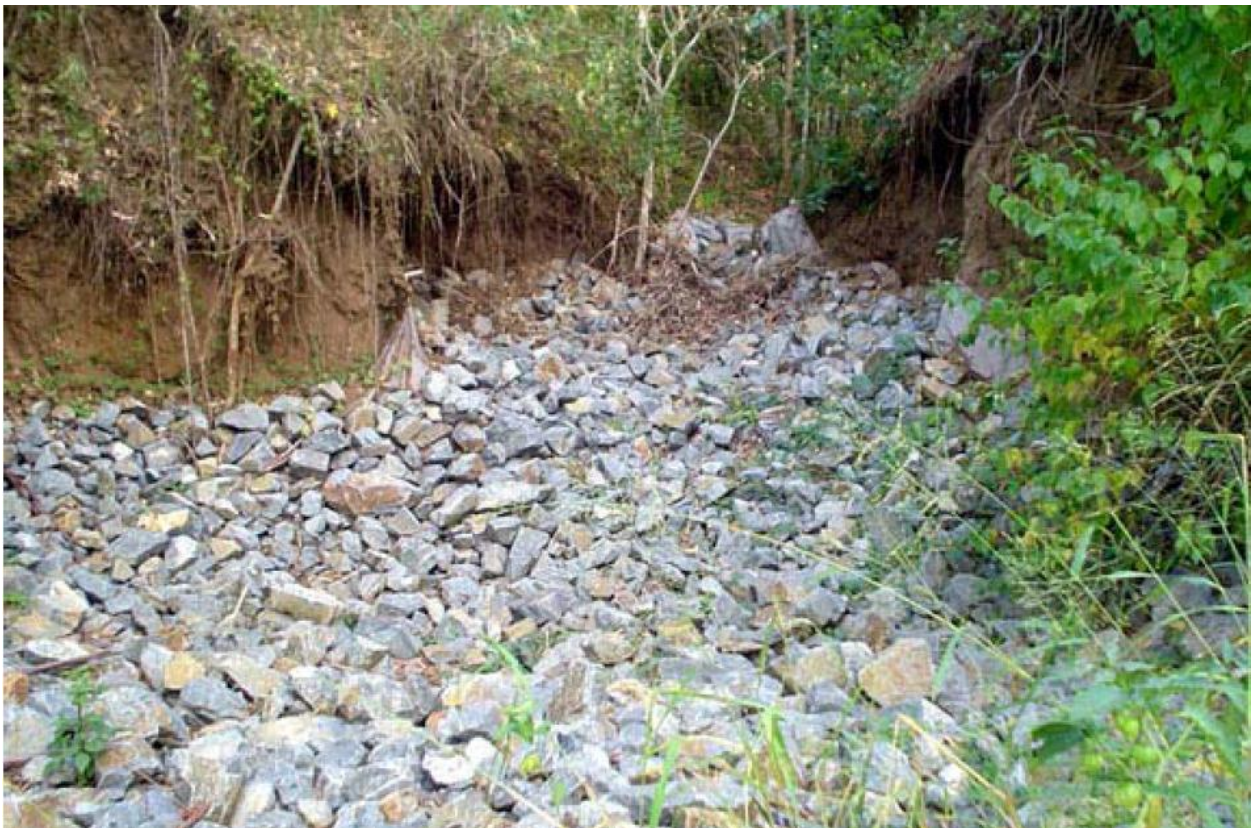
Figure 12 A Rock lined chute

The rock lined chute is used to lower surface water into the open channel where a gully has developed. The chute is sized according to drainage area and site factors. Proper sizing of the rock to withstand the expected velocity of water in the chute is the key factor. For the installation of this structure a good source of rock must be available in the area.

- The non-availability of rocks in the area could be step back in the use of this alternative

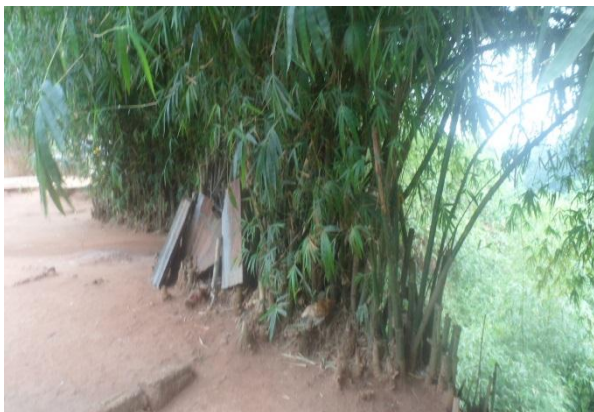
Figure 17 Bamboo planted to mitigate erosion

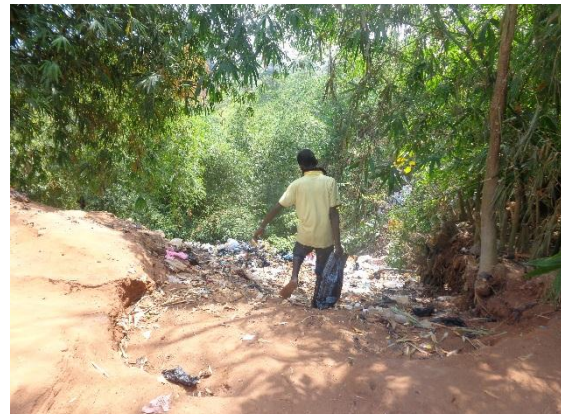
Figure 18 Residents dumping refuse at erosion site

All the respondents in the area dispose their household waste into the gully or along the illegal dumpsite at the edge of the erosion.
