ADDIS ABABA SIDEWALK SAFETY AND IMPROVEMENT STUDY

Report No: 169923

The World Bank

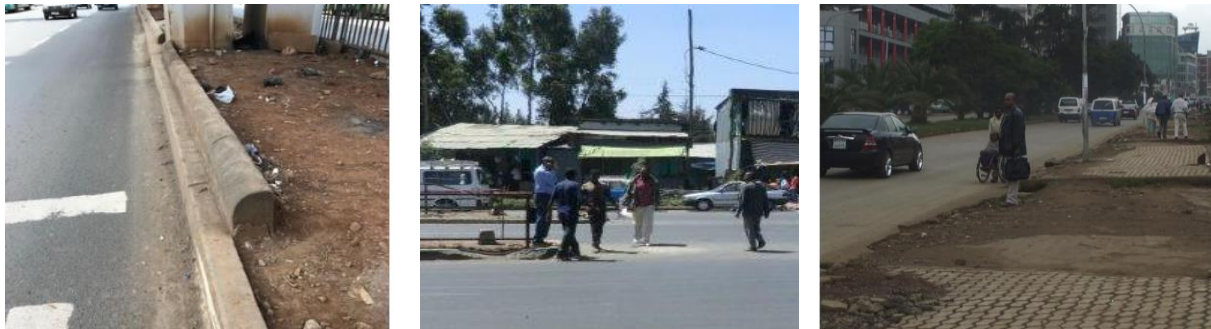
Figure 1. Example of sidewalk and intersection problems.

(a) Lack of sidewalk or deficient construction and design (b) Presence of guard rail and illegal crossings (c) Construction and maintenance deficiency, and pedestrian invasion of the road

It showed the problems associated with sidewalk deficiencies and pedestrian mobility range from design, construction to maintenance (see Figure 1), which enables risky behaviors, especially on behalf of drivers and pedestrians. Across the city, it is common to find locations with inadequate intersections, deficient crossings, missing sidewalk segments, poor accessibility for vulnerable users, and even

intentional barriers, including guard railings on main avenues. Sidewalks also lack maintenance, being overcome with vegetation, rocks, or debris. Moreover, a lack of law enforcement causes the sidewalks to often be obstructed by street vendors, parked vehicles, or loading and unloading maneuvers.

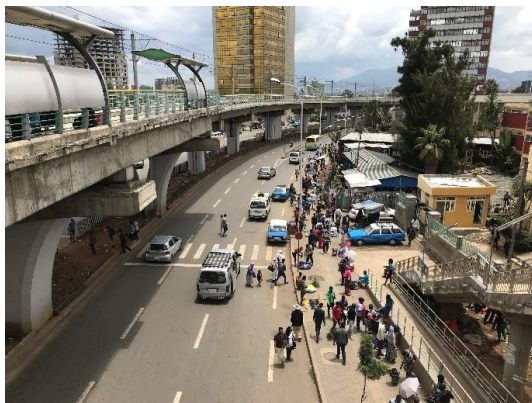
Figure 2. Sidewalks around the LRT Corridor.

For instance, these problems can be observed along the LRT corridor presented in Figure 2, where wide and newer sidewalks present higher pedestrian flows. The effective width of the sidewalk is reduced by the invasion of informal vendors and parked vehicles, which in turn forces pedestrians to walk on the road with mixed traffic. Crossings for pedestrians are limited, which leads to jaywalking. Lighting is also scarce.

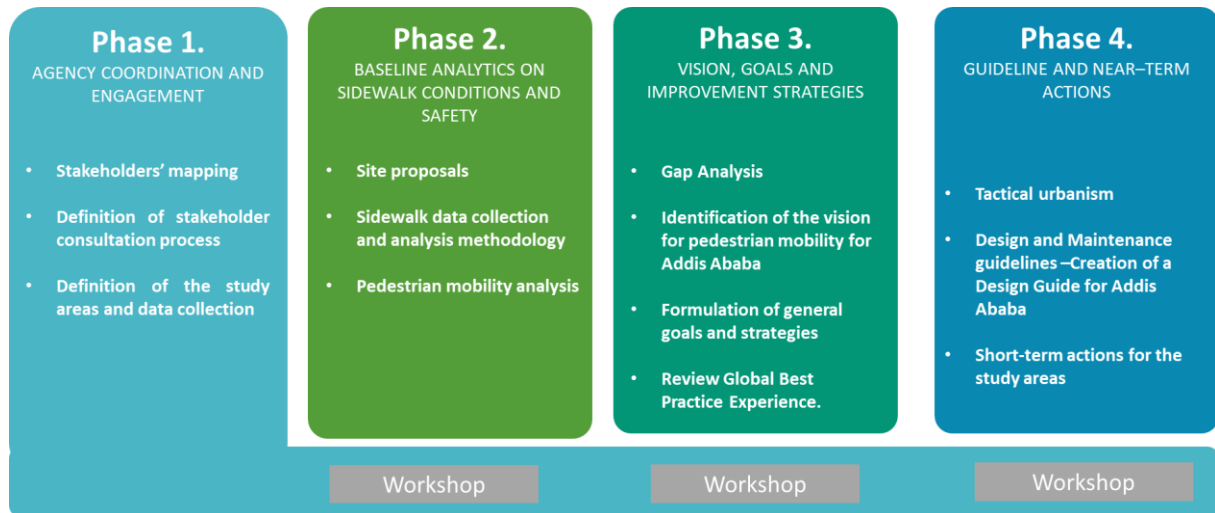
Figure 4. Phases of the project.

The project consists of four phases, as described in Figure 4, of which Phase 1 is executed throughout the entire project as stakeholder engagement is required in every step. Each Phase is described in the following subsections.

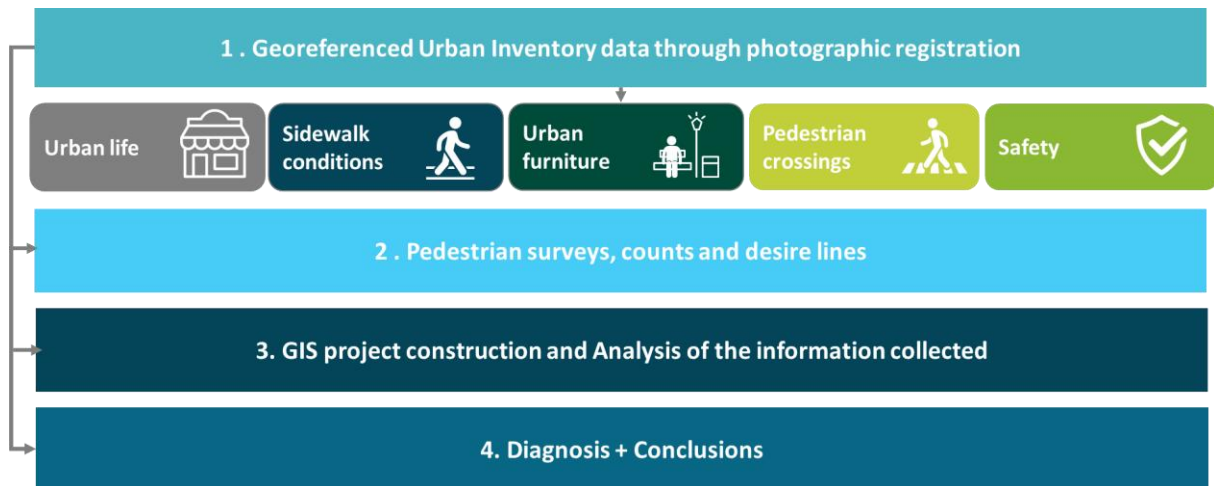
Figure 7. The process of walkability analysis.

The analysis brings sidewalk inventory data and user surveys into a GIS database for a spatially referenced analysis to represent a comprehensive understanding of sidewalk conditions and quality walkability from an infrastructure, user experience, and urban design perspective (see Figure 7).

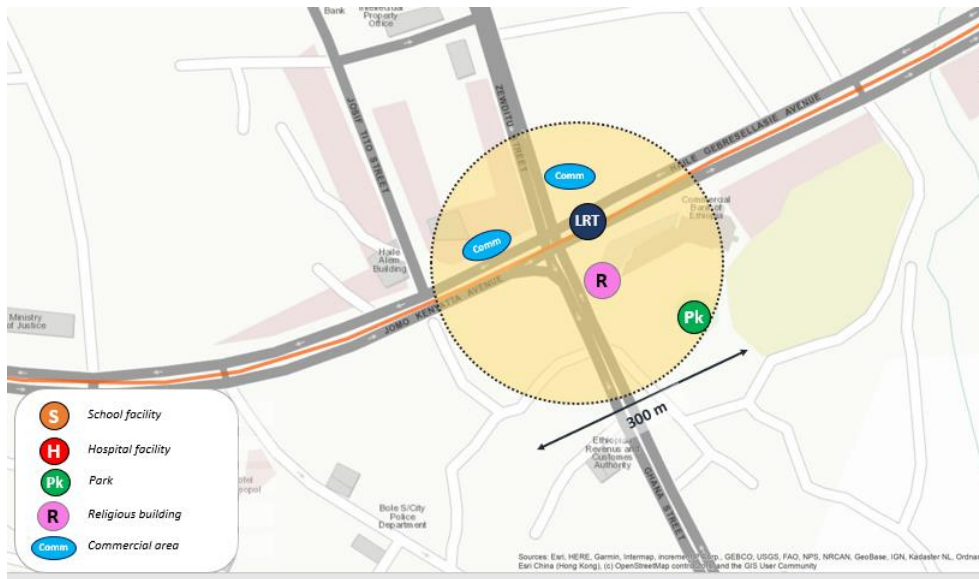
Figure 10. St Urael Station study area (shaded in light yellow).

St Urael Station is an essential commercial and financial center with religious venues and a main intersection, including St Urael Church and the AB Zone Business Center.

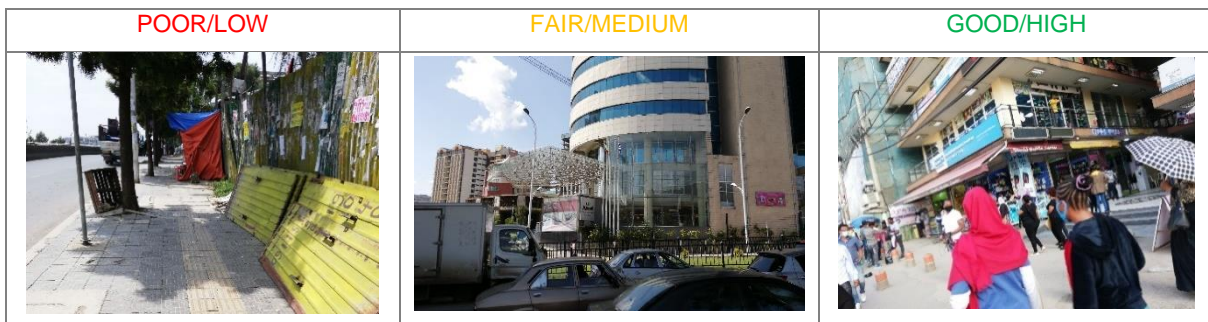
**Permeable access to building fronts.** Street permeability depicts the level of activities by front properties adjacent to the sidewalk and measures how sidewalks are connected and accessible with regard to indoor activities. A permeable front often incentivizes walking and promotes attractive activities for pedestrians in the public space, such as neighborhood shops, restaurants, or cafes, making the environment more dynamic. High permeability is defined by those fronts that promote pedestrian activity and allow pedestrians access. On the other hand, fronts that are not very permeable discourage activities in public spaces, generating a perception of insecurity or lack of leisure opportunities for pedestrians, especially at night. Fronts are classified according to their degree of permeability, into different categories as shown below.

In the study area, only 15% of the network has fronts with high permeability. In contrast, more than half the network (55%) having fronts with low permeability (see Figure 17 below). This finding calls for the need to incorporate land-use policies and enhance mixed-use as part of sidewalk

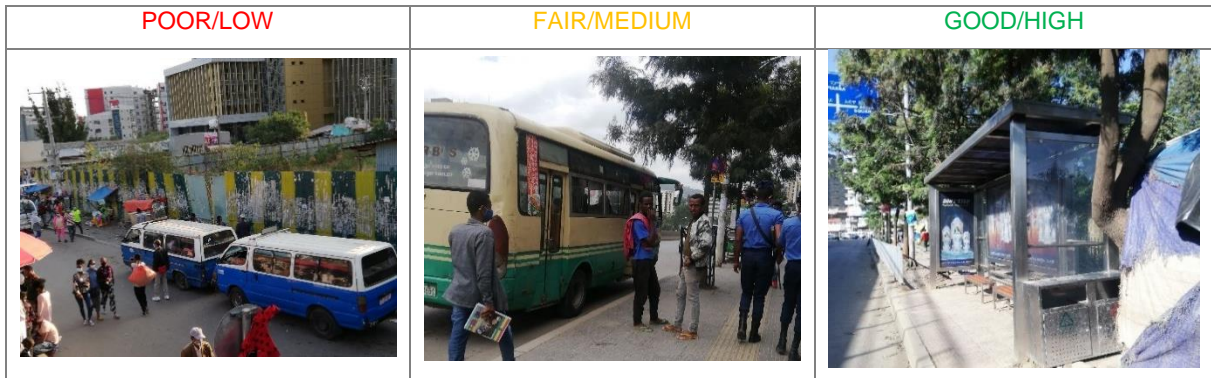
Figure 17. Bus stop indicator analysis in the study area.

Bus stops. Places with well-defined bus stops tend to incentivize the use of public transport as bus riders can easily walk from bus stops to local destinations. It also gives a sense of security and attracts more pedestrians under public visibility. The bus stop indicator is divided into three categories.

A bus stop analysis was conducted using a raster analysis with GIS software that reveals areas with high, medium, and poor presence of bus stops. **Most of the transport network has a low presence of adequate bus stops, which discourages last-mile connection for bus riders, leads to the emergence of informal ones, and generates road safety risks.**

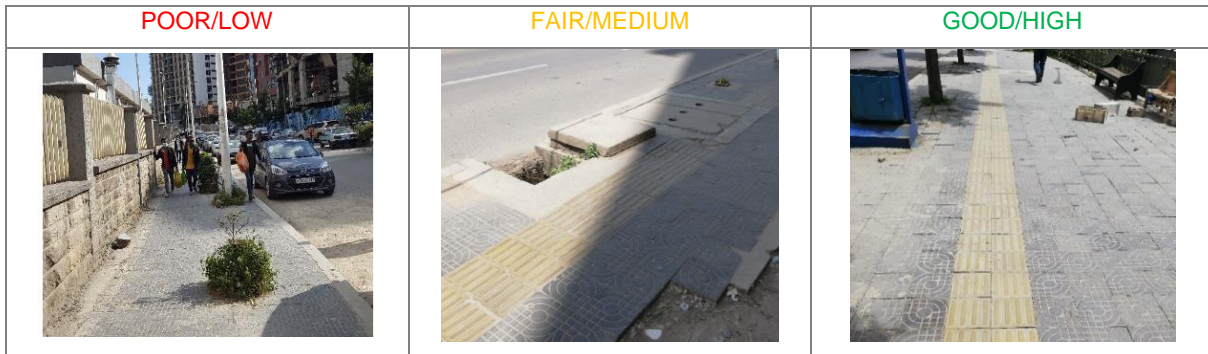
Figure 20. Tactile pavement indicator quantification for the study area.

Tactile pavement. Pod tactile floor for visually disabled persons is a surface with a texture that visually impaired pedestrians can recognize when stepping on it. The presence of this type of flooring translates to safety for users with reduced sight. However, it is not desirable to have non-continuous tactical flooring along the sidewalk. Thus, three categories have been established: the presence of continuous tactile pavement, the presence of non-continuous pavement, and its absence.

54% of the network has no tactile pavement for visually impaired users. Only 24% of the network has continuous tactile pavement on the newly built segment.

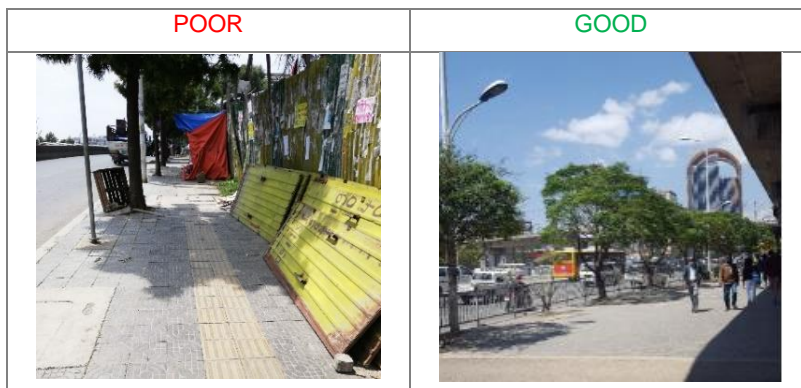
Figure 22. Obstacle type quantification for the study area.

Obstacles. A variety of obstacles on sidewalks have negative effects on their users and represent a road safety risk because they reduce the space available, and even cause users to step off the sidewalk and into vehicle traffic.

In the studied area, 20% of the sidewalks are obstructed. Most obstructions are caused by trash, holes, or construction waste (63%). However, it can be observed that street vendors (37%) occupy more of the street width than trash. Therefore, relocation or formalization of vendors should be prioritized.

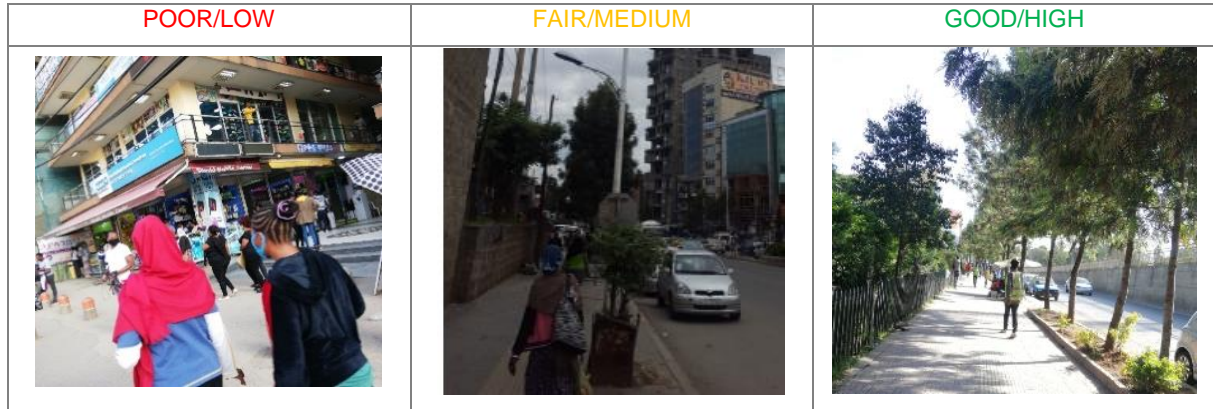
Figure 23. Tree density indicator analysis in the study area.

Trees. Vegetation is an essential element on the sidewalks because it provides shading. Sometimes trees can also act as a barrier for pollution and protection from rain. The tree density analysis was conducted differently from other indicators: the evaluation was carried out using a raster analysis in the GIS software.

The presence of trees is significant in a large part of the segments analyzed, especially in St Urael Square and Meskel Square. Evidence suggests that new sidewalk designs contain an adequate density of trees. **The study reveals that 13% of the studied area has high density, 16% has medium density, 23% has poor density, and finally, 49% has no trees.** For instance, the area near Megenagna station has a very low tree density.

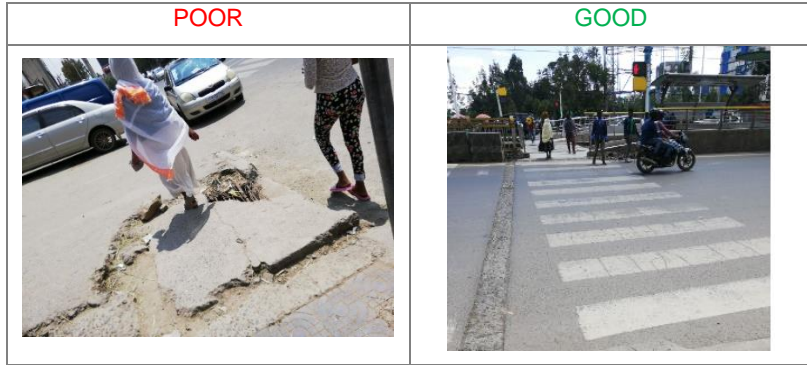
Figure 25. Accessible crossings indicator quantification for the study area

Accessible crossings. The degree of crossing accessibility is associated with the characteristics of a pedestrian crossing. The degree of accessibility is provided by elements that allow persons with reduced mobility (PRM) to make use of a sidewalk without difficulty and is reflected by pedestrian signaling, traffic lights, and adequate accessible ramps especially for people with mobility constraints.

65% of crossings are not accessible for PRM. Most dangerous pedestrian behaviors were identified at these crossings.

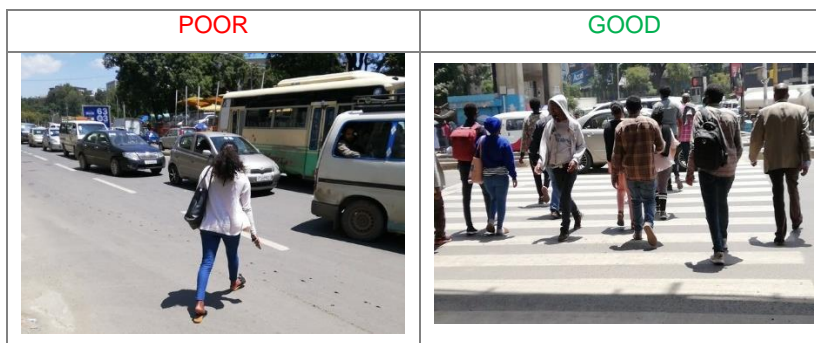
Figure 26. Pedestrians crossing improperly in the study area

Improper crossings. Identifying locations where improper crossings occur (jaywalking) indicates that there are inadequate numbers and density of pedestrian crossings along the corridor. This indicator identifies the locations where improper crossings happened during the urban inventory.

The following figure illustrates the classification of crossings and indicates the locations of improper pedestrian crossings. **79% of the network in the studied area is associated with improper crossings.** Most identified inappropriate pedestrian behaviors occur near existing crossings, which may indicate their lack of quality.

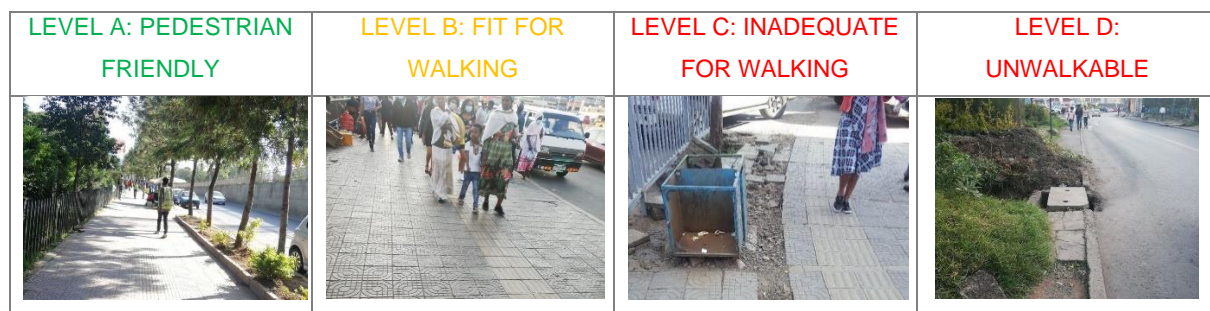
After the numerical quantification of each variable for the specific segment of the network, the Global Walkability Index was calculated using both general weight factor and a school area weight factor. Thus, even though the Walkability Index’s total value changes depending on the weight input, the overall classification level was the same for both analyses. This analysis can also be used as a tool for prioritizing improvements.

According to the network classification, the higher the Walkability Index score, the higher the classification level. This means that more criteria are met in terms of a sidewalk being pedestrian-friendly, and therefore, that the segment is more walkable. Level A indicates that most of the criteria identified are complied with. Level B refers that although the most relevant criteria are met, the sidewalk still requires some form of minimal investment to be of optimum quality. Level C conveys that the sidewalk requires major improvements in order to become walkable (this includes sidewalk

reconstruction), while level D means that the sidewalk is either non-existent or unusable, and requires redesign.

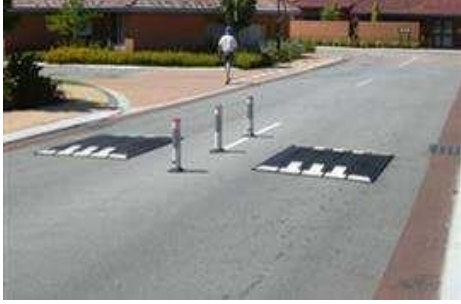
Pedestrian crossings (Shenyang, China)	Implement signaling at crosswalks	Provide safety for vulnerable users	low	low

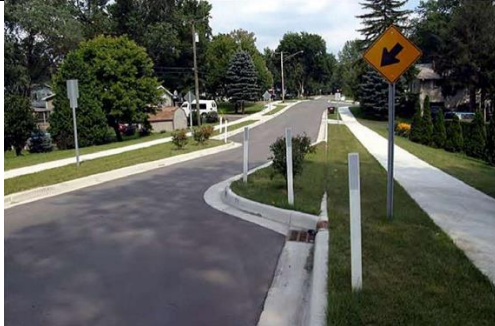
Pinch points or chokers (Delaware, USA)	Curb extensions to narrow a street in specific points	Increase sidewalk space, decrease crossing distance, and reduce traffic	medium	medium	●	Two-way streets, moderate speed

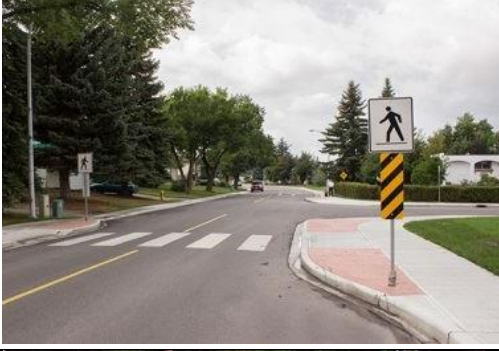
Intervention	Description	Benefits	Cost	Maintenance	Applicability	Street type	Example
Curb Extensions (Watsonville, CA, USA)	Street modifications that visually and physically narrow the roadway	Create safer and shorter crossings for pedestrians while expanding available space	medium	medium	●	Two-way streets, moderate speed

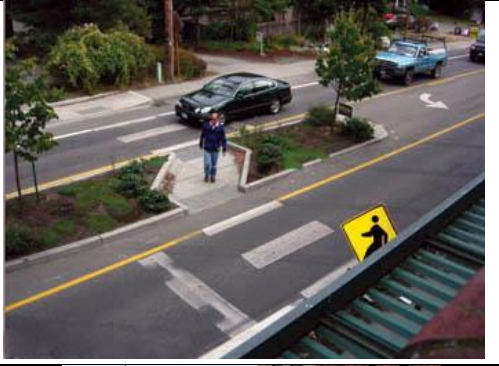
Medians (Bainbridge, WA, USA)	Barriers in the middle of the street that act as islands and separate traffic flow	Create 2-stage crossing for pedestrians	medium	medium	●	Two-way streets, moderate speed

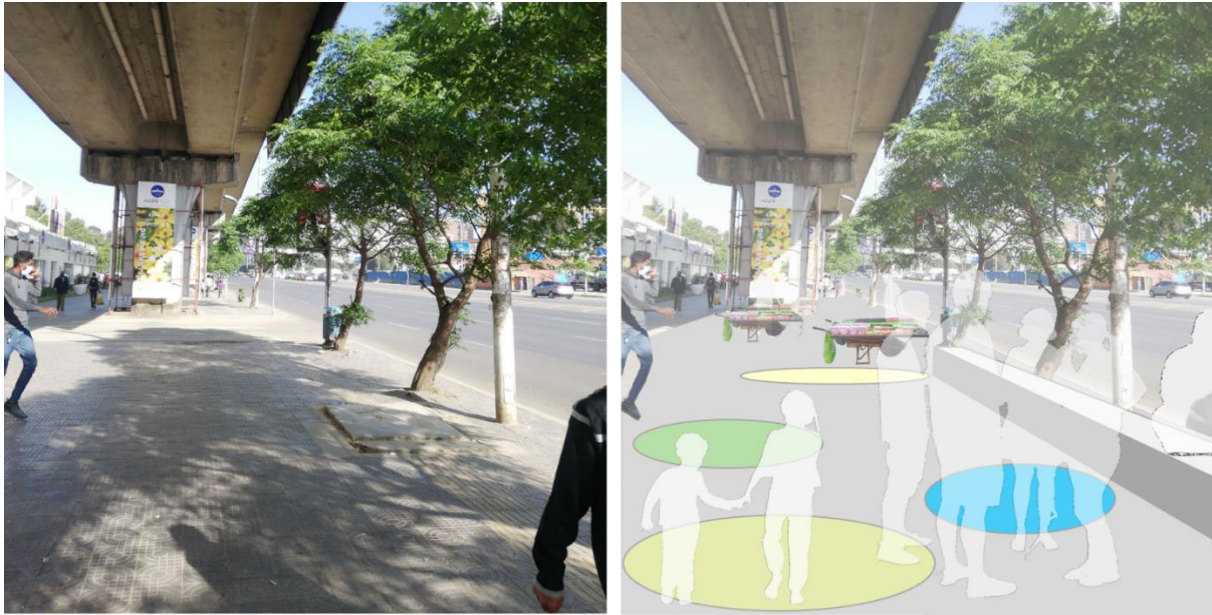
Figure 37. Conceptual solutions in terms of new uses under the LRT infrastructure

The new Meskel Square project represents an opportunity to create a new commercial center in an iconic public space for Addis Ababa. The existing areas under the LRT infrastructure are currently places with no particular uses. A transformation of the spaces under the LRT is proposed for commercial use and enhancement of social activities; complementing furniture and shade/canopy solutions should be added within the square (see Figure 37).

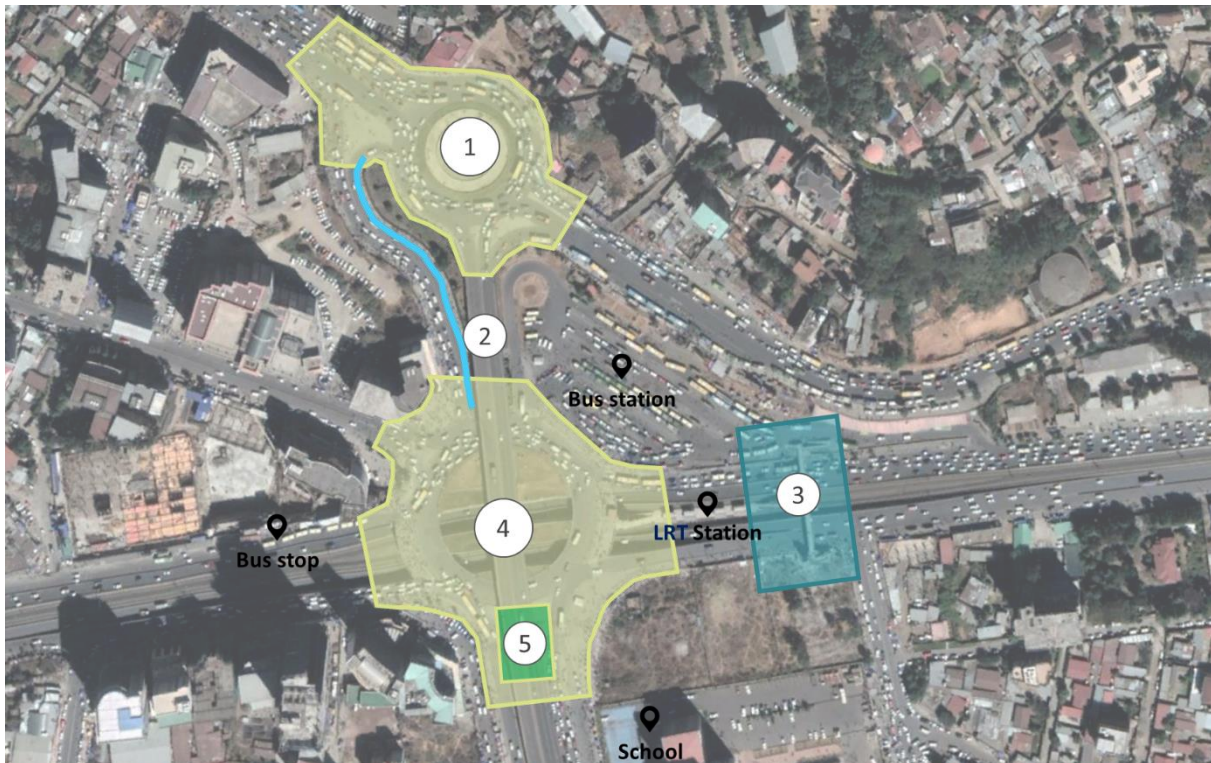
Figure 40. Proposed actions for Megenagna Station

Finally, the Megenagna Station area is an important multimodal transport and commercial hub. These aspects make this site an adequate study area to propose short-term actions to enhance pedestrian environment and safety. Currently, an elementary school and government buildings are in proximity to the area. Overall, five actions are proposed for the Megenagna Station (see Figure 40).

The actions to enhance Megenagna Station need to be complemented with actions on the nearby Wal-Argi square, given the importance of pedestrian mobility and the direct relation between both squares. Therefore, proposals 1 and 2 are for the Wal-Argi square.

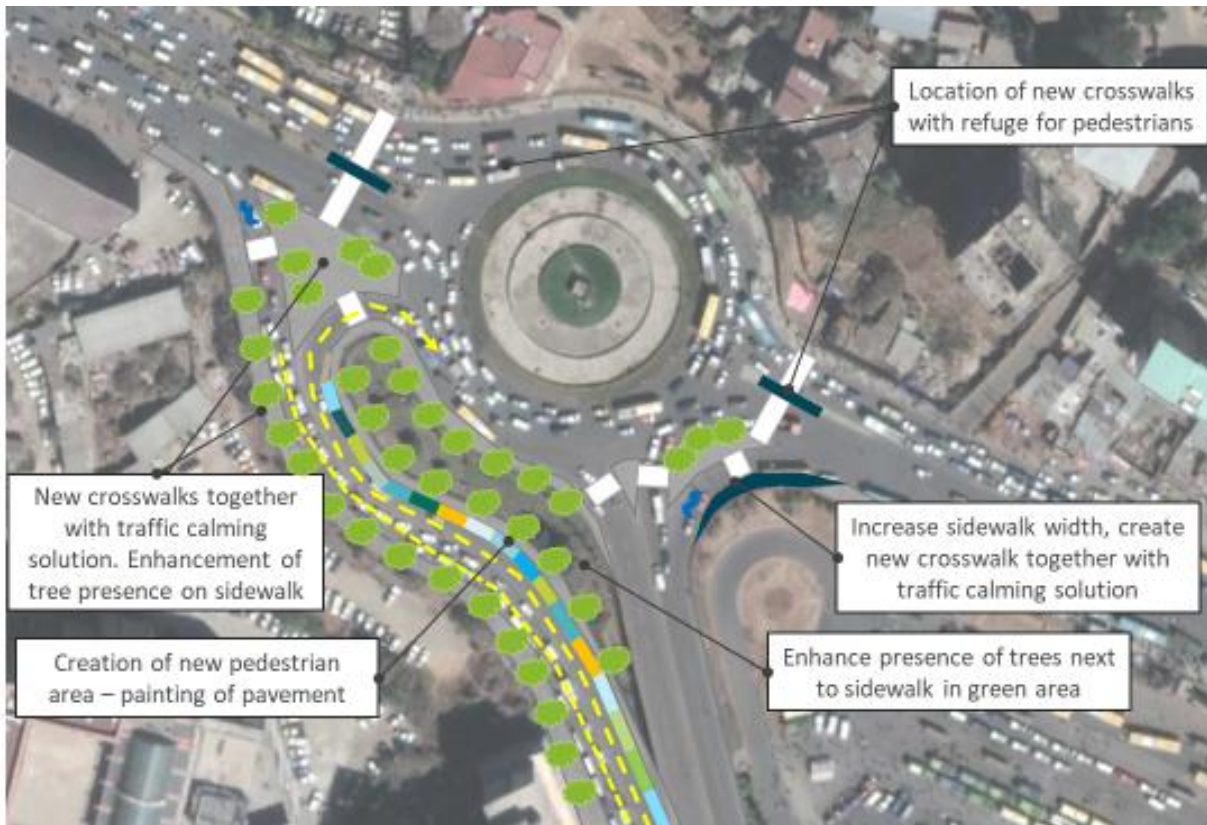
Figure 41. Conceptual proposal for redesigning the Wal-Argi square area and enhancing the connection between Megenagna Station and Wal-Argi square.

The connection between Wal-Argi square and Megenagna Station square is currently inadequate, due to a high volume of pedestrian flow and reduced pedestrian sections. The lack of space causes pedestrians to invade traffic lanes, creating safety concerns. Therefore, the proposal aims to improve traffic safety and comfortability for pedestrians going from one square to the other (see Figure 41).

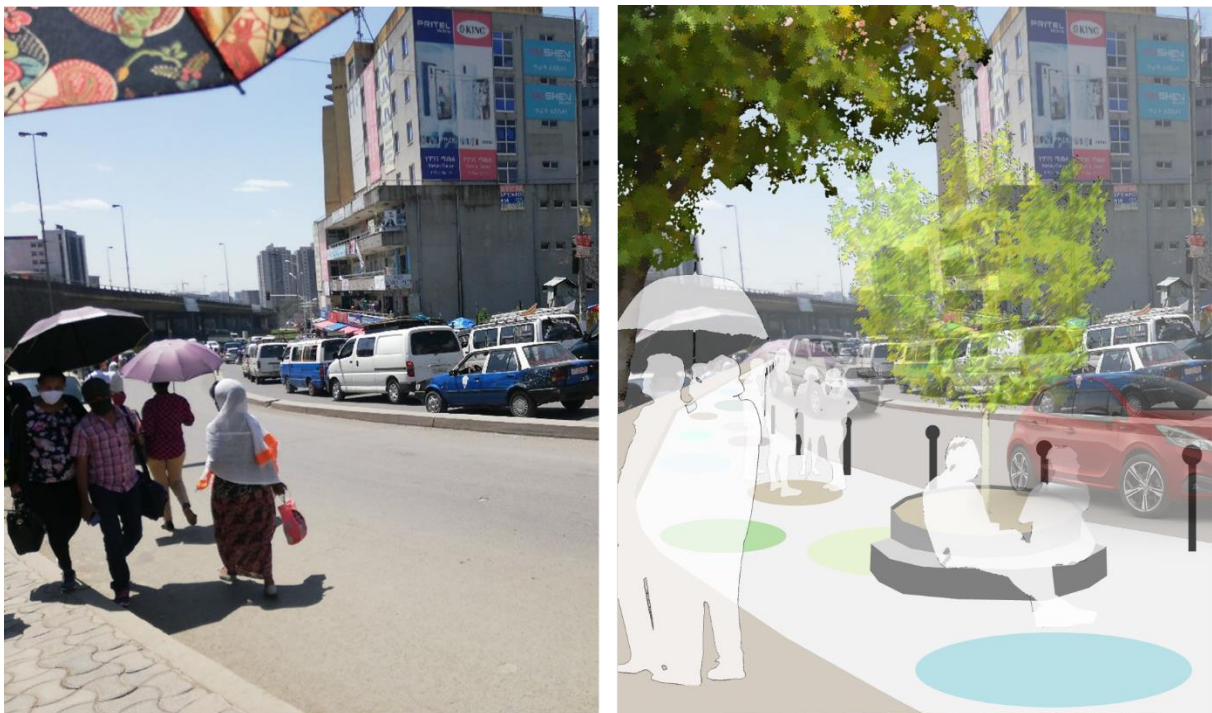
Figure 42. Conceptual proposal for connecting streets between both squares.

Firstly, a new pedestrian area is proposed along the connecting street. An action that would reduce the width of the traffic lane by 2 meters. The design of this new area is proposed in a colorful manner, providing new seating areas, tree pots and social areas (see Figure 42).

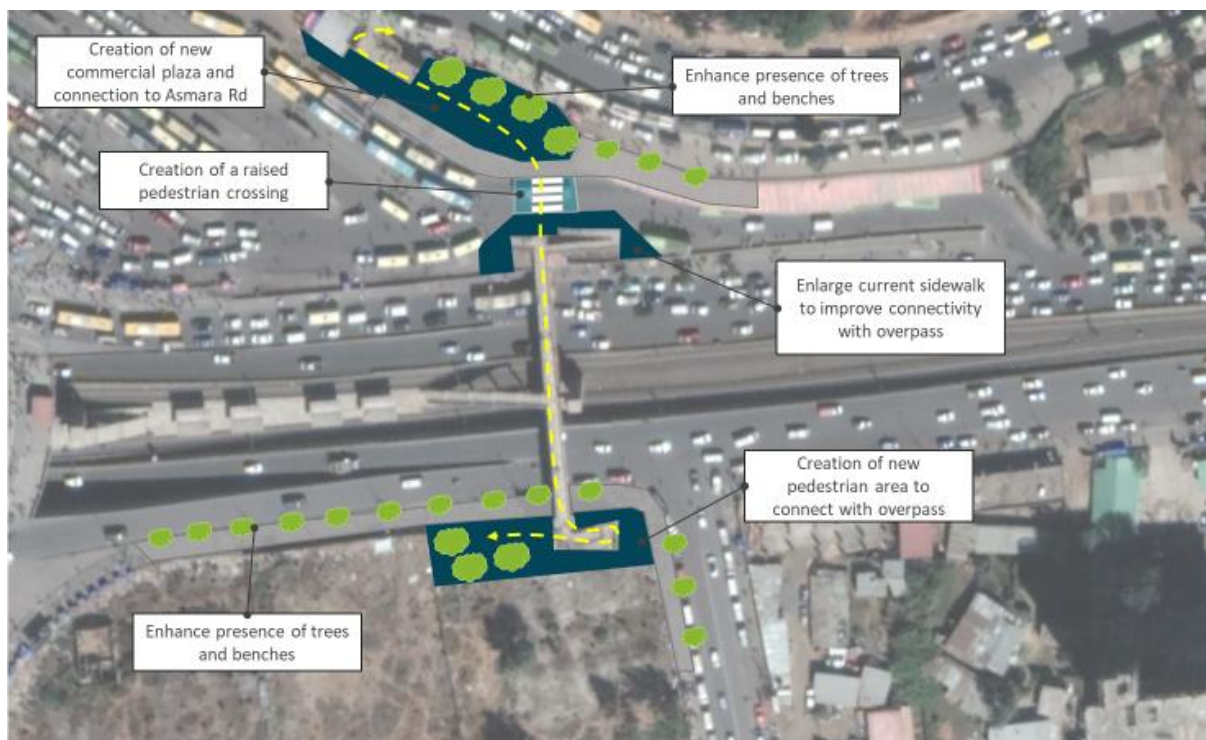
Figure 43. Conceptual proposal for improving connectivity between the LRT station and the nearby urban area and bus station.

The current entrance design of the Megegnagna LRT Station is not adequate, especially pertaining to its connection to the Bus Terminal. Therefore, a redesign of the entrances is proposed, mainly based on the creation of new sidewalk infrastructure to provide a wider and better approaching lobby for the station (see Figure 43). In addition, the strategy will organize pedestrian flows coming to the LRT station from upper Asmara Rd.
