Melamchi Flood Disaster in Nepal

Damage and Risk Quantification with Drone
Survey, Satellite-Based Land Displacement
Analysis, and 2D Flood Modeling

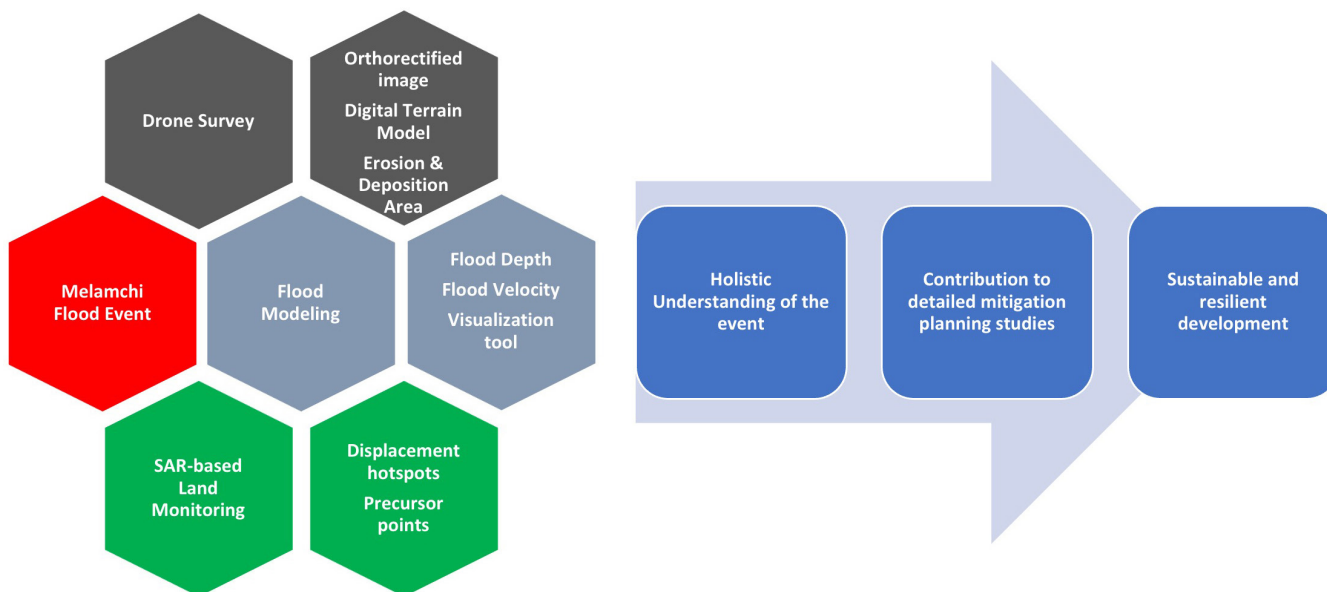
Figure 1: Diagram illustrating the flow of post-flood disaster risk management engagement.

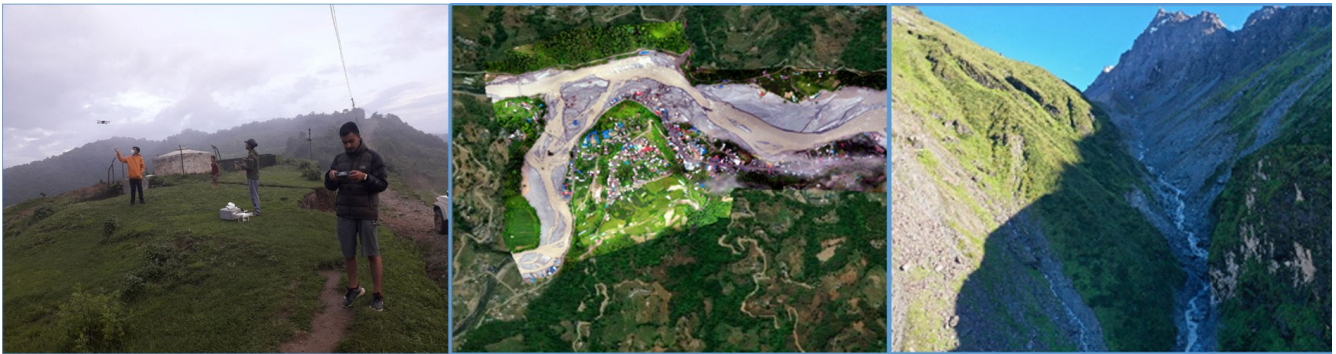
Figure 5: Team capturing data using the drone, damage at Melamchi Bazar from the drone image, and the steep hilly terrain where the drone was used to document the damages and to collect post-flood topographic data

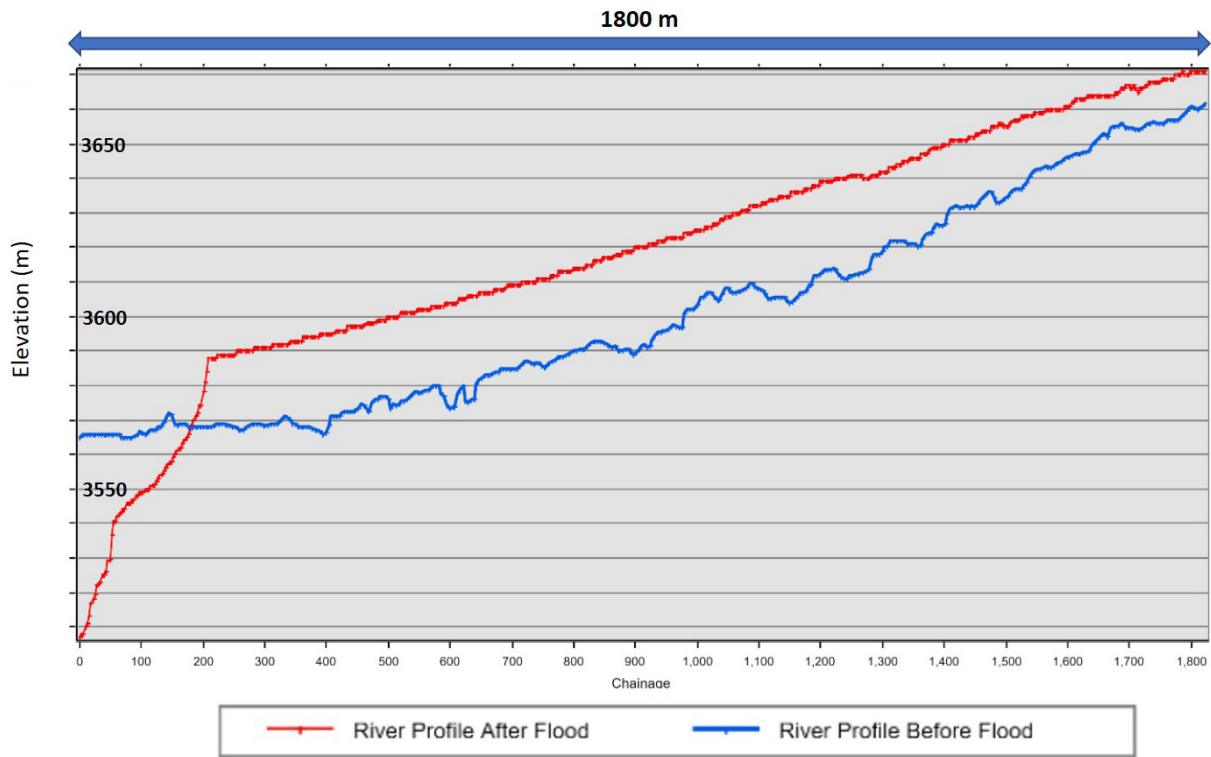
7a) longitudinal section showing the river profile before and after the flood

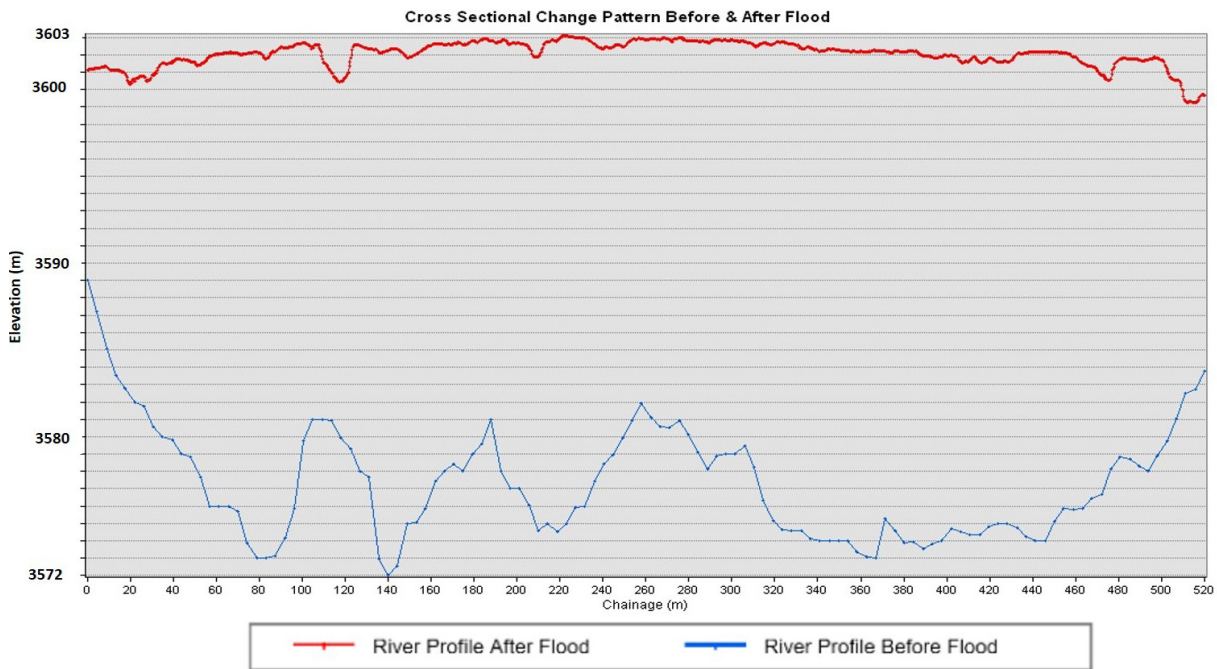
7b) cross-section showing the river profile before and after the flood. Before-flood DEM source is WDRF (5m spatial resolution), and the after-flood DEM source is drone data (50 cm spatial resolution) as part of this project

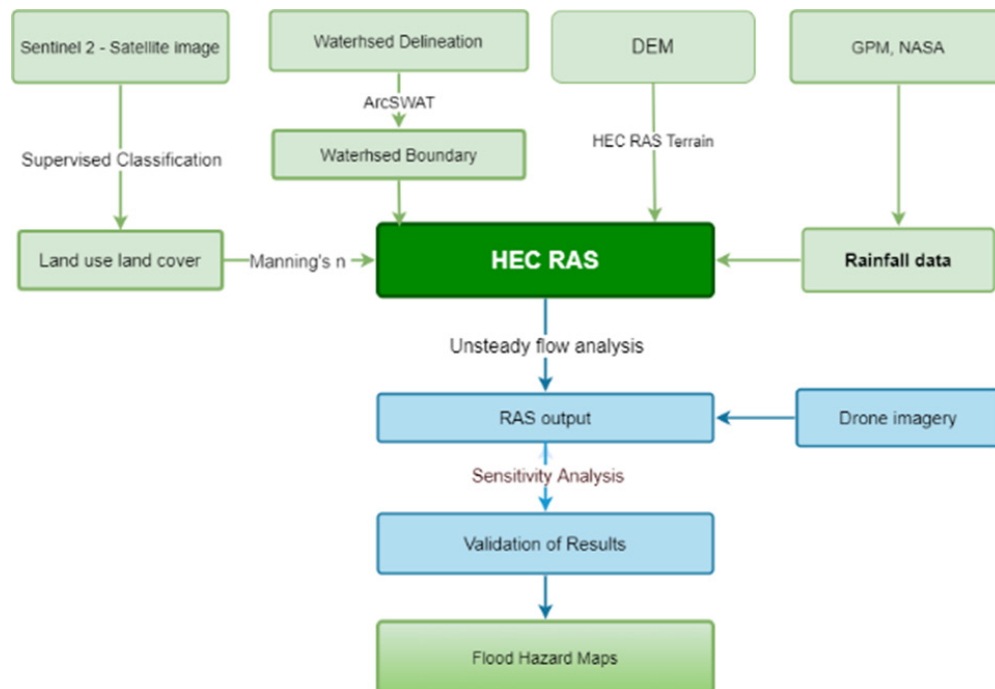
Figure 11: Schematic showing the flood modeling methodology.

stability conditions (courant number ≤ 1). Flood hazard, depth, velocity, and flood extent maps were generated, which were subsequently used to analyze the hazard to the community. A schematic showing the methodology followed for the flood modeling is shown in Figure 11.

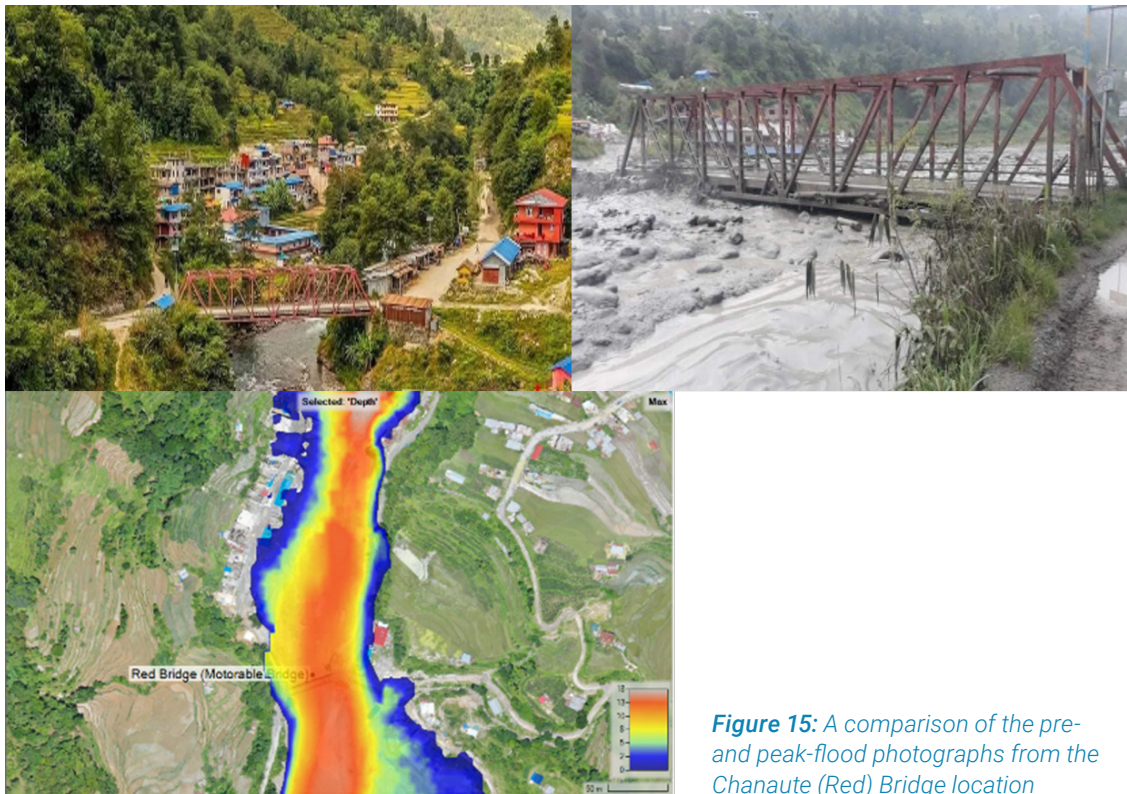
Figure 15: A comparison of the pre- and peak-flood photographs from the Chanaute (Red) Bridge location

This location was used for the modeled flood validation due to the availability of pre- and post-flood photographs (Figure 15). The modeled estimates of flood depth indicated a flood depth of 11.8m with debris, which indicates a good correlation between the modeled flood and conditions observed on the ground. The observed flood depth was used to back-calculate the peak discharge (which was estimated at 4,256 m³/s). And as this calculation was based on pre-flood cross-sections without considering elevated bed levels due to sediment deposition during the event itself, the estimated peak discharge may have some uncertainty and could be on the higher side.

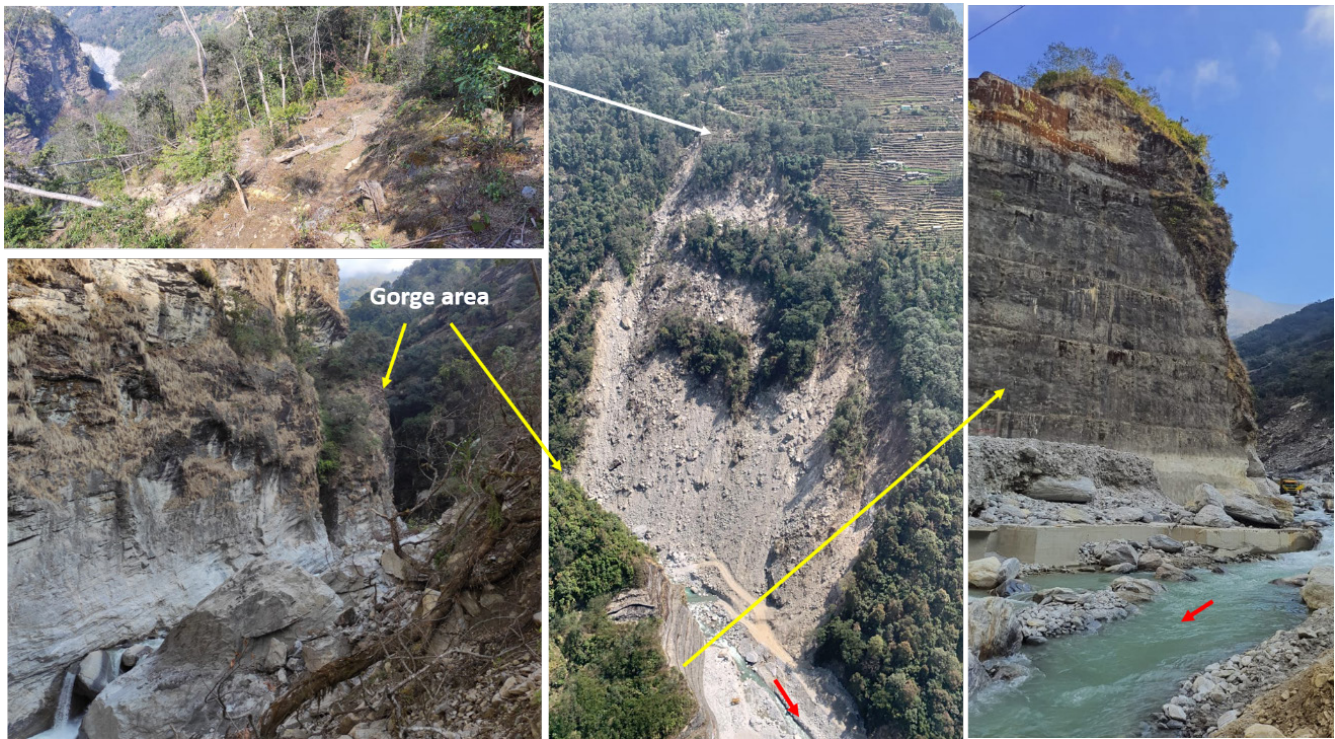
The headworks area of the Melamchi Water Supply Project, with financial support from ADB, experienced severe damage, and more than 16 m of debris accumulated in

this area overall. Several massive landslides have also occurred in this area. The narrow gorge just upstream of the headworks is the endpoint of the erosional channel of the Melamchi River in the 2021 flood. From the headworks to downstream, the channel experienced massive depositions. As a result, all the downstream settlements were partly buried. The effects were well observed downstream to the confluence of the Indrawati and Melamchi rivers (Figure 22).

Figure 22: Landslide in headworks area, deep gorge and headworks area under cleaning.

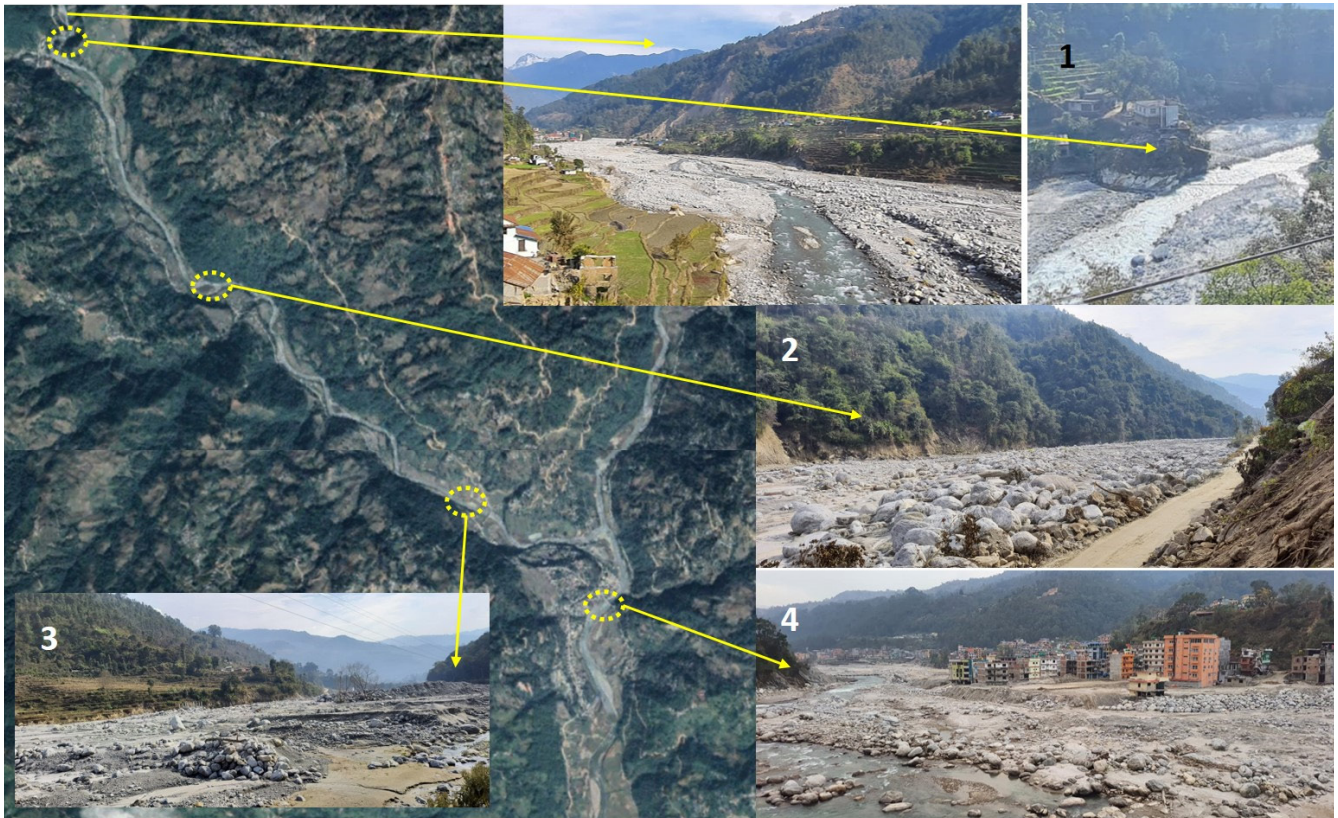
Massive sediment and debris deposition was observed at four (4) locations while traveling from Tamarang to Melamchi Bazar. The first location is the gorge area (Figure 23) of Bhattar Phat, where the remnant of the old chain suspension bridge was buried during the 2021 flood event. In this narrow channel, the upstream area up to Gyalthum of Helambu Rural Municipality, the sediments accumulated, huge boulders were deposited in the riverbed and buried 2nd level terraces (Figure 23). The second location was at the Thulophat area, where many huge boulders, eroded from the narrow upstream channel, were accumulated (Figure 24).

Figure 23: Four locations (Talarang to Melamchi Bazar section) of sediment blockage during the 2021 flood in the Melamchi River. These locations highly controlled the sedimentation process. Location 1 is Talarang, location 2 is Thulophat, location 3 is Phatte, and location 4 is Melamchi River.

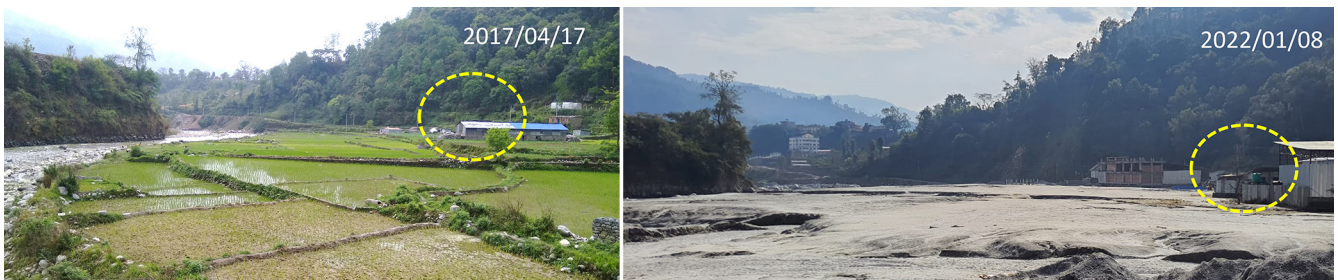
Figure 24: Significant deposition of debris occurred at Phatte due to a slowdown of flow caused by a downstream bridge as a blockage. Only fine sediments were found deposited downstream of the bridge.

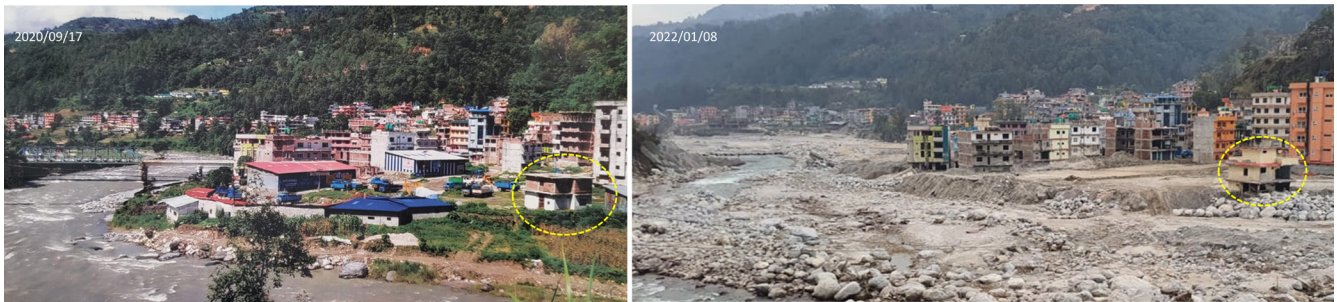
Figure 25: Before and after view of damaged Melamchi Bazar. The Pul Bazar was the major obstacle, and more than 16 m of sediment was accumulated in the Melamchi Bazar.

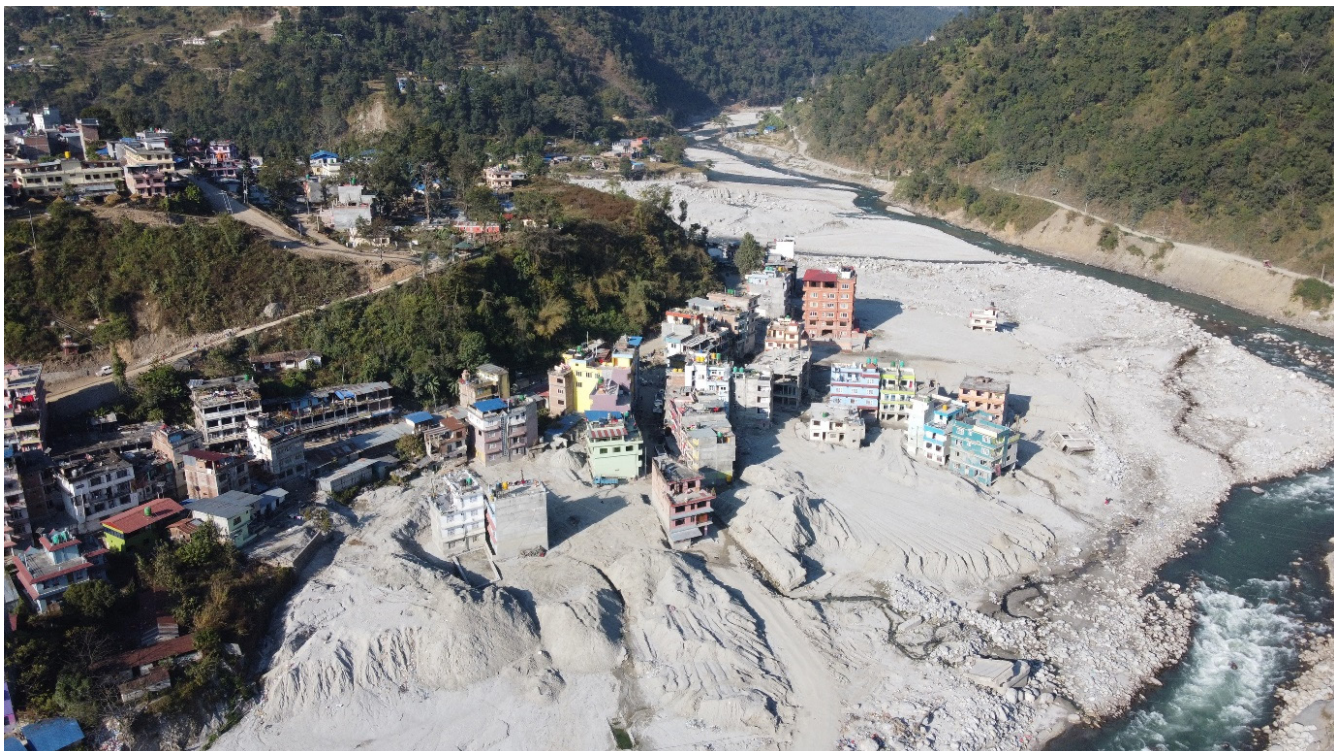
Similarly, the fourth was at the confluence of the Indrawati and Melamchi Pul Bazar areas. The sediments with huge boulders could not pass through a narrow channel below the bridge, due to which debris reservoir was formed, and fine sediments deviated towards the Pul Bazar area (Figure 25). As a result, more than 16 m thick sediments were deposited in the area (Figure 26).

Figure 26: Many buildings in Melamchi Town was covered by the debris.

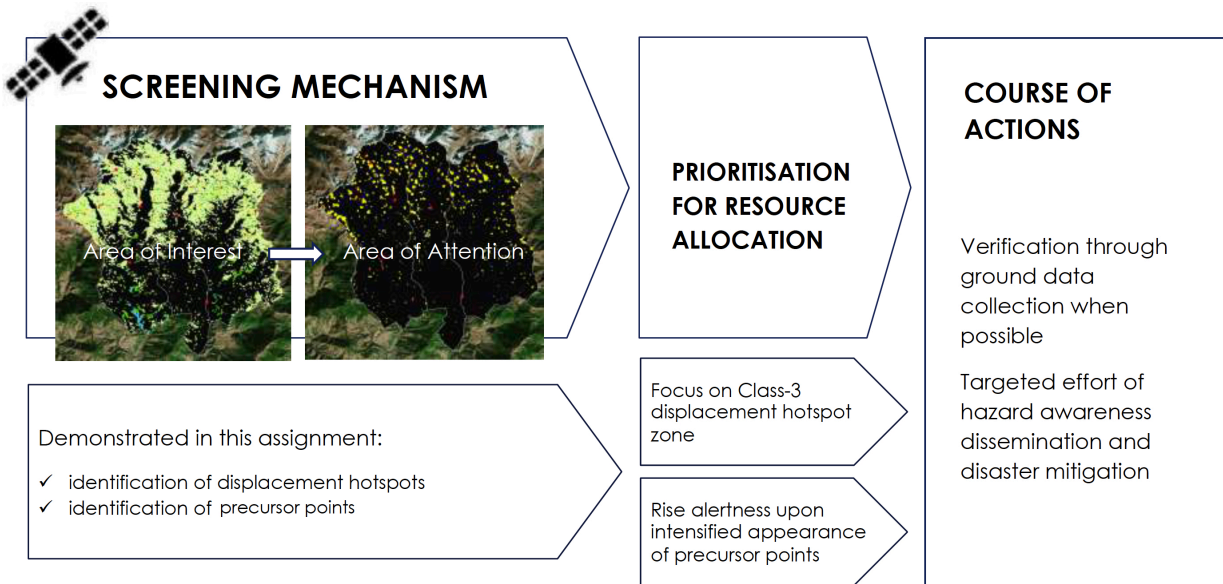
Figure 27: Conceptual scheme for SAR technology adoption

The application of SAR satellite data and land displacement analysis emphasizes 1) the power of SAR technology and its benefit to disaster risk managers and other authorities, and 2) the adoption of the technology itself in disaster risk management practice. The role of SAR satellite data and analysis results is most suitable in circumstances in which it is challenging to obtain the onsite measurement in a timely/regular manner due to the hindrance of cost and location accessibility challenges. The adoption of SAR technology and analysis in disaster risk management practice can be considered following the conceptual scheme illustrated in Figure 27.
