**PALAU FSM CONNECTIVITY PROJECT
(Project No. P130592)**

Pohnpei Cable Landing

**Addendum to IEE document
(*World Bank Project Number P130592*)**

**Report prepared by
Argo Environmental Ltd**

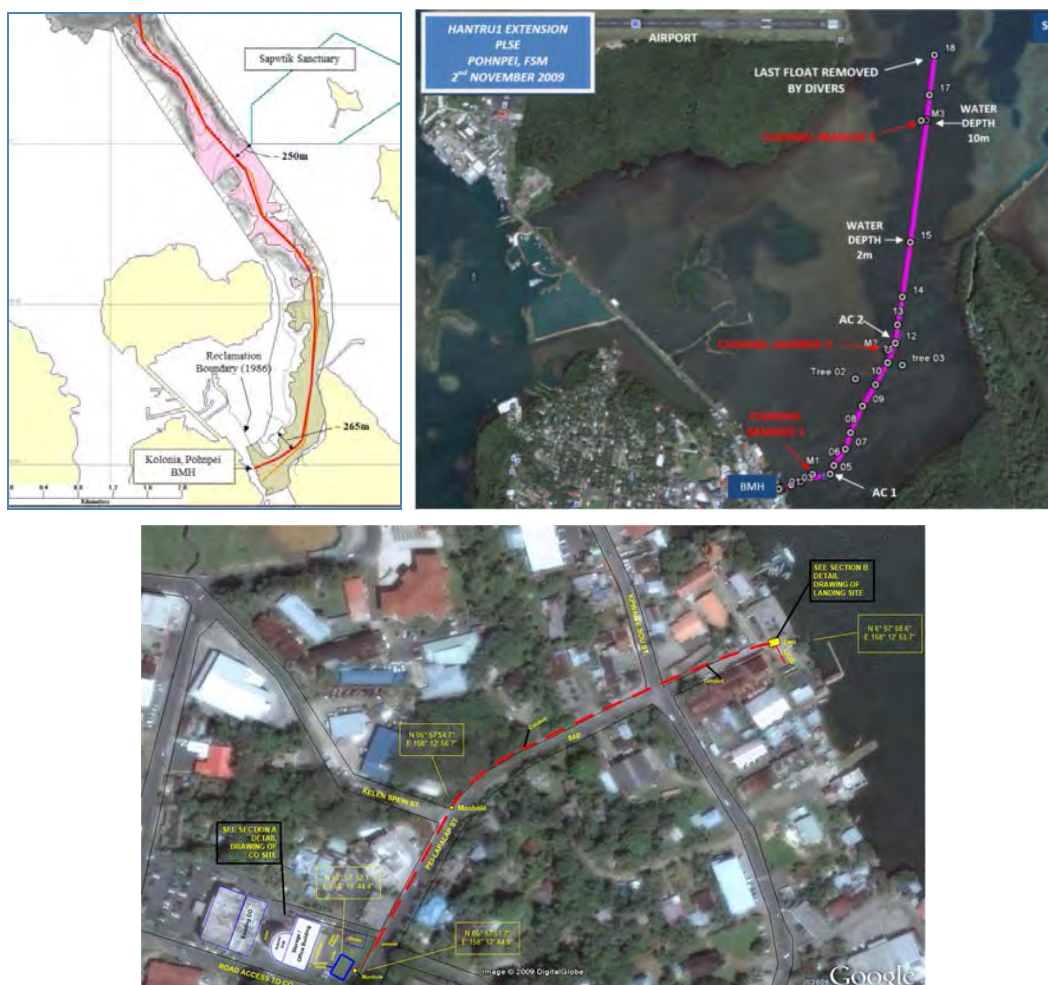
Figure 3: Existing Pohnpei - Hantru marine and terrestrial cable route

The Chuuk-Pohnpei PLSE will be laid along the same route and in close proximity to the existing PLSE for the Pohnpei-Hantru Segment 4. The planned PLSE lay for the Chuuk - Pohnpei PLSE is expected to be very similar. Figure 3 shows the Pohnpei - Hantru Segment 4 PLSE installation.

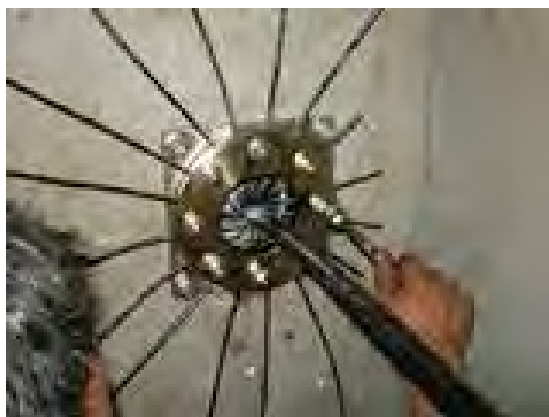
Figure 4: Securing the PLSE within the Beach Manhole

Once the PLSE is secured in the BMH (Figure 4), the installation vessel will proceed seaward deploying the PLSE cable on the sea bottom along a predetermined route.

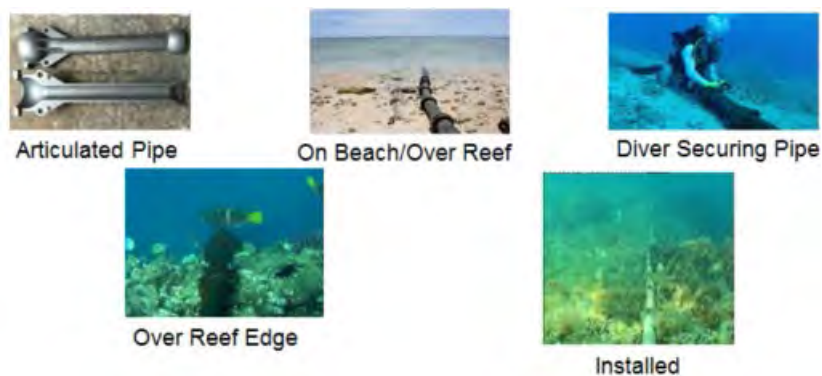
Figure 5: Articulated Pipe

Close to the BMH, articulated piping will be applied for approximately 50m onto the PLSE to provide extra protection for the cable (Figure 5).

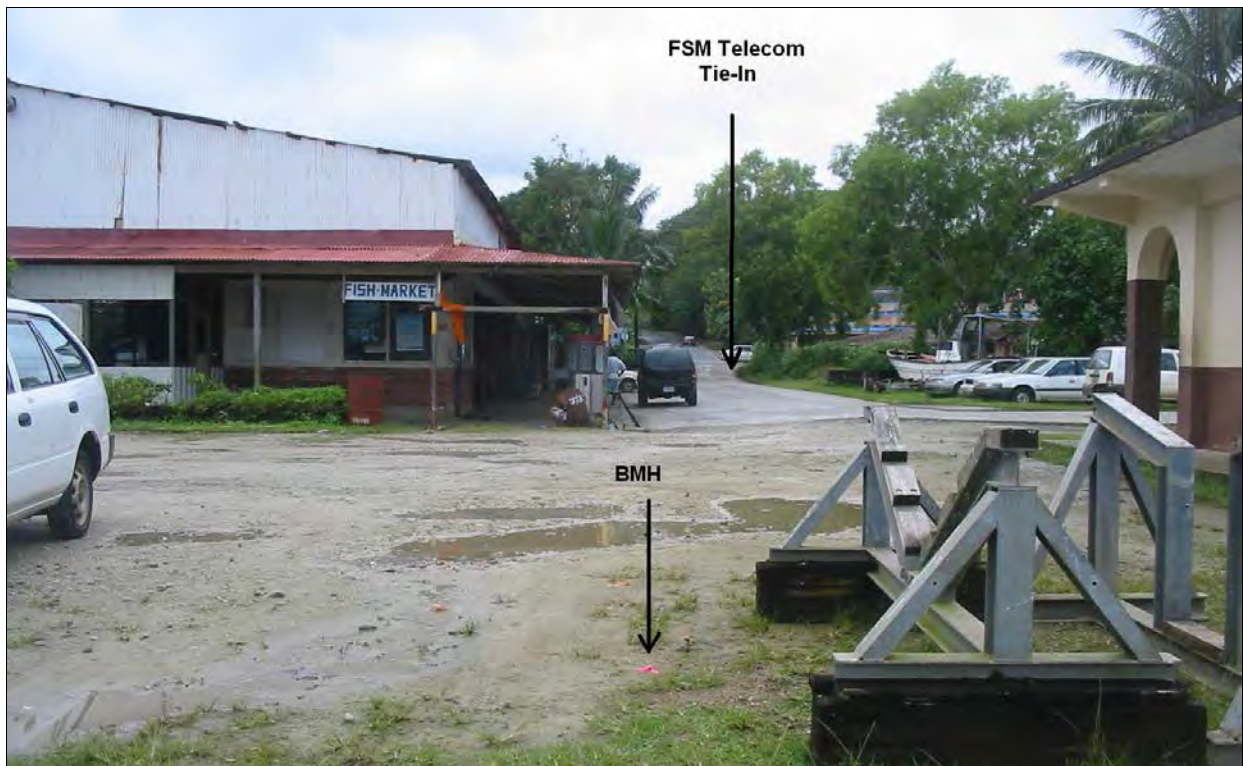
Figure 3.1.4: Pohnpei BMH with tie-in location

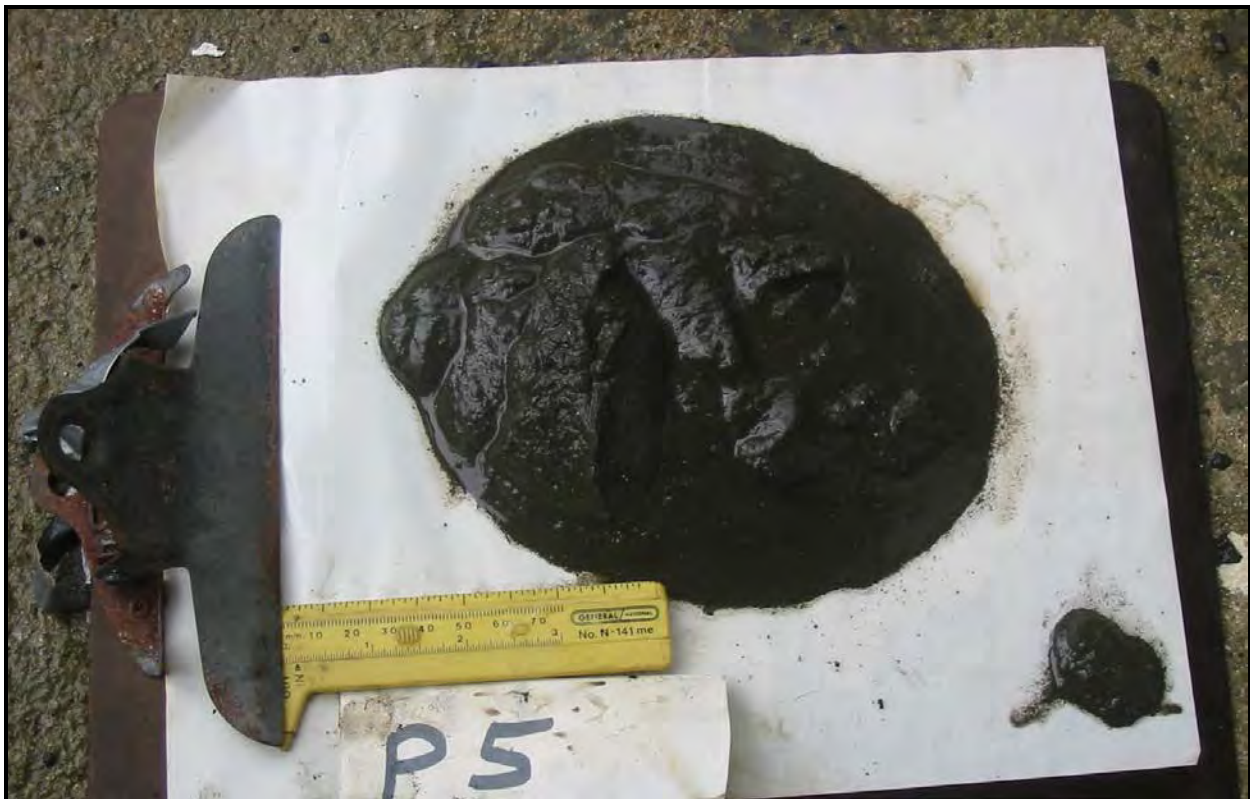
Figure 3.1.6: Typical sediment sample

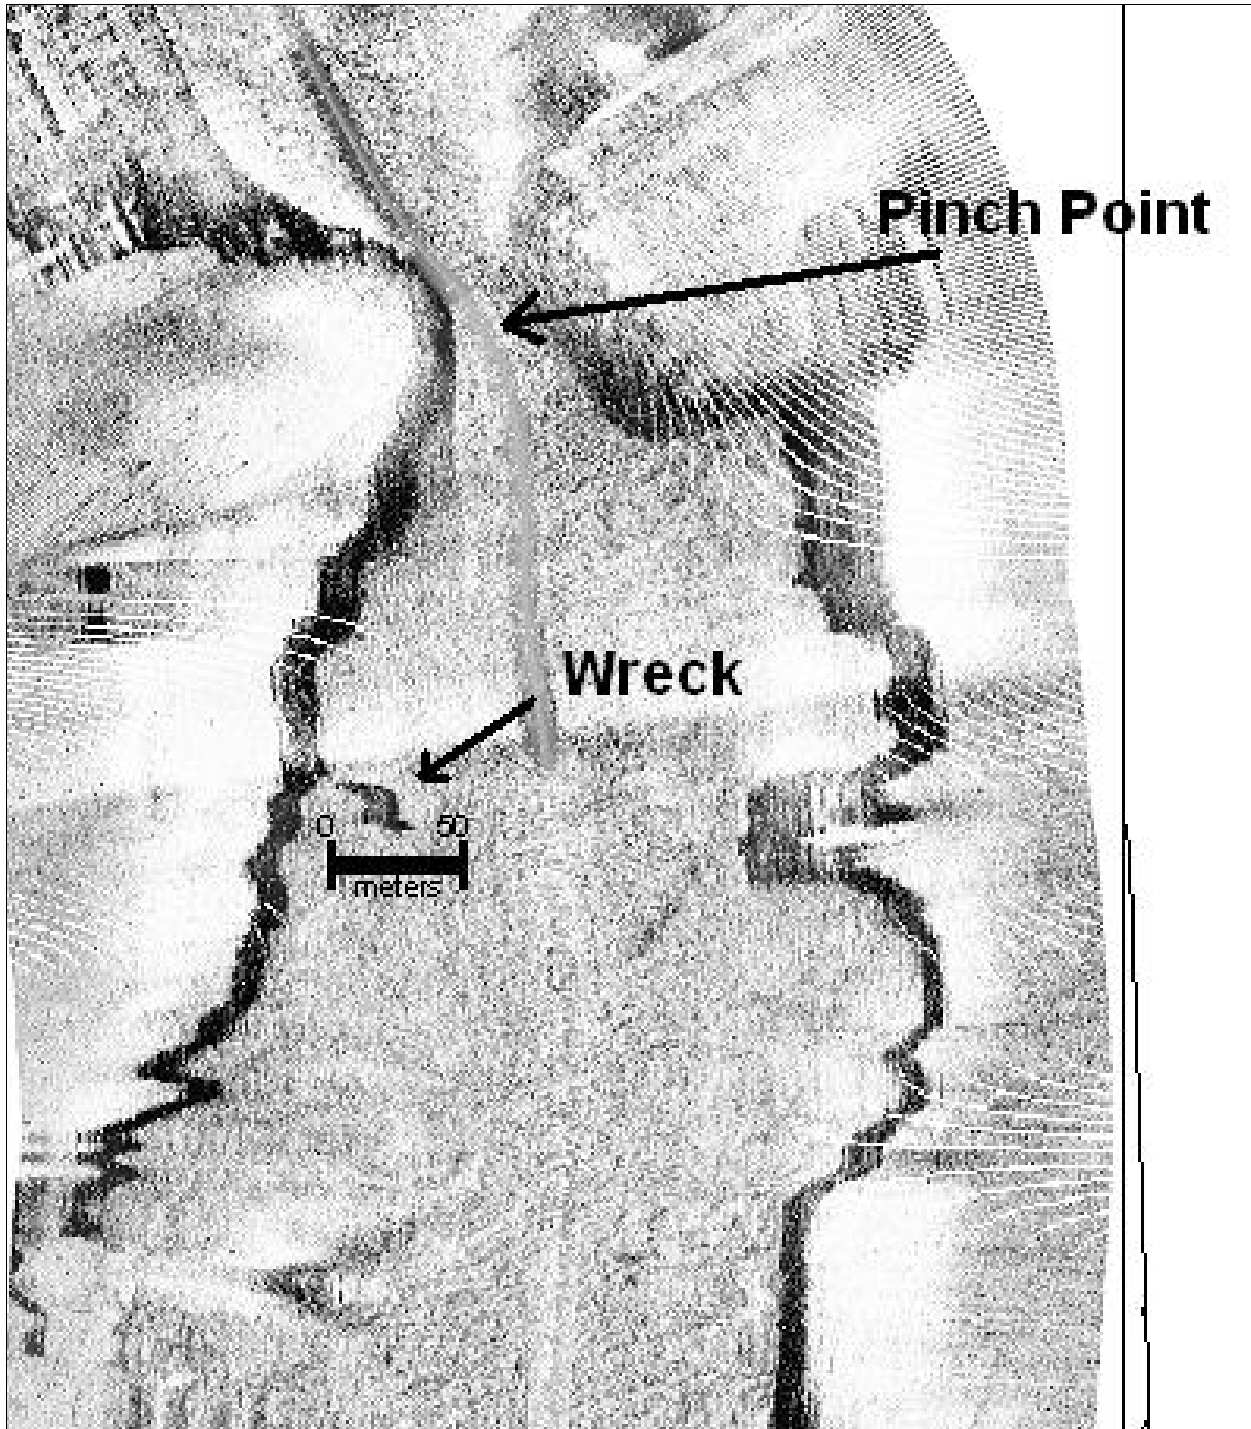
Figure 3.1.7: Side-scan Sonar record (125 kHz, 200m range) showing wreck and pinch point

The only sonar target found during the survey is in Zone 2 in 15 meters water depth. Target PO-SC-001 is probably a shipwreck. (See also Section 3.1.6.2.) According to the small boat survey boat operator, at one time a fishing boat was stranded on the shallow coral reef and then disappeared – likely slipping off the reef edge into deeper water.

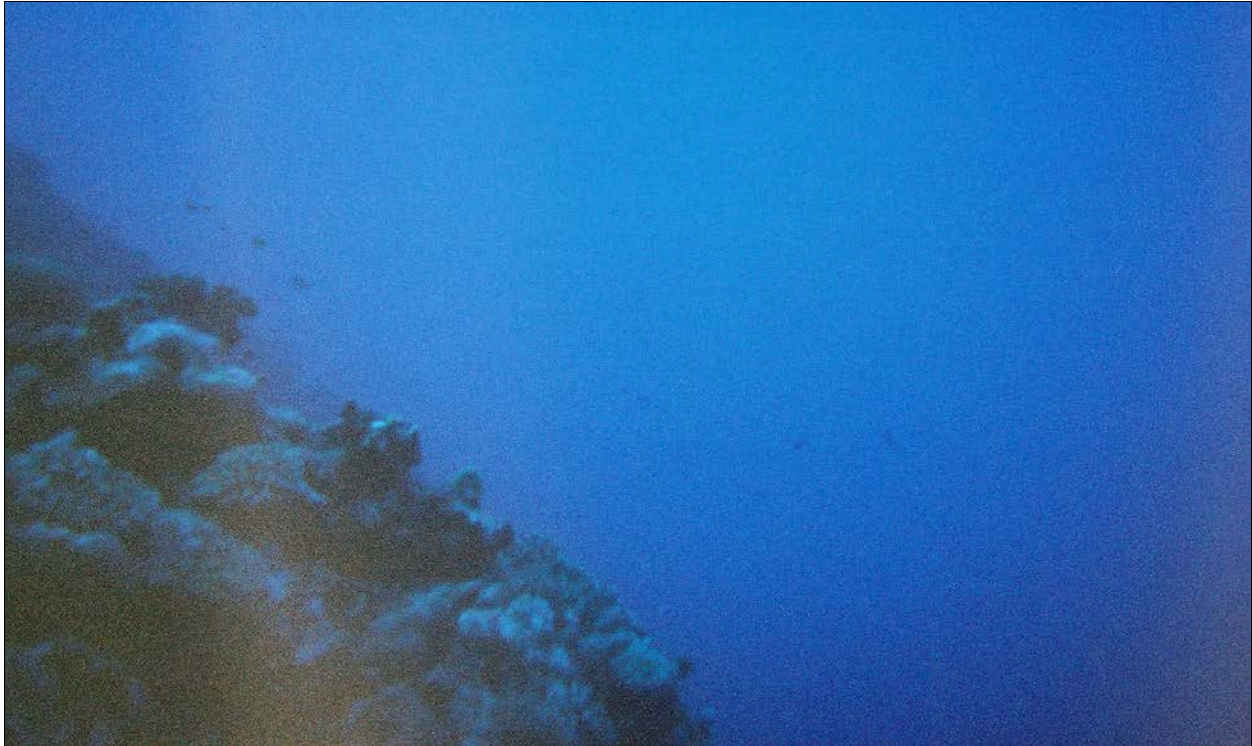
Figure 3.2.4: Bathymetric drop-off at 15m

The offshore area was inspected during one diver swim. Only one swim was attempted as the steep waves breaking in shallow water was considered hazardous. The diver swim ended at the 15-meter drop-off where the bathymetry plunges (Figure 3.2.4). The offshore area was homogenous, with 100% low relief live coral coverage. Individual coral head size increased gradually from the breaking zone to the drop-off (Figure 3.2.5).

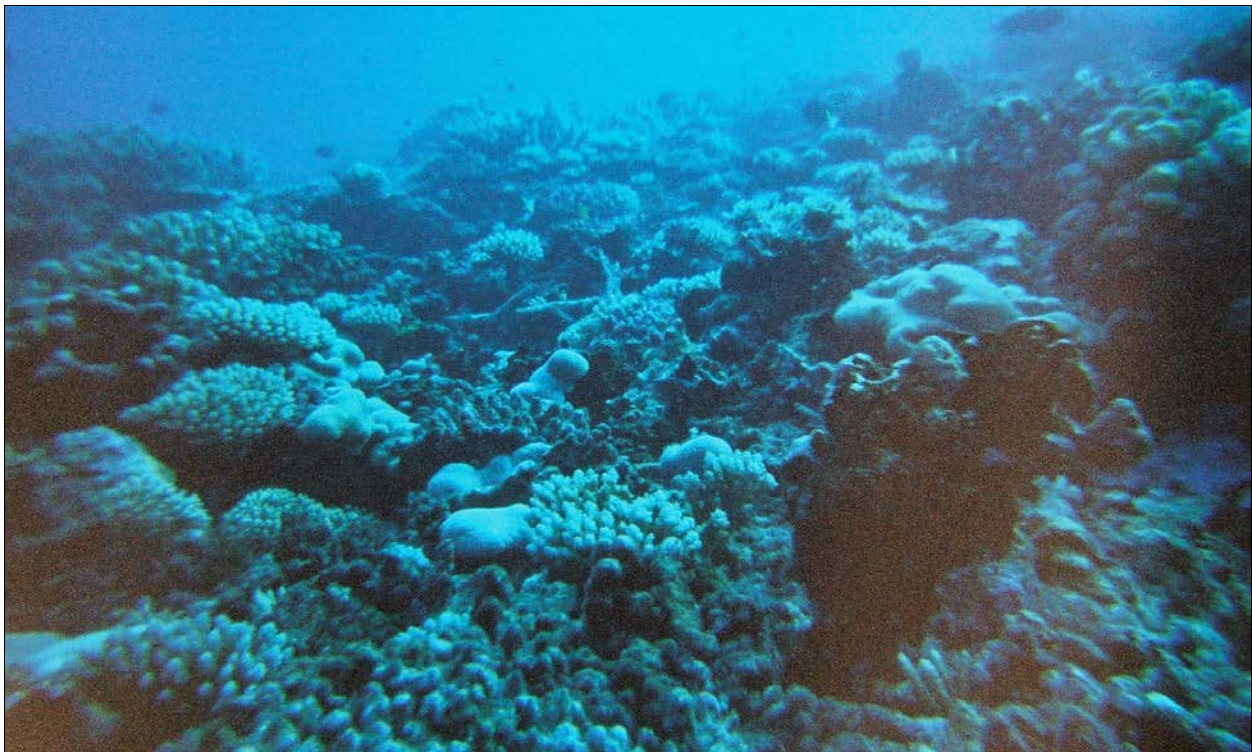
Figure 3.2.5: Typical bottom conditions near the drop-off

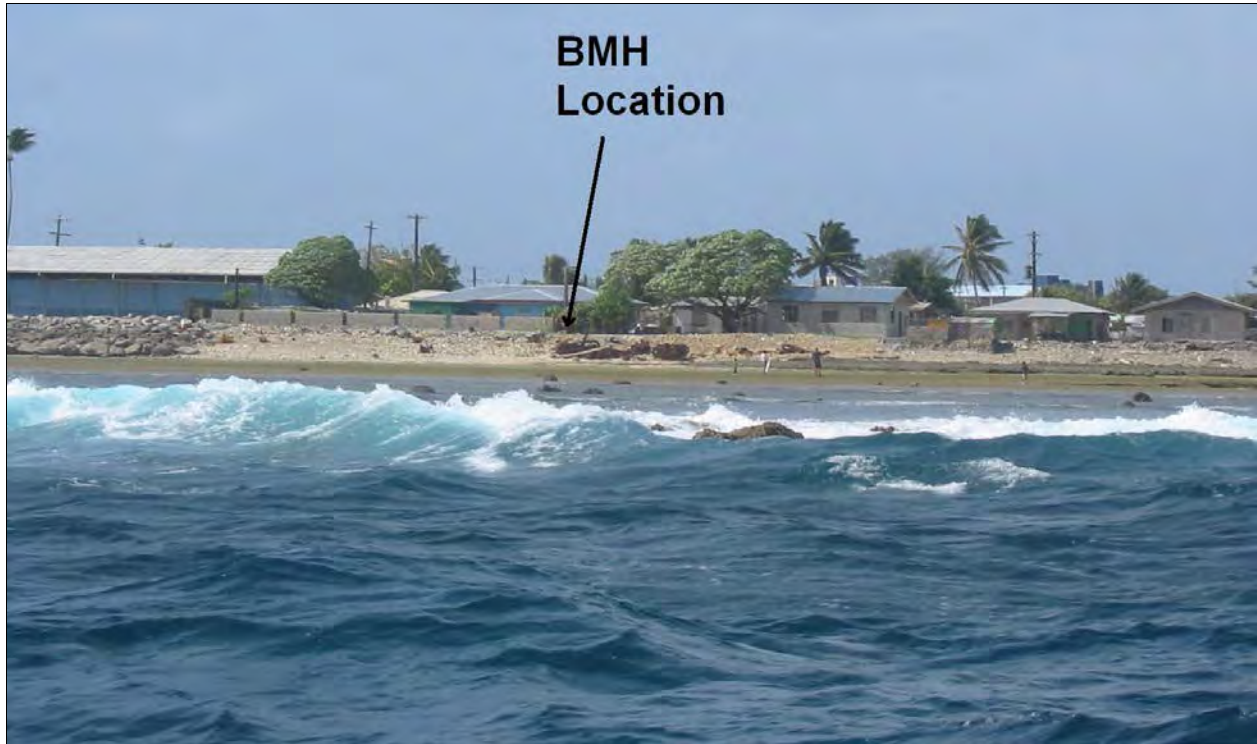
Figure 3.2.7: BMH location and emergent spur features in wave breaking zone

The wave-breaking zone is about 50 meters wide at low tide (i.e. waves break across the entire reef flat during high tide conditions). Surge channels (spur and groove structures) that are incised up to 2.5 meters into the limestone substrate characterize the seabed morphology. The top of the channels, or spur features, rise above the water surface at lower tide elevations, and have the appearance of large boulders in the surf zone (Figure 3.2.6). Figure 3.2.7 is a photograph taken from offshore that shows the emergent spur features at low tide, as well as the BMH location.

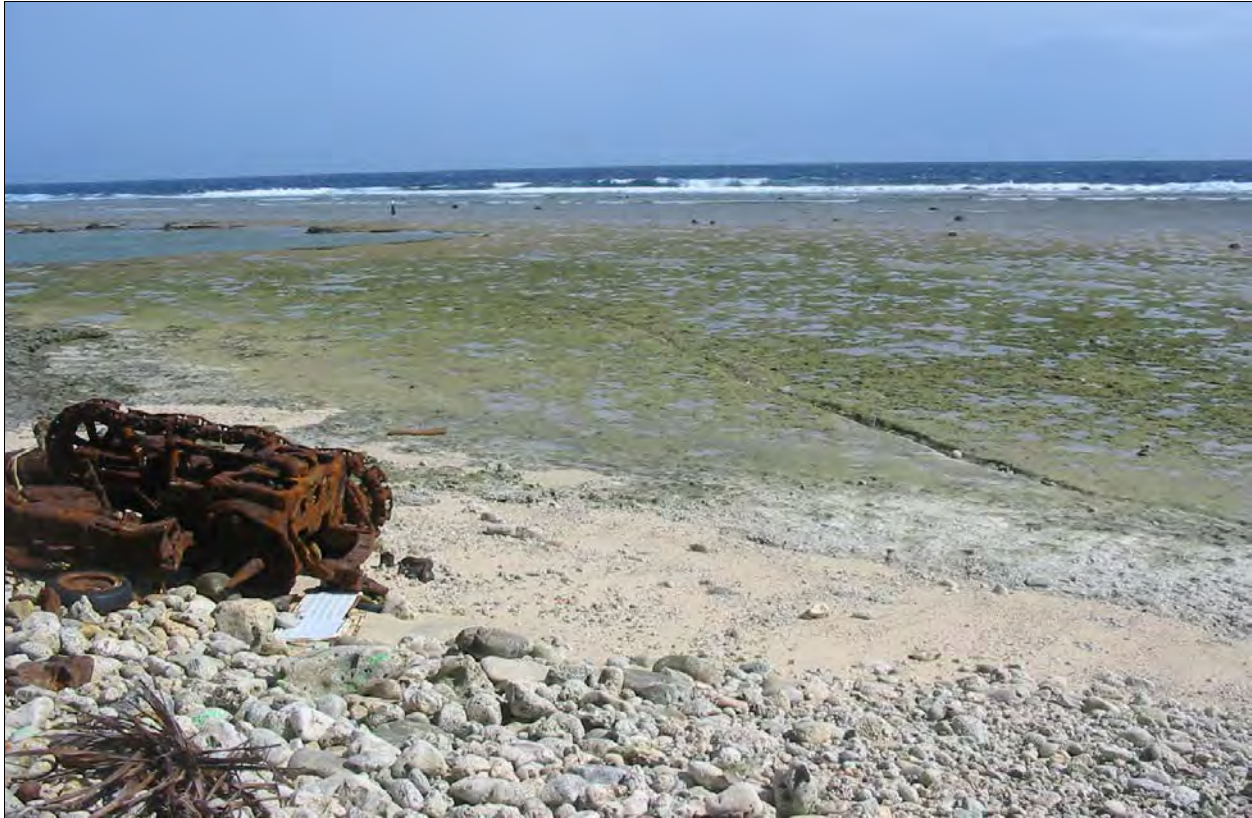
Figure 3.2.9: Reef flat at low tide (1)

The reef flat is composed of very dense, crystalline limestone. It is flat, with a nominal elevation of 1 meter LAT (rising from about 0.5 to 1.2 meters over a distance of 150 meters), with little or no pockets of sediment. Portions of the reef flat have been excavated for building material, and a large pool (less than a meter deep) has formed north of the survey route. Figure 3.2.8 shows the reef flat at high tide, while low tide conditions are exhibited in Figures 3.2.9 and 3.2.10. The excavated area can also be seen in Figure 3.2.9.

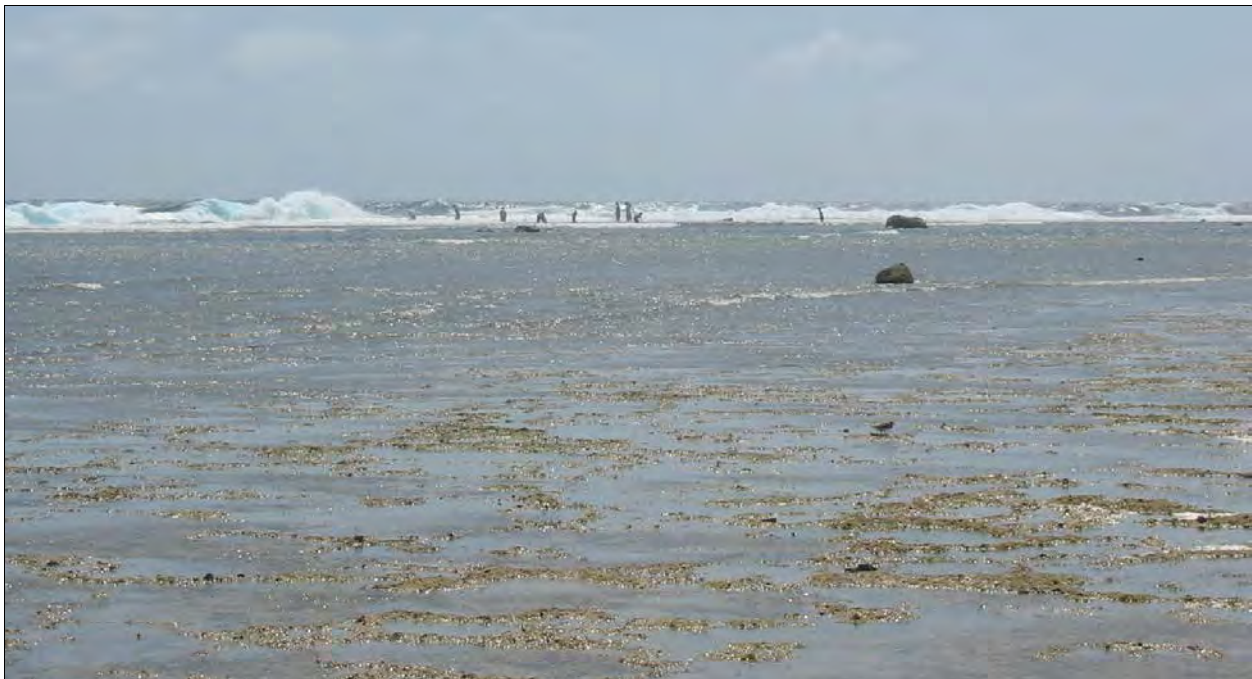
Figure 3.2.10: Reef flat at low tide (2)

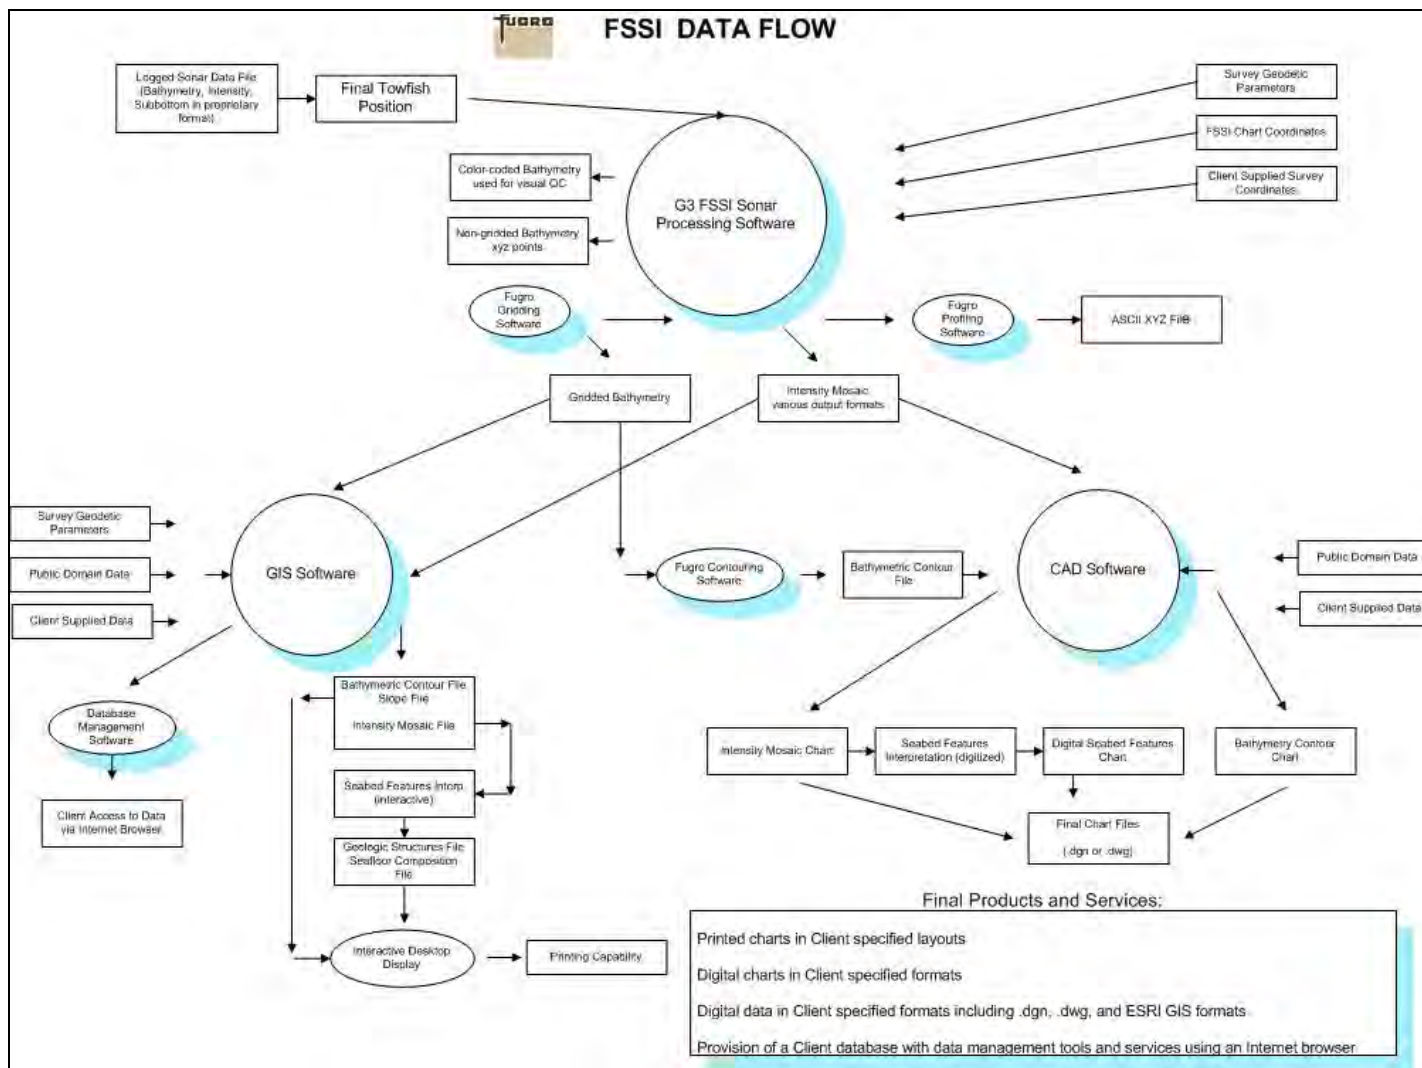
Figure 4.2.1: Sys100D/09 Sonar Data Processing Flow
