**MIZORAM STATE ROADS PROJECT  
(PHASE-II)**

**Environmental Impact Assessment  
for Buangpul-Lunglei Section P1B**

June 2003

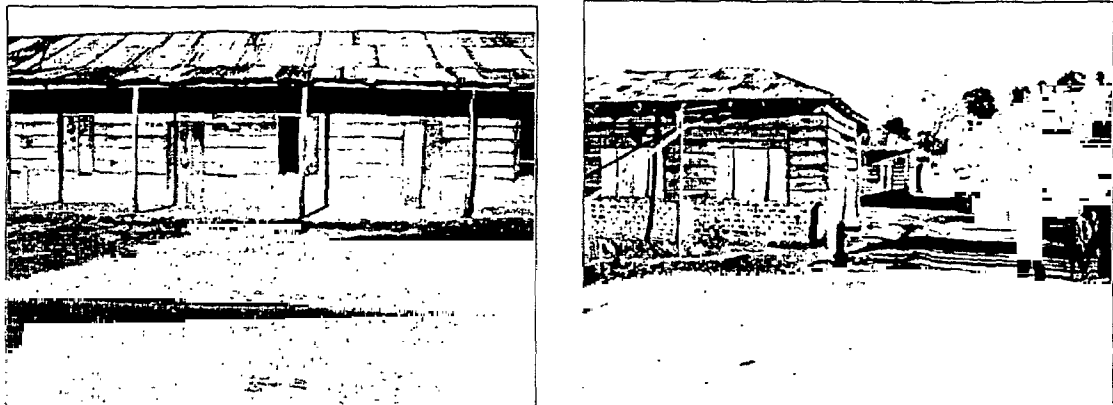
**Figure 5-9 : Govt. Middle School at Ramlaitui Village**

In Ramlaitui village, the secondary school is located adjacent to the road. It is housed in a wooden building with from the back, away from the road (**Figure 5-9**). The school is not being relocated. Here, in addition to the noise level, safety of students is also an issue to be addressed.

Here too, the options can be use of barrier or double-glazing. The advantage of barriers in this particular instance stems from the requirement of safety of the students. Since the structure is made from wood, the replacement with double glazed shutters

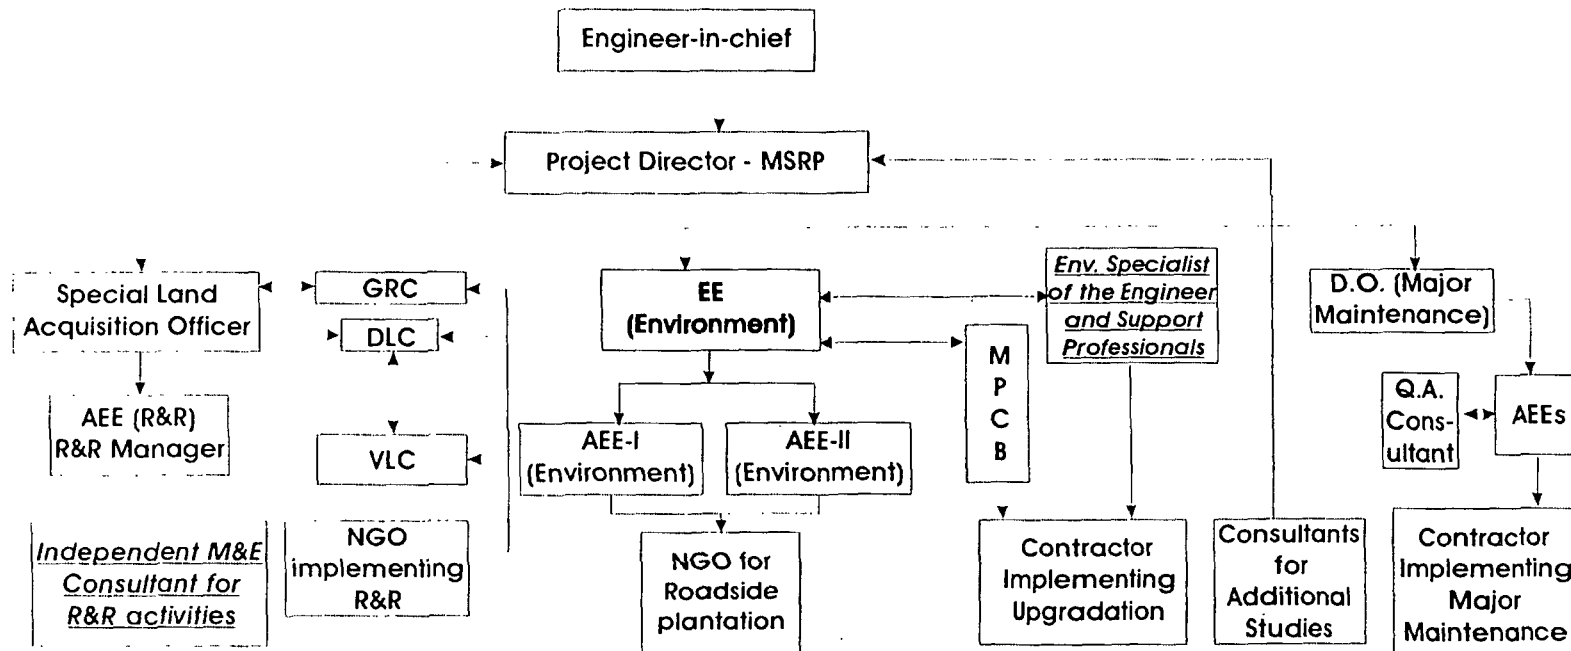
Figure 7.1: Implementation Arrangement

The implementation mechanism of PIU, environmental cell is shown in the flow diagram in **Figure 7-1**.
