FEBRUARY 20, 2023

Global Rapid Post-Disaster Damage Estimation (GRADE) Report

February 6, 2023 Kahramanmaraş Earthquakes

Türkiye Report

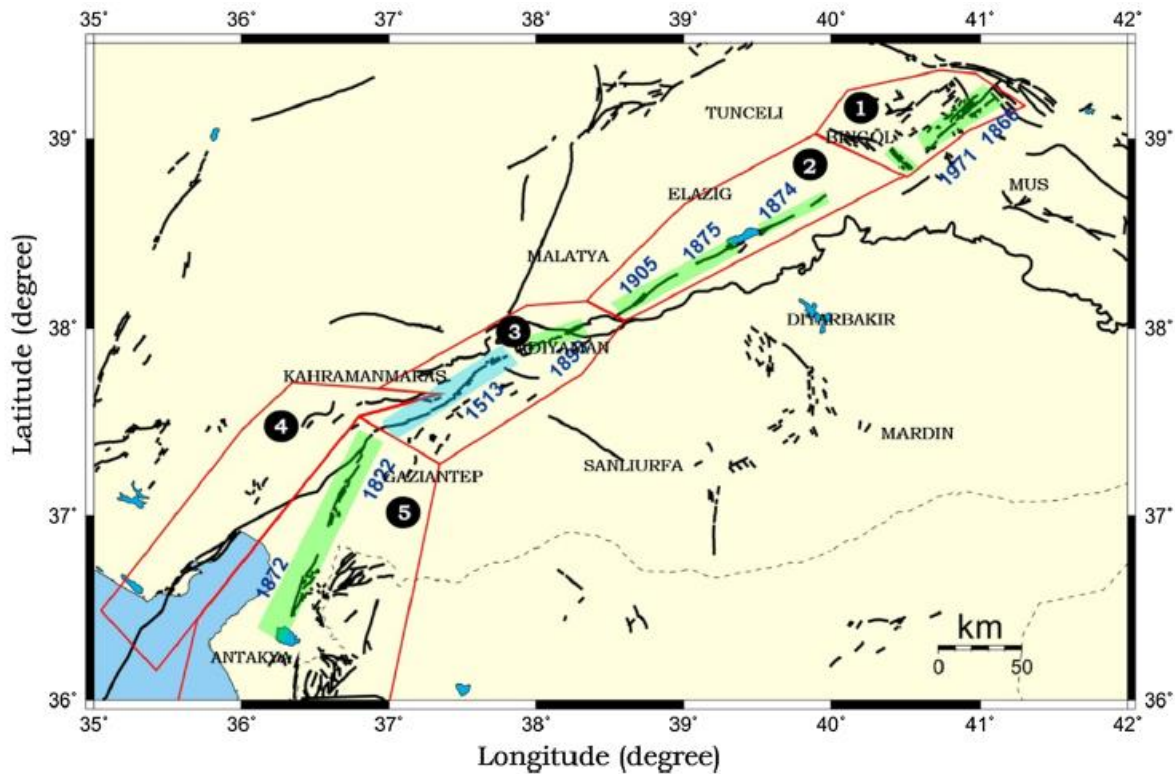
The EAF is highly active and historically its eastern segments (from Bingöl to Adıyaman) have ruptured in an East-West progression in the period 1866 to 1905 in five major earthquakes (in 1866, 1874, 1875, 1893 and 1905); while the southwestern segments (around Antakya) ruptured in 1822 north of Antakya and then in 1872 nearer to Antakya (Bayrak et al., 2015). The central-western segments, broadly between Adıyaman and Gaziantep and including Kahramanmaraş to the north, had ruptured in a large event (estimated magnitude 7.4) in 1513 and then just over 250 years later, on November 29, 1795, in a destructive event near Kahramanmaraş (estimated magnitude 7.0).

Figure 8: Map of the main five segments of the East Anatolian Fault Zone and major earthquakes ($M \geq 7$) that occurred in 1822–1971, showcasing “seismic gap” in the segment that ruptured in the mainshock of February 6, 2015. Source: Bayrak et al. (2015).

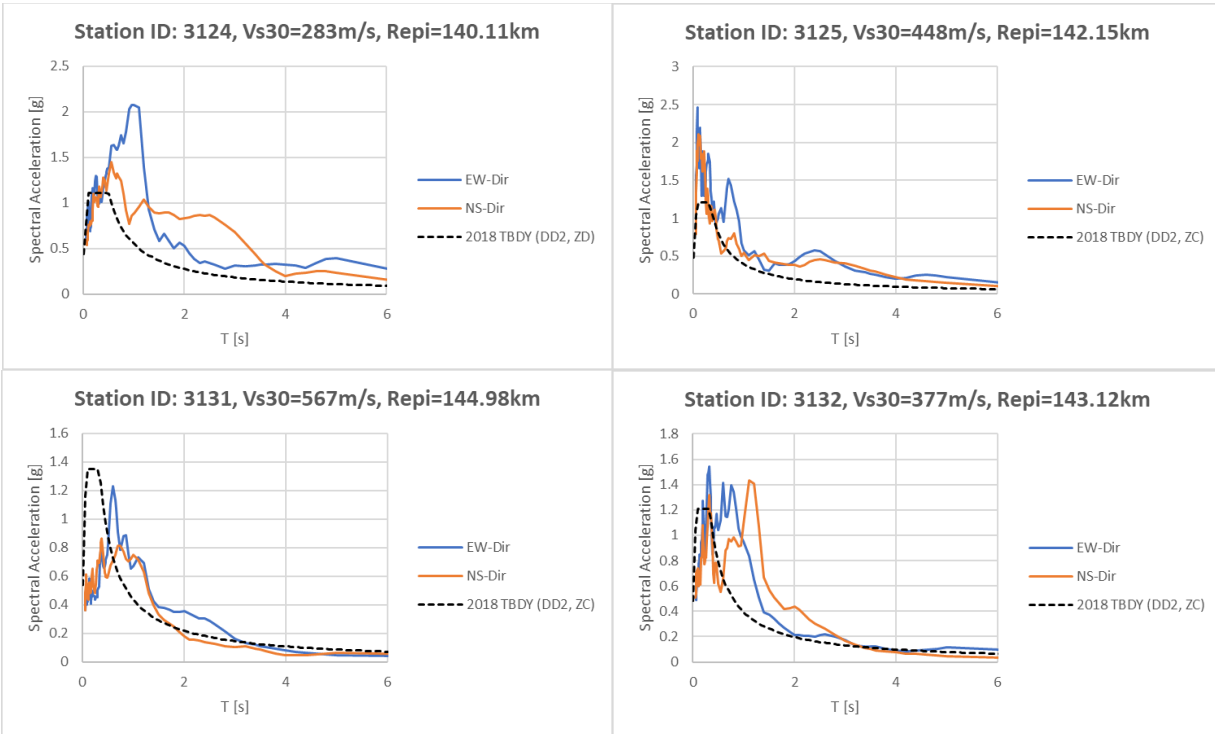
Figure 2: Plots comparing the EW and NS components of spectral acceleration at various stations in Antakya to the horizontal elastic response spectrum according to the seismic design code in Türkiye (2019). Recordings relate to the magnitude 7.7 earthquake occurring on 06/02/23 at 01:17 UTC.

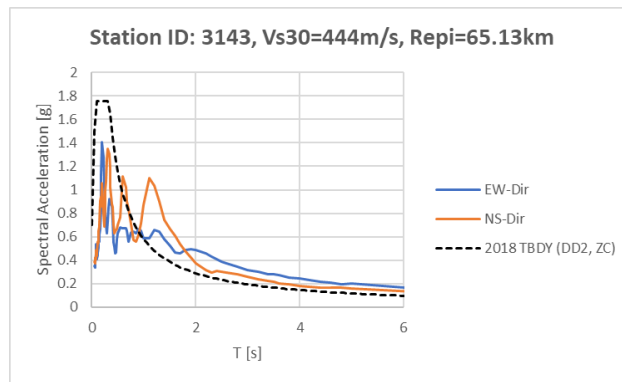
Figure 3: Plot comparing the EW and NS components of spectral acceleration at a station in Hassa to the horizontal elastic response spectrum according to the seismic design code in Türkiye (2019). Recordings relate to the magnitude 7.7 earthquake occurring on 06/02/23 at 01:17 UTC.

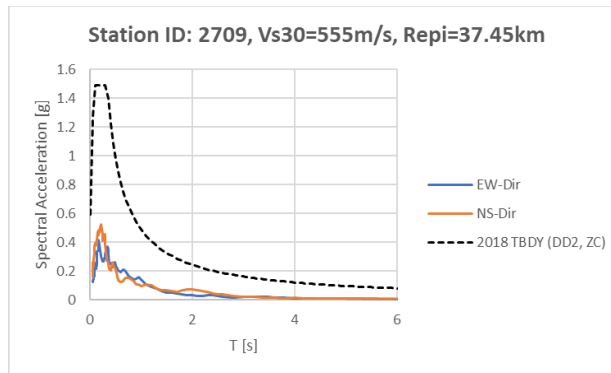
Figure 4: Plot comparing the EW and NS components of spectral acceleration at a station in Nurdagi to the horizontal elastic response spectrum according to the seismic design code in Türkiye (2019). Recordings relate to the magnitude 7.7 earthquake occurring on 06/02/23 at 01:17 UTC.

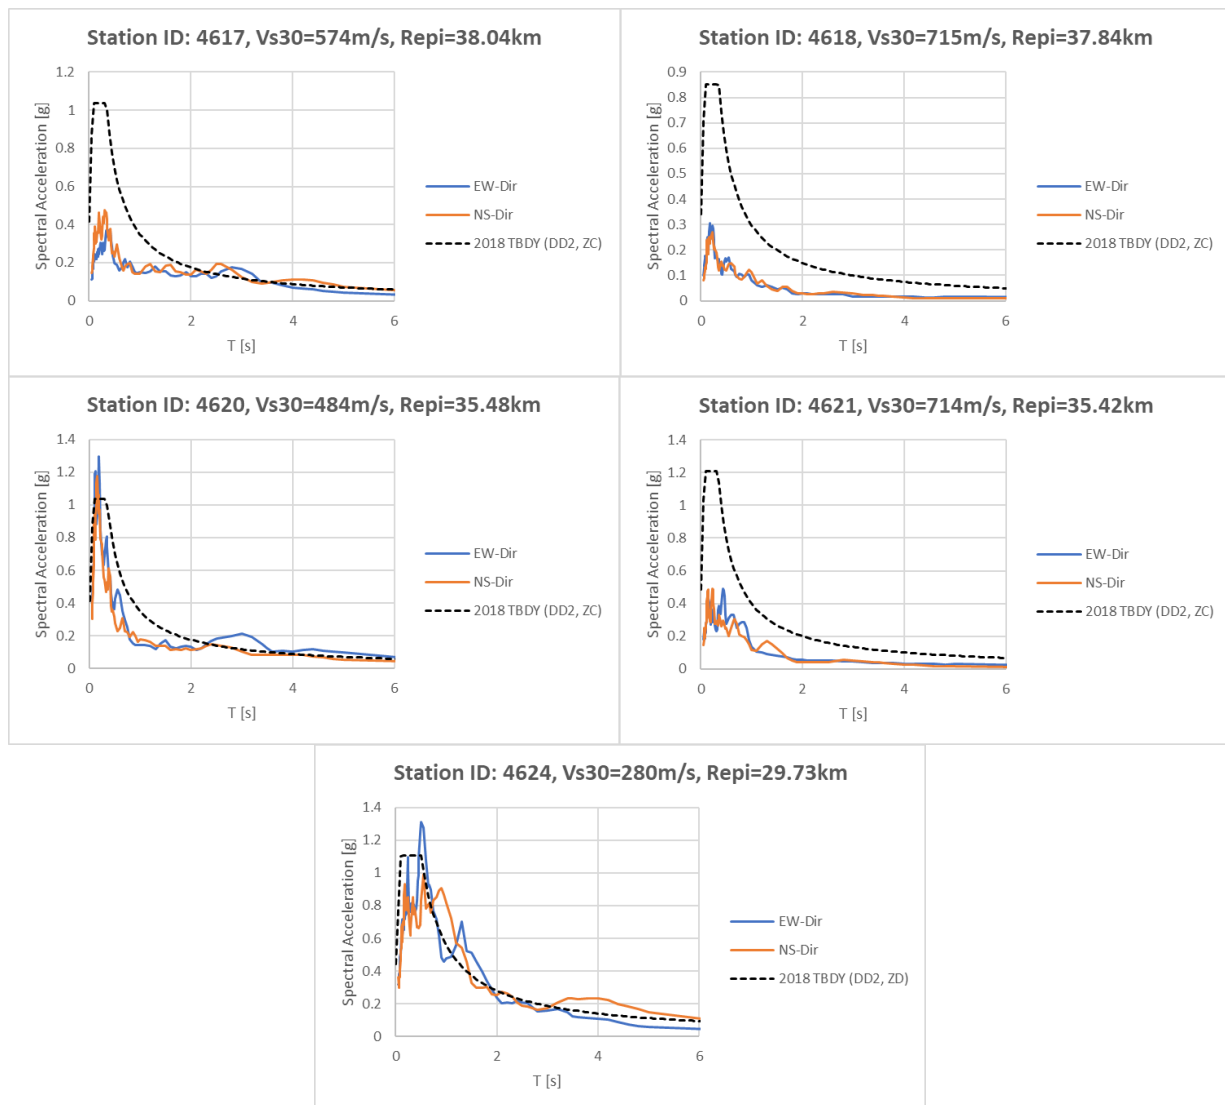
Figure 5: Plots comparing the EW and NS components of spectral acceleration at various stations in Kahramanmaras to the horizontal elastic response spectrum according to the seismic design code in Türkiye (2019). Recordings relate to the magnitude 7.7 earthquake occurring on 06/02/23 at 01:17 UTC.

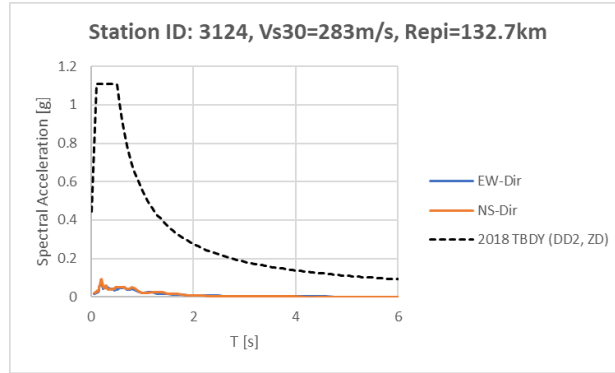
Figure 6: Plot comparing the EW and NS components of spectral acceleration at a station in Antakya to the horizontal elastic response spectrum according to the seismic design code in Türkiye (2019). Recordings relate to the magnitude 5.6 earthquake occurring on 06/02/23 at 01:26 UTC.

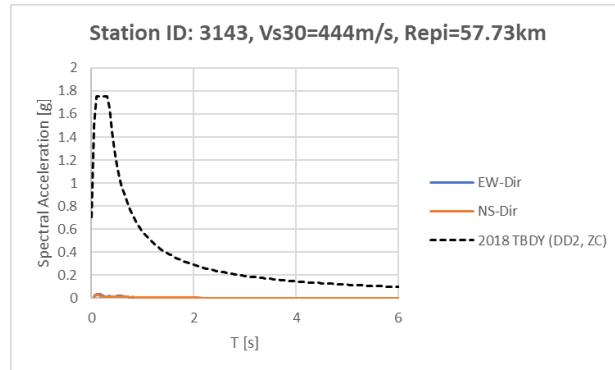
Figure 7: Plot comparing the EW and NS components of spectral acceleration at a station in Hassa to the horizontal elastic response spectrum according to the seismic design code in Türkiye (2019). Recordings relate to the magnitude 5.6 earthquake occurring on 06/02/23 at 01:26 UTC.

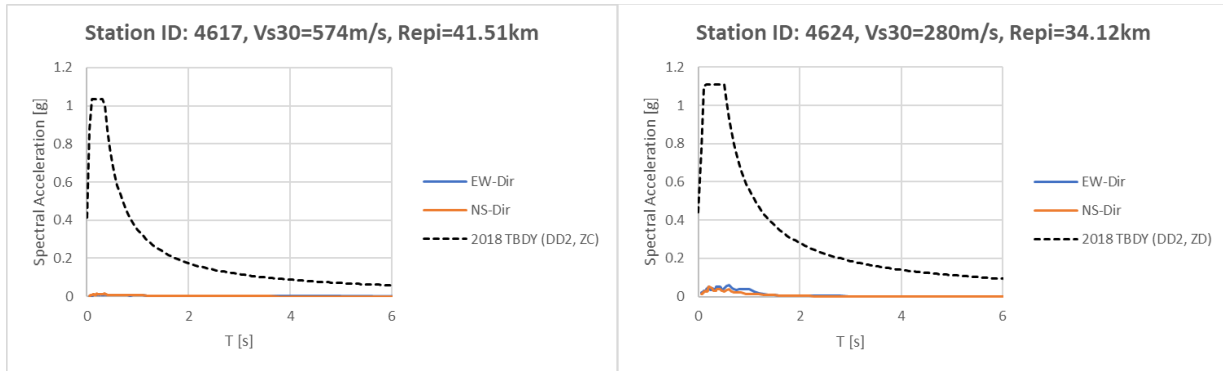
Figure 8: Plots comparing the EW and NS components of spectral acceleration at various stations in Kahramanmaraş to the horizontal elastic response spectrum according to the seismic design code in Türkiye (2019). Recordings relate to the magnitude 5.6 earthquake occurring on 06/02/23 at 01:26 UTC.

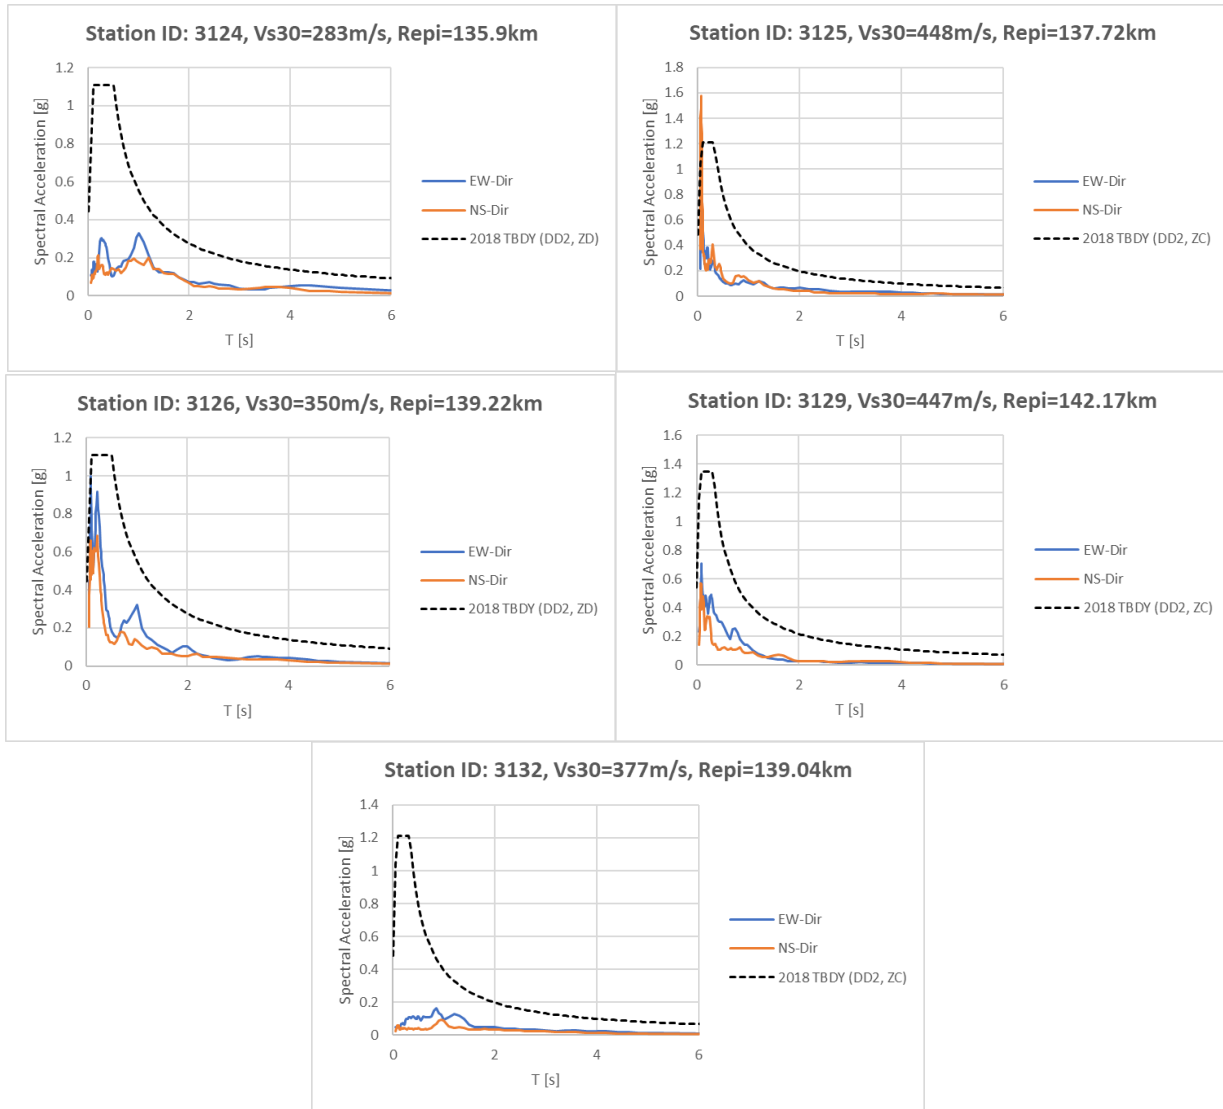
Figure 9: Plots comparing the EW and NS components of spectral acceleration at various stations in Antakya to the horizontal elastic response spectrum according to the seismic design code in Türkiye (2019). Recordings relate to the magnitude 6.6 earthquake occurring on 06/02/23 at 01:28 UTC.

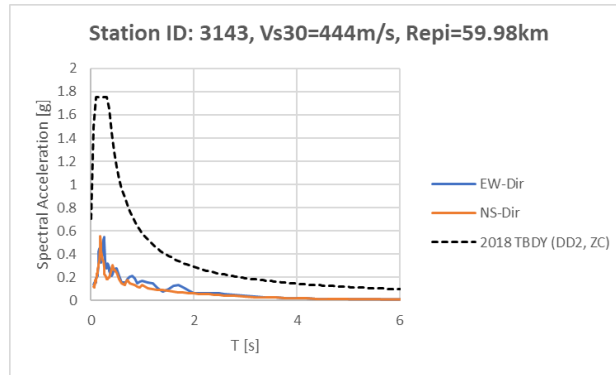
Figure 10: Plot comparing the EW and NS components of spectral acceleration at a station in Hassa to the horizontal elastic response spectrum according to the seismic design code in Türkiye (2019). Recordings relate to the magnitude 6.6 earthquake occurring on 06/02/23 at 01:28 UTC.

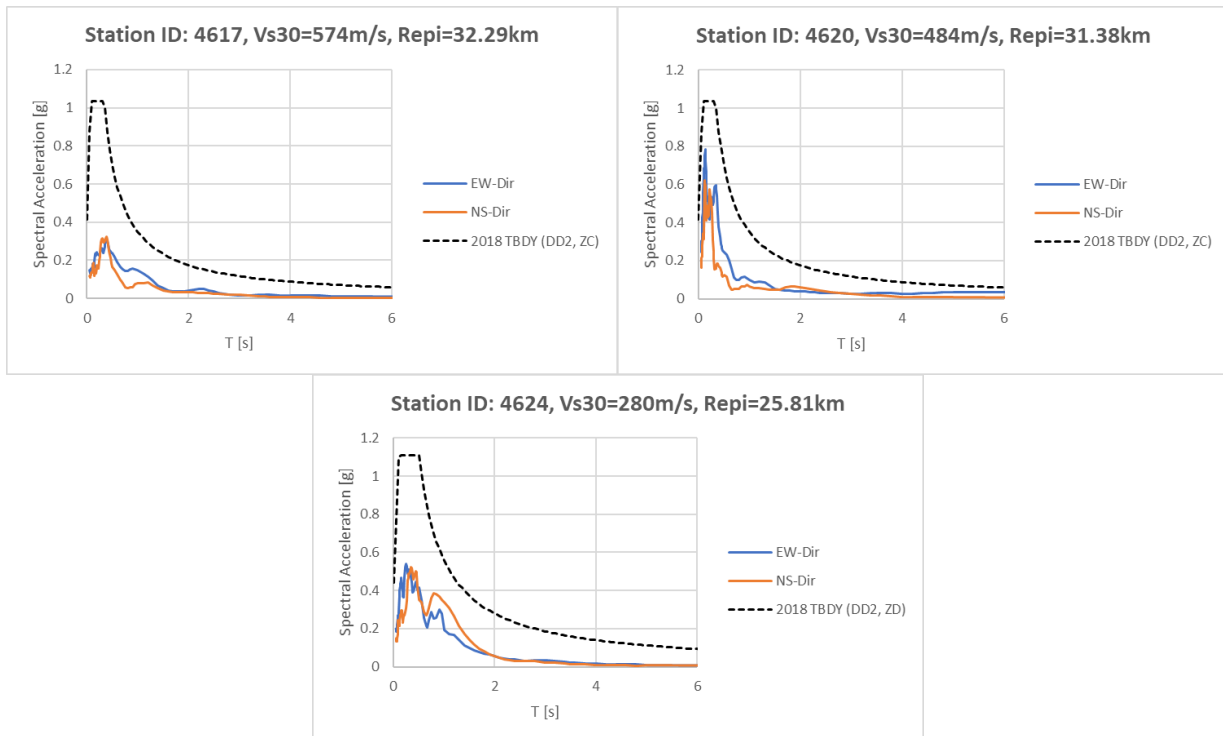
Figure 11: Plots comparing the EW and NS components of spectral acceleration at various stations in Kahramanmaraş to the horizontal elastic response spectrum according to the seismic design code in Türkiye (2019). Recordings relate to the magnitude 6.6 earthquake occurring on 06/02/23 at 01:28 UTC.

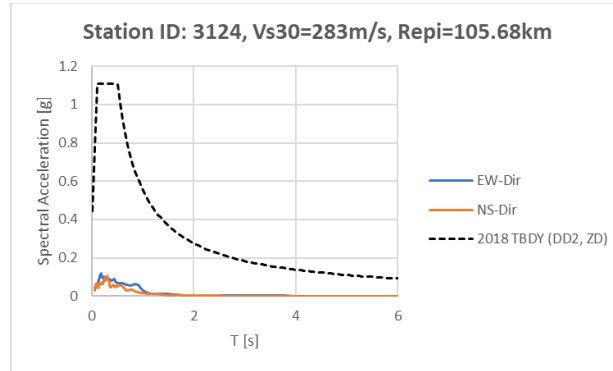
Figure 12: Plot comparing the EW and NS components of spectral acceleration at a station in Antakya to the horizontal elastic response spectrum according to the seismic design code in Türkiye (2019). Recordings relate to the magnitude 5.7 earthquake occurring on 06/02/23 at 01:36 UTC.

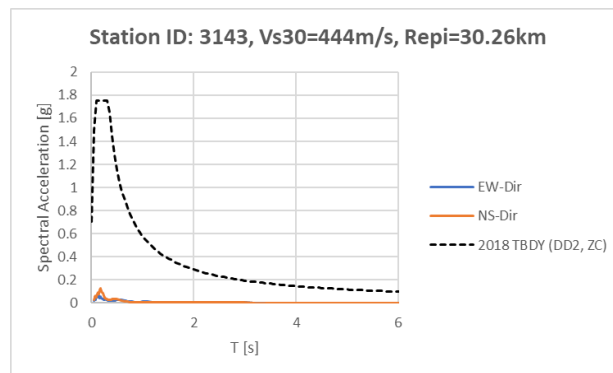
Figure 13: Plot comparing the EW and NS components of spectral acceleration at a station in Hassa to the horizontal elastic response spectrum according to the seismic design code in Türkiye (2019). Recordings relate to the magnitude 5.7 earthquake occurring on 06/02/23 at 01:36 UTC.

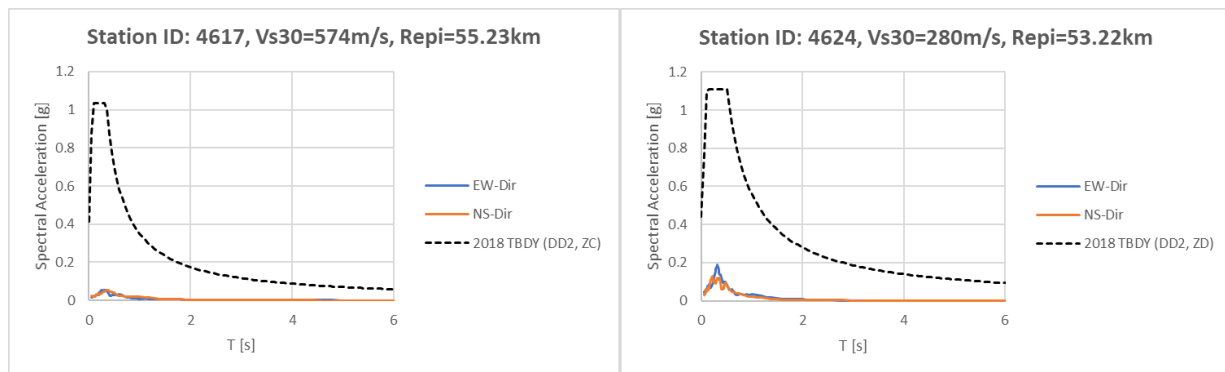
Figure 14: Plots comparing the EW and NS components of spectral acceleration at various stations in Kahramanmaraş to the horizontal elastic response spectrum according to the seismic design code in Türkiye (2019). Recordings relate to the magnitude 5.7 earthquake occurring on 06/02/23 at 01:36 UTC.

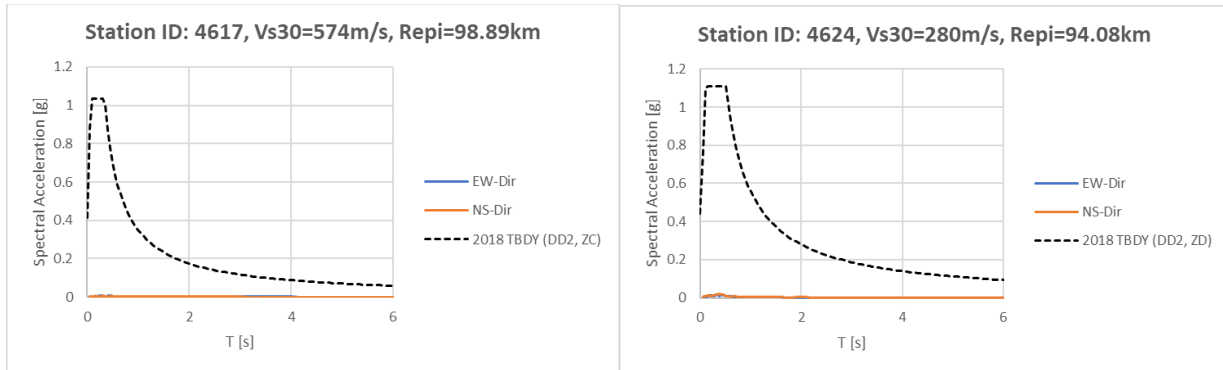
Figure 15: Plots comparing the EW and NS components of spectral acceleration at various stations in Kahramanmaraş to the horizontal elastic response spectrum according to the seismic design code in Türkiye (2019). Recordings relate to the magnitude 5.6 earthquake occurring on 06/02/23 at 02:03 UTC.

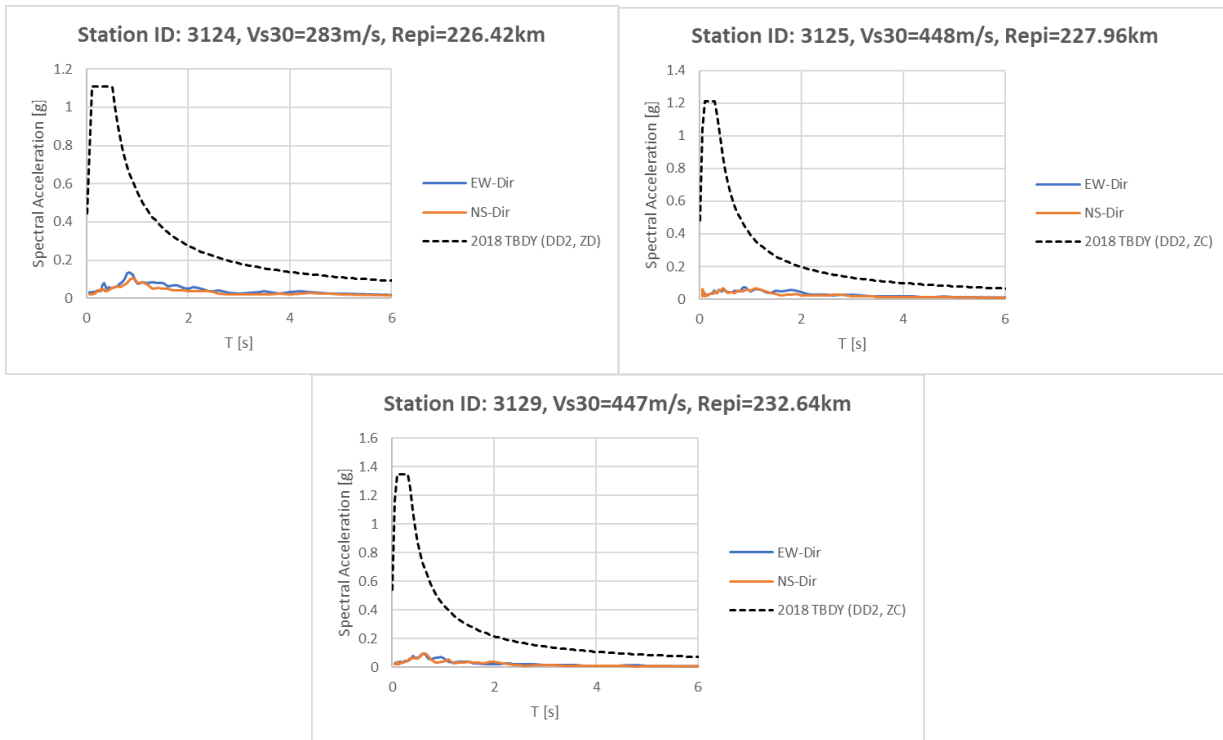
Figure 16: Plots comparing the EW and NS components of spectral acceleration at various stations in Antakya to the horizontal elastic response spectrum according to the seismic design code in Türkiye (2019). Recordings relate to the magnitude 7.6 earthquake occurring on 06/02/23 at 10:24 UTC.

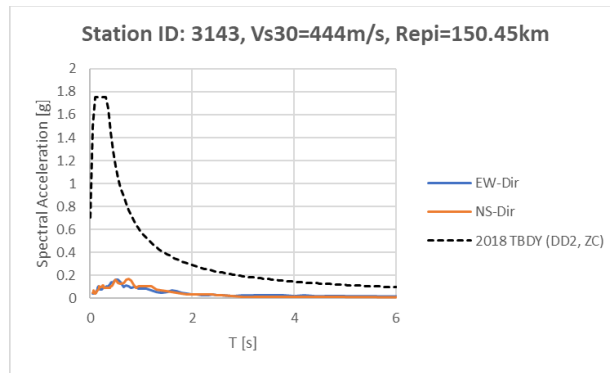
Figure 17: Plot comparing the EW and NS components of spectral acceleration at a station in Hassa to the horizontal elastic response spectrum according to the seismic design code in Türkiye (2019). Recordings relate to the magnitude 7.6 earthquake occurring on 06/02/23 at 10:24 UTC.

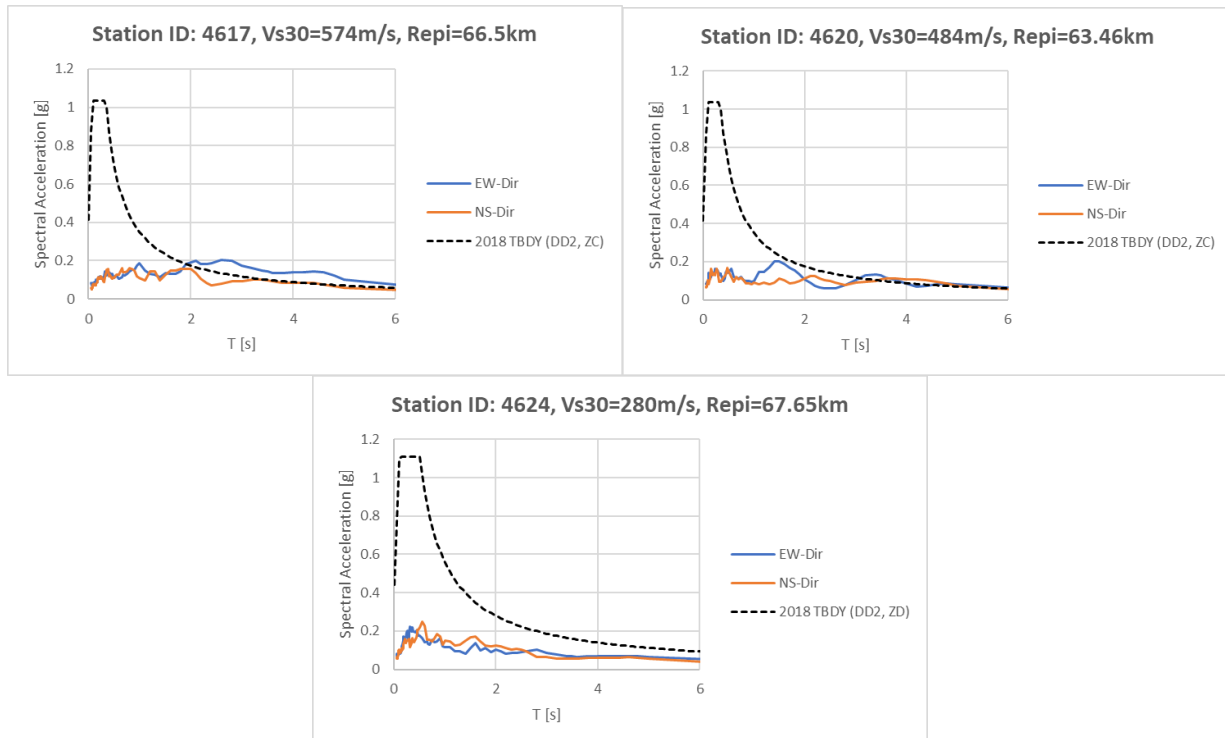
Figure 18: Plots comparing the EW and NS components of spectral acceleration at various stations in Kahramanmaraş to the horizontal elastic response spectrum according to the seismic design code in Türkiye (2019). Recordings relate to the magnitude 7.6 earthquake occurring on 06/02/23 at 10:24 UTC.
