**DAM REHABILITATION AND SAFETY IMPROVEMENT PROJECT  
(WB8)**

**ENVIRONMENTAL AND SOCIAL IMPACT  
ASSESSMENT REPORT**

**SUBPROJECT: DAK LAK DAM REHABILITATION AND SAFETY  
IMPROVEMENT PHASE 1**

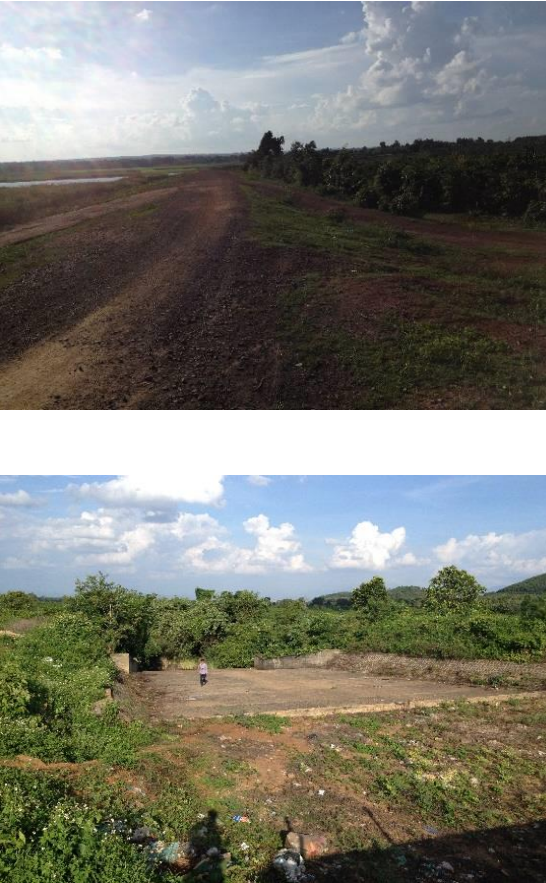
Location	Current status	Work item	Status images
<p>1) <b>Ea Uy reservoir</b> in Hoa Tien commune, Krong Pak district</p>	<p>The work was built in 1980 to provide irrigation water for 207.3 ha of two-crop rice area, 344ha of coffee area and 6.45 ha of secondary crop area of Hoa Tien commune. Catchment area is 34.43 km<sup>2</sup>, with net capacity of 3.76 million m<sup>3</sup> corresponding to the reservoir surface area of about 1.08km<sup>2</sup>.</p> <p>Homogeneous earth dam, 850mlong , 6m-width dam crest as rural road had degraded and unsafe risk. In the middle of the dam and the two shouders, there is leakage flow through the dam body and foundation, seepage streaks appear from dam downstream to downstream dam abutment, increasing the instability factors for downstream slope.</p> <p>The entire entrance, the old overflow threshold and the first 15m slope of the flood discharge spillway have not been protected</p>	<p><i>a, Earth dam</i></p> <p><u>Dam crest</u>: : Width of dam crest B = 6m (equivalent to the current crest width); dam surface has a structure in sync with the road through the dam: The structure of the surface layer is 18cm-thick M300 cement concrete, the lower layer is crushed aggregates type 1, thickness of 150mm, the curb of the downstream edge is M200 concrete; in upstream, breakwater is made of M200 reinforced concrete with a height of 0.7m, a wall thickness of 0.4m</p> <p><u>Upstream dam slope</u>: The section of the dam slope from the elevation of 483.80m up to the dam crest, with the slope coefficient m = 3.0 is reinforced by the poured-in-place M200 concrete slabs, the slab has dimension (3.0x3.0) and 10cm thickness, contains drainage holes, underneath lining cement paper against water loss of cement mortar, followed by macadam, filtered sand layer with thickness of 15cm each layer.</p> <p><u>Downstream dam slope</u>: The downstream face is removed 0.5m on average, processed termites, reinforced for erosion by planting grass inside the drainage ditch made of crushed stone, the slope coefficient according to the new design is m = 2.75; 3.0. Backfill the hollow of the downstream face and make dam structure at the elevation of</p>

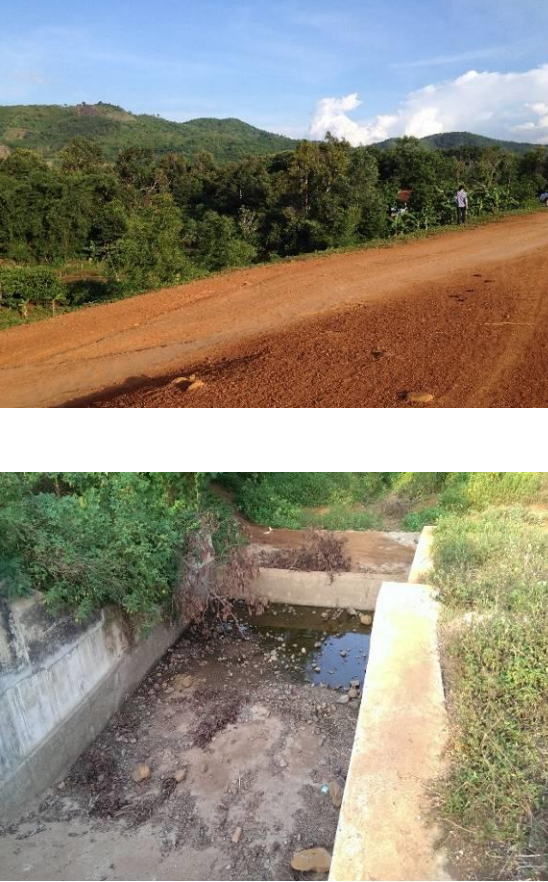
Location	Current status	Work item	Status images
<p><b>2) Buon Dung II reservoir</b> in Ea Yong commune, Krong Pak district</p>	<p>Buon Dung 2 reservoir is built in 1992 to provide irrigation water for about 100ha of coffee area around the reservoir and downstream area. Catchment area of 6.8km<sup>2</sup>, net capacity of 0.47 million m<sup>3</sup>.</p> <p>The upstream slope of the dam is not reinforced, so it is broken by waves. The dam surface has uneven height. At downstream of the dam, there is not drainage device, affecting the safety of earth dams in the long term. There is no bridge over flood discharge spillway. There are no culverts to drain water through the dam, which does not guarantee bottom discharge and provide irrigation water for downstream areas.</p> <p>The project does not have sluices through the dam, so when the downstream needs water, it cannot regulate water, sedimentation and reduce the net capacity of the reservoir.</p>	<p><b>a, Earth dam</b></p> <p><u>Dam crest:</u> Heightening, embankment with soil. Designed crest elevation = 525.20m; elevation of breakwater = 525.70m, dam crest length L = 264.0m, dam crest width Bd = 6.0m, top crest surface is made of M300 reinforced concrete with thickness of 18cm. The edge of dam crest is reinforced with a concrete curb of M200.</p> <p><u>Upstream slope:</u> Protect upstream slope with cast-in-place concrete slabs with dimension (3x5) 10cm thick, below are filtered sand and macadam layers, 15cm thick. Lay out from the dam crest to the elevation of the dead water level is 518,700m.</p> <p>Upstream slope mt = 3.0. Decompose the upstream slope at the erosion position and re-embank by hand with an average peeling thickness of 0.3m. Lay out 10cm thick reinforced concrete slabs M200 from the top of the dam down to the height of 517.70m and pave stone in the frame of reinforced concrete M200 size 5x5m from + 517.7 or less to protect the upstream face, arrange 4 drainage holes with pipes PVC D34. Arrange a filter layer upstream of the upstream face with a 15cm thick gravel layer, and a 15cm thick layer of filtered sand below</p> <p><u>Downstream slope:</u> Downstream slope m<sub>h</sub> = 2.75. Maintain the current status of lower slope, make drainage ditches and plant grass on the entire slope for protection. Downstream slope drainage uses a</p>

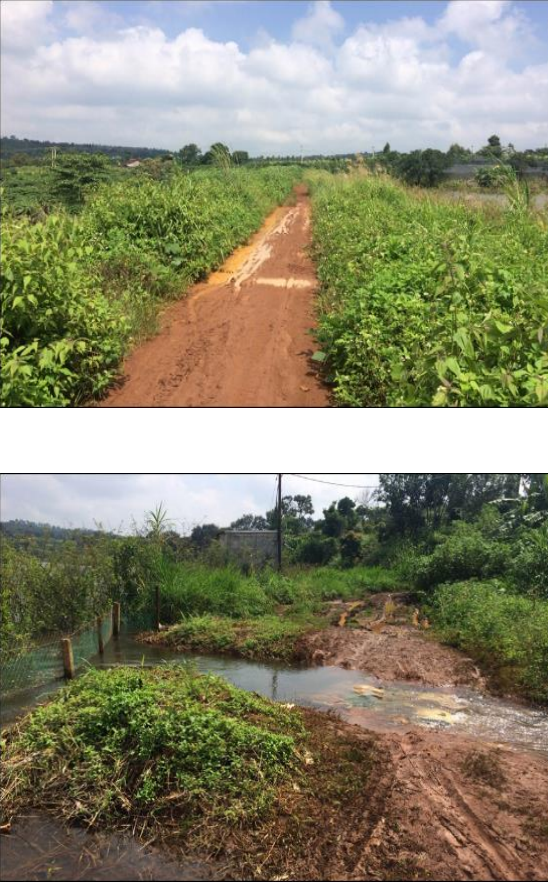
Location	Current status	Work item	Status images
<p>In Dlie Ya commune, Krong Nang district</p>	<p>area of inhabitants along the reservoir and downstream of the project. Catchment area: 2.40 km<sup>2</sup>, net capacity: 0.2x10<sup>6</sup> m<sup>3</sup>.</p> <p>The upstream slope has not been reinforced with reinforced concrete, slopes with overgrown grass, it is difficult to observe the dam cracks and seepage, there is no downstream drainage for seepage treatment on the dam body.</p> <p>Under the effect of the wave, currently the dam has been eroded, causing instability. The downstream dam has a steep slope, due to lack of attention and protection, the seedlings and weeds are growing with the average height <math>h = (3 \div 4)</math> m. There is no occurrence of seepage, in the middle part of the downstream dam slope, there is no drainage device.</p> <p>Spillway is made by soil, free flow, no bridge traffic overflow. The entire entrance, overflow threshold and the beginning of the unpaved slope and water slope have been eroded, eroded deep</p>	<p>concrete 1x2M300, arranged with wave walls and bundles of downstream seams with concrete M200.</p> <p><u>Upstream reinforcement:</u> Slope coefficient <math>m = 3.0</math>, slope is reinforced with cast-in-place reinforced concrete M200 with (3.0x3.0)m size 10cm thick with drainage holes. Beneath the drainage holes is a layer of gravel, sand filter with a thickness of 15cm each layer.</p> <p><u>Downstream slope:</u> In downstream slope, handle termites, reinforce to control erosion by planting grass, reinforce concrete drainage ditches, new slope coefficient according to design <math>m = 2.75</math>. Fill up the structure of the downstream drainage slope foot by applying the downstream drainage slope, the height of the slope top of <math>\nabla 494.50</math>m, the length of the slope drainage is in the range of the old stream bed and terrace.</p> <p><b><i>b, Spillway:</i></b></p> <p>Spillway is in free form. The threshold elevation = normal water level +498.20m; width Btr = 12m; The spillway is made of M200 stone concrete with 1x2 size, the bed is lined by M100 stone mortar with 4x6 size 10cm thick.</p> <p>The section is narrowed after the length of 6.95m, the width is 12.0 - 4.6m, the cross section is rectangular, the structure is made of M200 stone reinforced concrete with 1x2 size, the bed is lined by M100 stone cement mortar with 4x6 10cm thick, the bed slope is 8.20%.</p>

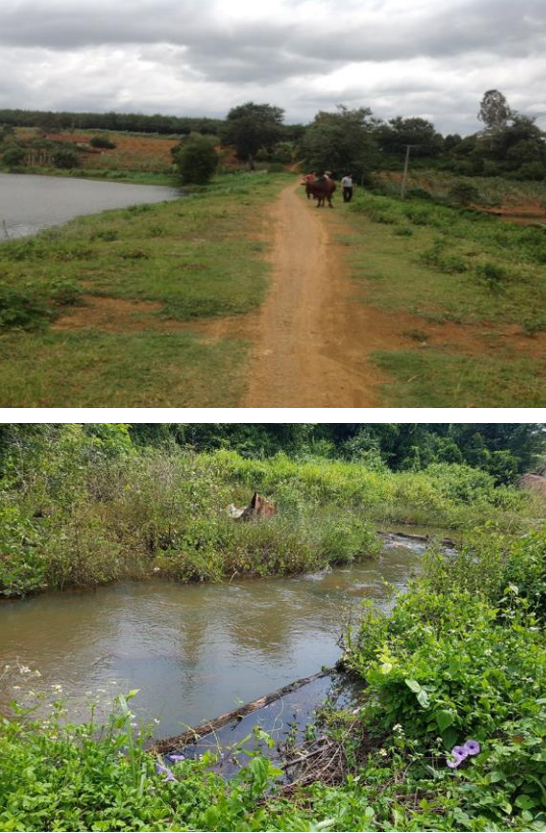
Location	Current status	Work item	Status images
<p><b>5) Ea Bro II reservoir</b></p> <p>Cu Pong commune, Krong Buk district</p>	<p>Ea Bo II reservoir in Cu Pong commune was built in 1988 to irrigate about 300 ha and 15 ha of surface water for aquaculture. Catchment area is 4.8km<sup>2</sup>with net capacity of 0.48 million m<sup>3</sup>.</p> <p>The dam surface has uneven height. At downstream of the dam, there is not drainage device, affecting the safety of earth dams in the long term. Flooding by land, there is no traffic bridge spillway. At present, spillway has been seriously eroded in the stilling section, the downstream channel section.</p> <p>The project does not have a water intake. Operating road: on the right abutment, there is no road, the left abutment of the earth road is narrow, protruding and difficult to walk.</p>	<p><b>a, Earth dam</b></p> <p><u>Dam crest:</u> Field dams are earthy clay <math>\gamma_{tk} = 1.36 T / m^3</math>. Elevation of the crest of the designed dam = 580.0m, elevation of the top of the wave wall = 580.50m, the crest length of the dam <math>L = 152.0m</math>, the crest of the dam crest <math>B_e = 5.0m</math> the top surface is concrete concrete M300 #. The edge of dam crest is reinforced with a concrete bundle of M200#. Planting grass to protect the lower slope, apply the downstream slope to waterproof the dam body.</p> <p><u>Upstream dam slope:</u> <math>m_t = 3.0</math>. Ground leveling with flat slope coefficient <math>m = 3.0</math> and reinforced with M200 cast-in-place reinforced concrete with (3.0x3.0) size 10cm thick with drainage holes on the ground of filtered macadam sand reverse. The underlayment of reinforced concrete sheet protects the upstream slope with macadam layer 15cm thick, the bottom layer is 15cm thick sand layer placed on the ground.</p> <p><u>Downstream dam slope:</u> <math>m_h = 2.75</math>. Remove the soil to cover the lower slope and plant grass on the whole slope to protect. Arrangement of drainage ditch between the toe and the hill abutment, the drainage ditch is built from M75# stone cement mortar with 25cm thick. Downstream face drainage uses a slope attic type combined with a drainage pile. Elevation of attic peak = 574.00m down to elevation of prismatic rock pile = 573.00m.</p> <p><b>b, Spillway:</b></p>

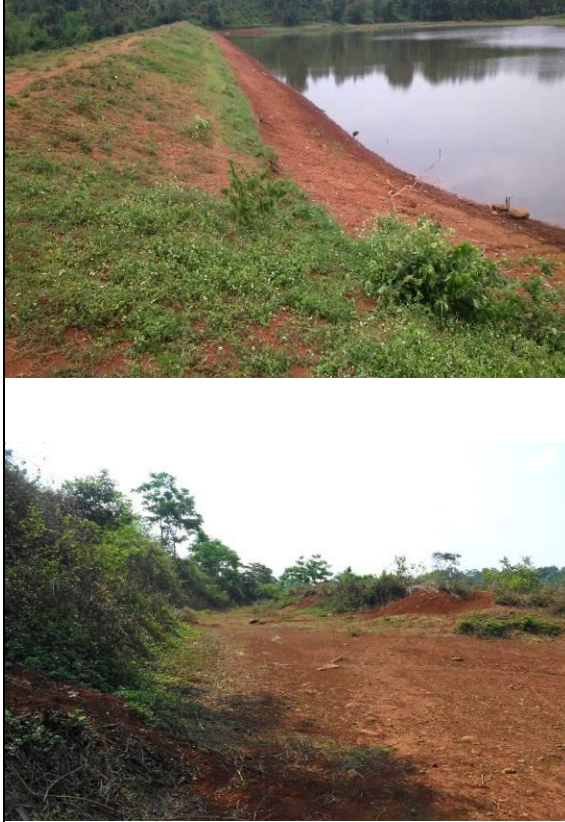
Location	Current status	Work item	Status images
<p><b>6) Ea Nao Dar reservoir</b> in Cu Bao commune, Buon Ho town</p>	<p>Ea Nao Dar Irrigation Project was built in 1988 to irrigate 70ha of rice and coffee. Catchment area is 3.4km<sup>2</sup> with net capacity of 0.22 million m<sup>3</sup>.</p> <p>The dam is 194m long, the dam crest is 4m wide, eroded; upstream slope has not been reinforced, eroded and eroded; downstream slope has been planted with grass, built drains and has no downstream drainage equipment.</p> <p>Sewers for water supply: Drain is still good, is operating normally.</p> <p>Spillage of land, two-side left-over land slopes have been eroded, narrowing the aperture when flooding in the flood season can not be discharged completely very dangerous, unsafe to the earth dam, the downstream side is also severely eroded, which will affect earth dams.</p>	<p><b>a, Earth dam</b></p> <p><u>Dam crest:</u> Earth dam is 194m long, dam surface is B = 4.0m; elevation of the dam crest + 660.8m. Dam surface structure: the bottom layer of stone slab of 4x6 M50 mortar is 10cm thick, the upper layer is made of M300 stone concrete with 1x2 size 18cm thick. At the upstream and downstream peaks of the dam, the crest edge is built by concrete M200.</p> <p><u>Upstream dam slope:</u> slope coefficient m = 3.0; reinforced with M200 cast-in-place reinforced concrete slabs with 10cm thick, the size cross section of (3.0x3.0m); The filtered layer below the ground is a 15cm thick layer of sand, the upper layer is 1x2 stone with a thickness of 15cm.</p> <p><u>Downstream dam slope:</u> slope coefficient m = 2.75; plant grass on the dam slope to protect, build drainage ditches between the dam slope and hillside by M100 stone. Drainage equipment after dam use rock pile and attic drainage type below is the filter layer including 15cm thick gravel stone, 15cm thick sand; The height of the drainage device is 655.5m.</p> <p><b>b, Spillway:</b> Spillway width is B = 26.0m; The entry section has a slope of 8%, after the entrance is a 8% water slope and the following part of the slope is the section of the stilling basin. Spillway is built from M200 reinforced concrete, the bed is lined by M100 stone mortar with 4x6 size.</p>

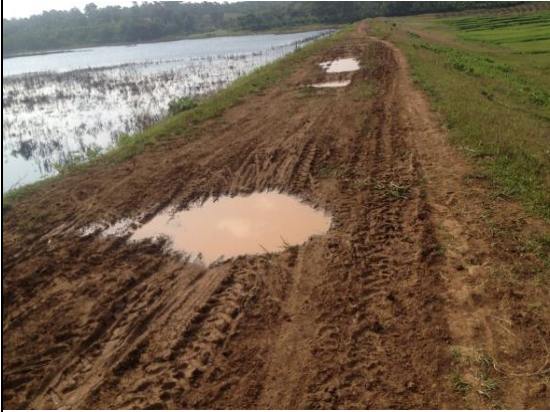
<p><b>7) Ea Ngach reservoir</b> In Ea Drong commune, Buon Ho town</p>	<p>Ea Ngach irrigation project was built in 1986 with the task of supplying irrigation water for 105ha of coffee, 20ha of two-crop rice, and secondary crop area of inhabitants along the reservoir and downstream of the project. Catchment area is 12 km<sup>2</sup> with net capacity of: 0.21x10<sup>6</sup> m<sup>3</sup>.</p> <p>The dam is 311.82m long, the dam crest is 3.5 - 4.5m wide, currently combining traffic; The structure of the dam slope is graded soil, the surface of the dam surface varies from 589.66m</p>	<p><i>a, Earth dam</i> Width of dam crest <math>B_c = 5m</math></p> <p><u>Dam crest:</u> The dam crest is made of cement concrete stone 1x2 M300 20cm thick, the bottom lining is separated by asphalt impregnated oil paper, curb of downstream seams with concrete M200, 0.2m high.</p> <p><u>Upstream dam slope:</u> Slope coefficient <math>m = 2.75</math> is reinforced with reinforced concrete sheet M200 in place, sheet size (3.0x3.0), 10cm thick, with drainage holes below is nylon layer, filter layer, sand filter with a thickness of 15cm each.</p> <p><u>Downstream dam slope:</u> Downstream slope is removed from downstream mud layer, termite nest is treated, reinforced against erosion by grass planting, drainage ditches are made of concrete combined with slope covering. Fill up the dam toe.</p>

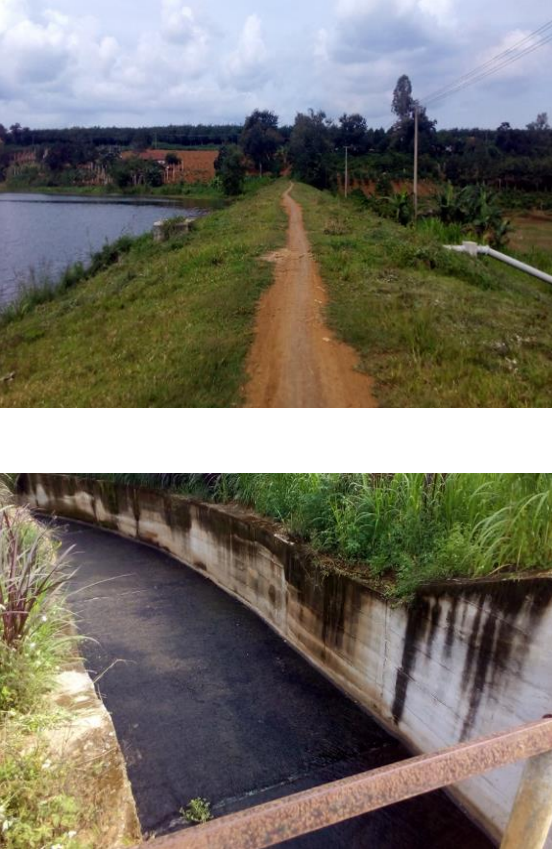
Location	Current status	Work item	Status images
<p><b>8) C19 Reservoir</b> In Ea Rieng commune, M'Drak district</p>	<p>The project was built in 1973 with the task of supplying irrigation water for about 170ha of coffee area around the reservoir and 30 ha of rice in the downstream area. Catchment area is 5.72 km<sup>2</sup> with net capacity of 0.33 million m<sup>3</sup>.</p> <p>Embankment dams with basalt soil, dam crest of 147m long, dam slope wide (3.5 - 4.5) m, high dam Hmax = 8.0m, elevation of dam crest ranges from elevation (460.35) ÷ 460.89) m; the upstream slope is broken, with the average coefficient of m = 2.75; The downstream slope has a slope coefficient of m = 2.75, planting protective grass, without drainage system; The dam surface has an uneven height. At downstream of the dam, there is not drainage device, affecting the safety of earth dams in the long term.</p> <p>Semi-permanent flood discharge with construction stone: Located on the left abutment of the dam, the spillway has a width of Btr = 10.0m, the threshold elevation of</p>	<p><b>a, Earth dam</b></p> <p><u>Dam crest:</u> Width B = 5.0m; the dam surface has a uniform structure with the road passing through the dam: M300 # concrete surface layer structure. Upstream edge is made of M200 concrete wall with a height of 0.5m. The edge of dam crest is reinforced with a concrete bundle of M200 #.</p> <p><u>Upstream dam slope:</u> Ground leveling with flat slope coefficient m = 2.75 and reinforced with reinforced concrete sheet M200 in place, sheet size (3.0x3.0) 10cm thick with drainage holes on the ground of reverse filtered macadam sand with thickness of 15cm.</p> <p><u>Downstream dam slope:</u> The downstream slope retains the current status m = 2.75, planting grass to compensate for the concave and concrete drainage ditches. Drainage downstream of the reverse filter layer in the form of slope cladding m = 2.75 from the elevation of 456.00m or less in the area of the old bed and terrace.</p> <p><b>b, Spillway:</b></p> <p>The section of the door in front of the spillway is 5m long, the width is narrowed from 45.0-28m, the spillway is built from M150# stone concrete with(2x4) size, 20cm thick, the bottom is lined by M100# stone concrete with (4x6) size 10cm thick .</p> <p>Spillway threshold is 3.3m long, 28.0m wide, it is built from M200 reinforced concrete covered with</p>

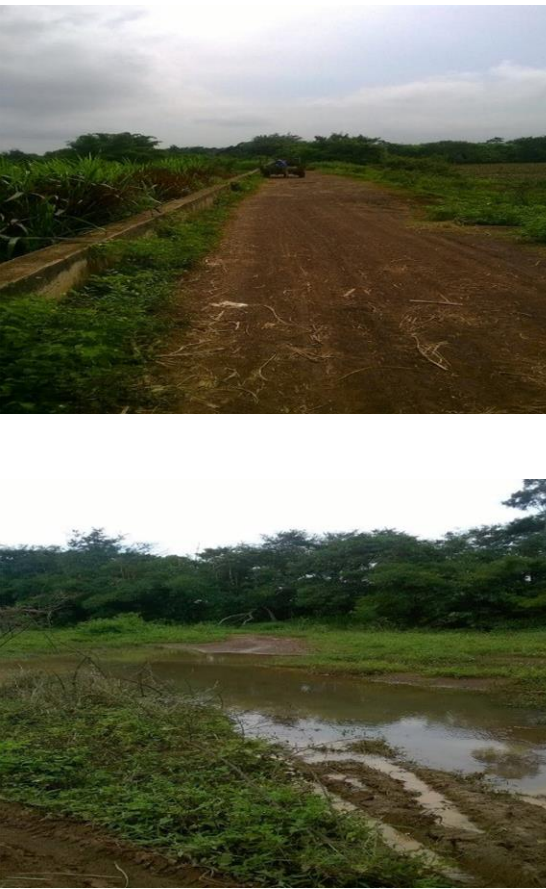
Location	Current status	Work item	Status images
<p><b>10) Doi 11 reservoir</b> Ea Kmut commune, Ea Kar district</p>	<p>Doi 11 reservoir has been put into use since 1986, with the purposes of irrigating 107ha of two-crop rice area, 124ha of coffee and secondary crop area of inhabitants along the reservoir and downstream of the project. Catchment area: 16.2 km<sup>2</sup>, Net capacity: 0.47 million m<sup>3</sup></p> <p>The earth dam is 848.3m long, the dam crest is 4.0m wide, combining traffic; Dam structure is graded soil, elevation of dam surface varies from 479.58m to 480.50m, does not guarantee the design elevation. The breakwater wall connecting the traffic between the two dam ends is not available and some sections are damaged; The upstream slope is reinforced with hard rock but has been eroded; Downstream slope collapses, average coefficient of slope <math>m = 2.60</math> to <math>m = 2.75</math> and downstream drainage is not yet available.</p> <p>Spillway: The entire entrance, the old spillway threshold and the unsecured protection slope are</p>	<p><b>a, Main dam</b></p> <p><u>Dam crest:</u> Width <math>B = 4m</math>; the dam surface has a homogeneous structure with the road passing through the dam: The surface of ground layer is concrete M300 stone 1x2, 18cm thick, curb of downstream edge is made of M200 concrete, the upstream side is arranged with concrete wall M200 with a height of 0.77m, a wall thickness of 0.2m (according to the existing situation).</p> <p><u>Upstream dam slope:</u></p> <p>The coefficient of slope <math>m = 2.75</math> is reinforced with cast-in-place reinforced concrete sheet M200, with sheet size (3.0x3.0) and 10cm thick There are drainage holes on the upstream slope, below is gravel layer, sand filter with a thickness of 15cm each.</p> <p><u>Downstream dam slope:</u> clear the downstream mud layer, handles termites, reinforces erosion by planting grass, concrete drainage ditches, the new slope coefficient according to the new design <math>m = 2.75</math>. Fill up for structure base. Drainage downstream use rock pile and attic drainage type, rock pile elevation is <math>\nabla 474.70m</math> with the width of 1.5m, length of stone pile is in the center of the river bed and old terrace.</p> <p><b>b, Spillway:</b></p> <p>The threshold elevation = normal rising water level = +477.90m; width Btr = 40m; it is built of M200</p>
