PROJECT PERFORMANCE ASSESSMENT REPORT

BELIZE

ROADS AND MUNICIPAL DRAINAGE PROJECT

(LOAN 4575-BEL)

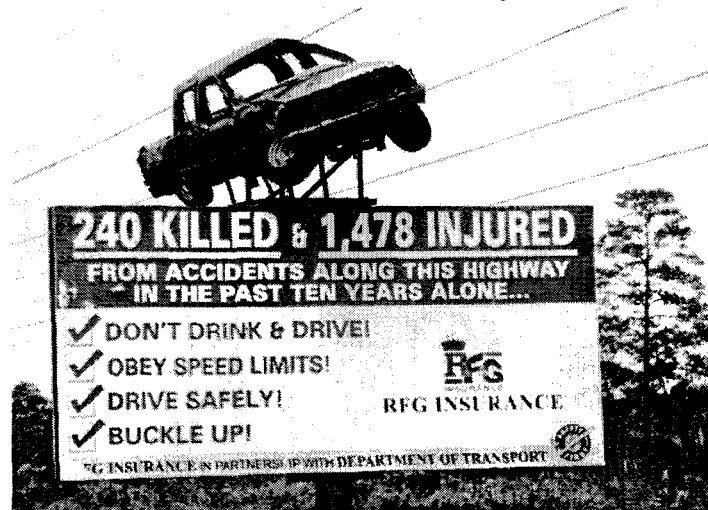
Picture 6: Traffic safety on the Western Highway 1998-2007– the main link between Belize City and Belmopan

high by international standards. In 2005 there were 2,349 traffic accidents and 56 deaths – a fatality risk rate of 19 per 100,000 of population (Picture 6). The budget for road safety became increasingly constrained (Table 5) given the estimated annual 10 percent growth of vehicular traffic.²⁰ Deteriorating road infrastructure exacerbates the safety problem: the condition of road shoulders on blacktop roads followed a similar pattern to that of road surfaces, but was worse for the narrower gravel roads where only 6 percent were in good or better condition.

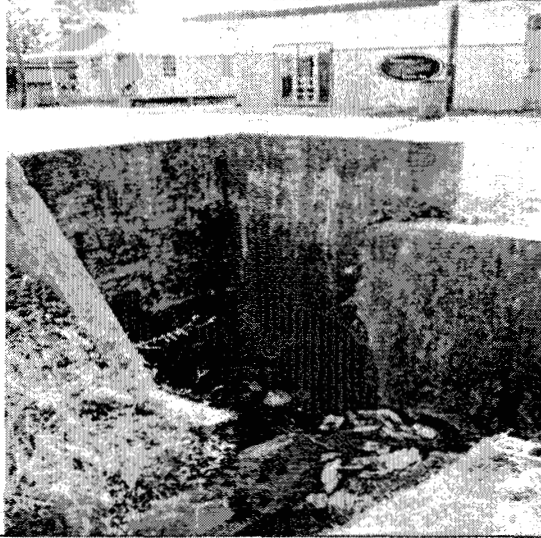
Picture 8: Plastic trash threatens the effectiveness of drainage systems in western Orange Walk

59. **Inadequate maintenance of municipal infrastructure poses substantial risks.** Municipal budgets allocated to maintenance of roadways and drainage cover only regular cleaning and, according to the maintenance staff in all the owns visited by IEG, are less than is needed. Preference is generally given to road and verge areas seen by the public - drains are generally out of sight and out of mind. Plastic trash poses the greatest cleaning problem as heavy rains quickly carry this to drains where it causes periodic blockages and flooding (Picture 8). Thus solid waste and garbage collection is also an essential
