ELECTRICITE DE GUINEE
(« EDG »)

Tombo Thermal Power Plant,
Garafiri, Grandes Chutes, Donk ea &
Ban eah Hydroelectric Power Plants

Environmental audit

Final report

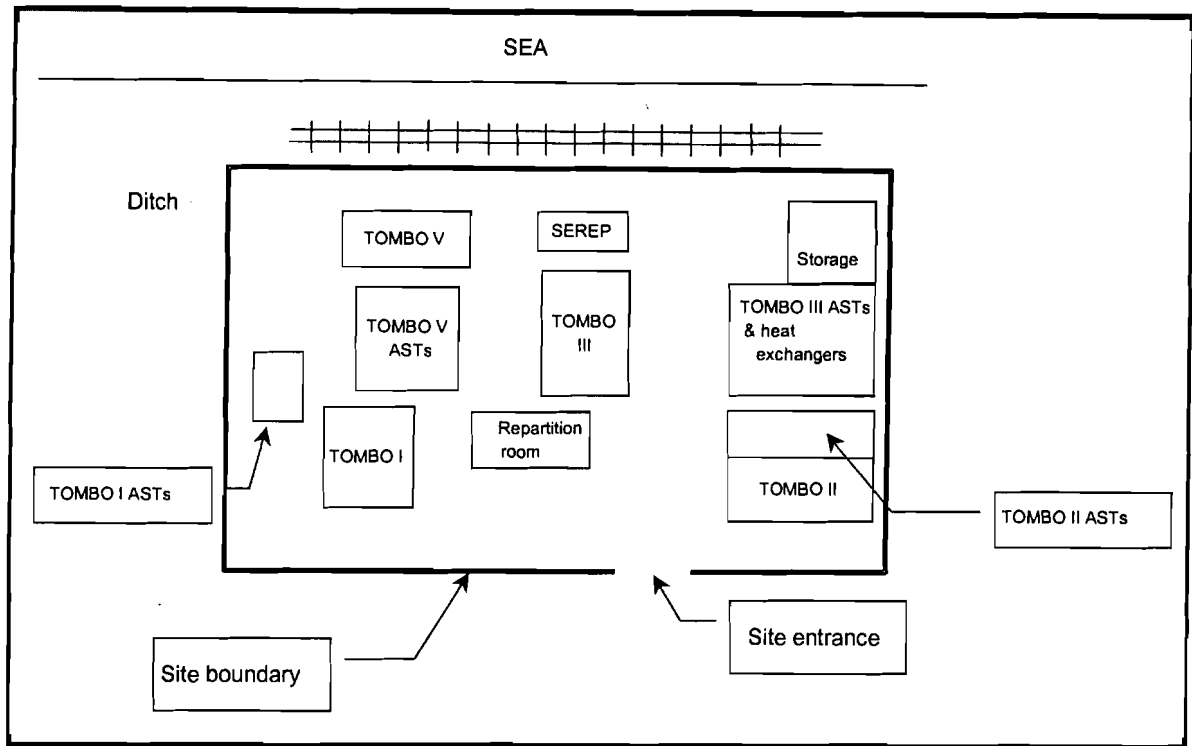
Layout of the thermal power plant of TOMBO (not at scale)

Note : AST = above ground storage tank

- A control room or a monitoring room where the following parameters are followed for the groups : speed, temperature, levels, pressure, current, tension etc.;
- A storage room for products & materials
- A repair workshop
- A treatment station (SEREP) with an incineration oven for the sludge is present on site, but is actually out of order
