# **PRACTICAL SEISMIC DESIGN AND CONSTRUCTION MANUAL FOR RETROFITTING SCHOOLS IN THE KYRGYZ REPUBLIC**

Svetlana Brzev and Ulugbek Begaliev

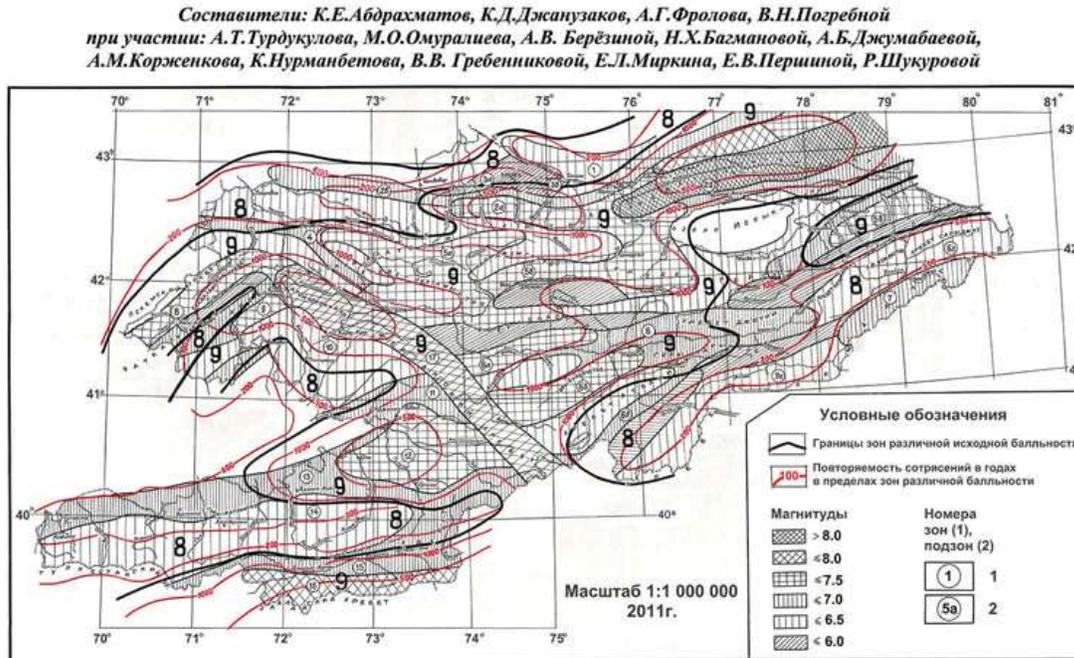
Figure 2-1. Current seismic zoning map for the Kyrgyz Republic (issued in 2012)<sup>1</sup>

The current seismic zoning map of the KR was developed in 2011 (Abdrakhmatov, 2011<sup>4</sup>) and it was put into effect in 2012 as a new annex to СНИП КР 20-02:2009 Earthquake Engineering Design Standard. The greatest hazard is represented by the zones in which the expected earthquake intensity is 9 or higher. The map is shown in Figure 2-1.

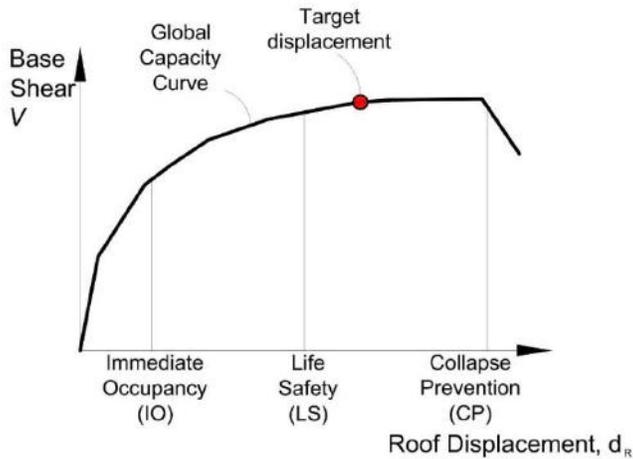
Figure 2-8. A sample Capacity Curve (CC) for a building, showing a possible target displacement relative to the predetermined performance levels.

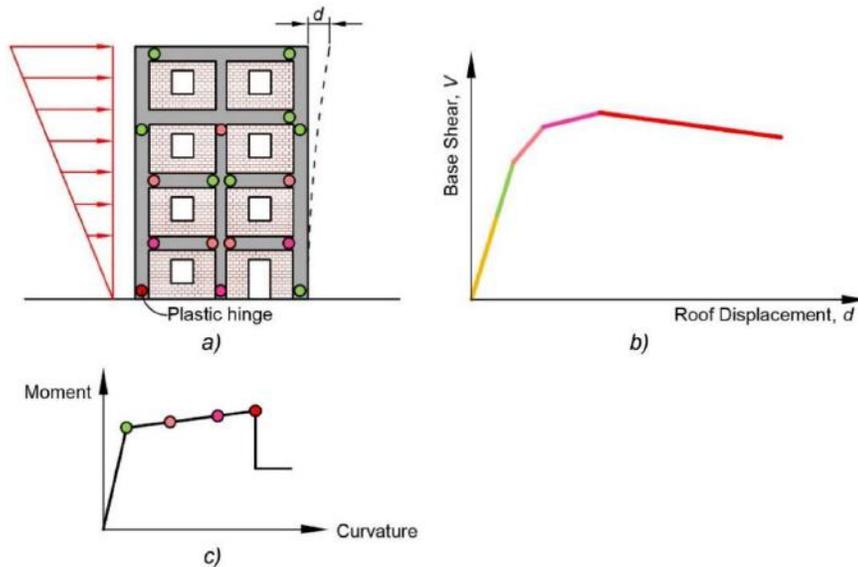
Figure 2-12. Model at the ultimate (failure) stage showing plastic hinges at different performance levels.

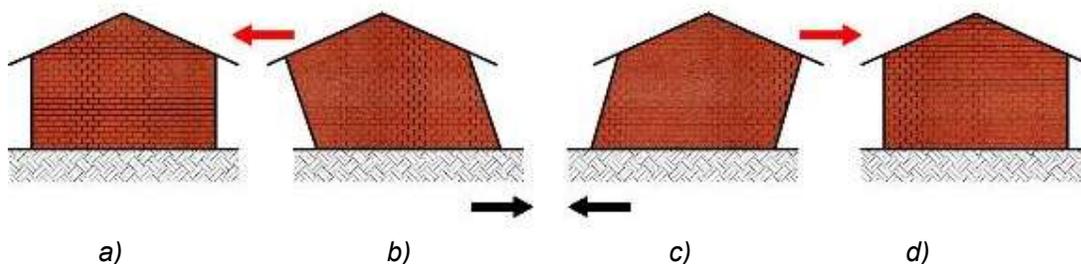
*Figure 3-1. Building response to earthquake motion: a) building at rest; b) ground accelerates to right; c) ground accelerates to left, and d) ground and building at rest.*

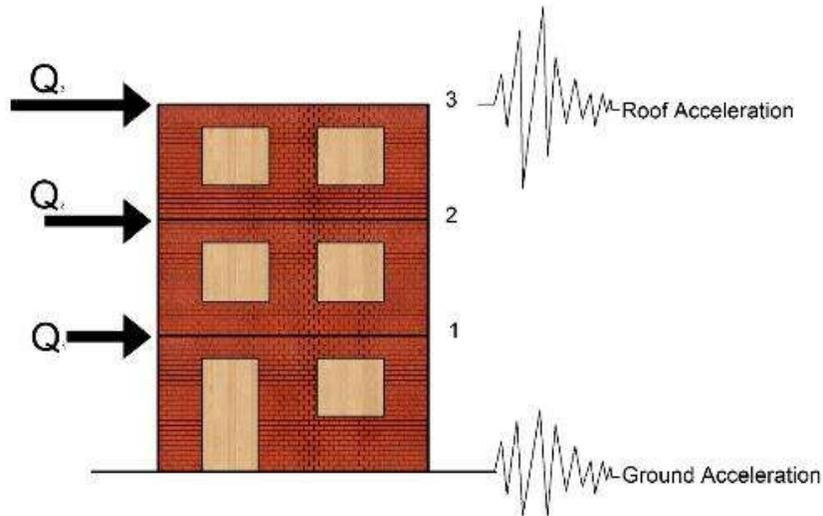
*Figure 3-2. Variation of accelerations and seismic forces along the building height.*

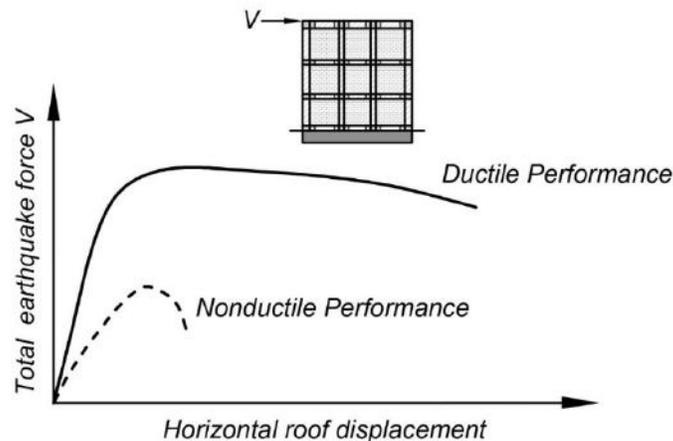
Figure 3-3. Ductile versus nonductile seismic performance of buildings (adapted from Murty, 2010).

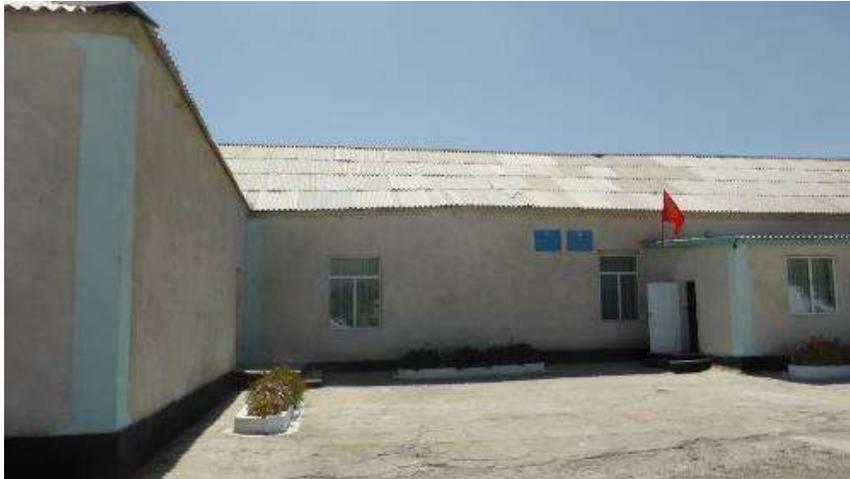
Figure 3-6. A typical school building (EMCA 11) (Jakipova school, Balykchy, built in 1953) (Photo: S. Brzev).

These are low-rise buildings, usually one- or two-story high, and are similar to housing typologies described by Uranova and Begaliev (2002). Key structural components of a typical building are illustrated in Figure 3-5. A photo of a typical single-story school building is shown in Figure 3-6. The walls are of unreinforced brick masonry, and mud- or cement-based mortar were used for construction. Either solid clay bricks or multi-perforated bricks were used for wall construction. Exterior walls are about 510 mm thick, while interior walls are about 380 mm thick. There are no RC confining elements in these buildings. These buildings have wooden floors which act as flexible diaphragms. Typical wooden floors are shown in Figure 3-7. Details of floor-to-wall connection are shown in Figure 3-8. It can be seen from the figure that wooden floor beams are supported by the walls without any anchorage. Lintel beams above windows and doors are made of timber planks or steel bars embedded in mortar. A typical roof structure consists of pitched timber rafters and purlins with light-weight roofing consisting of asbestos sheeting. The foundations are continuous RC footings beneath the walls.

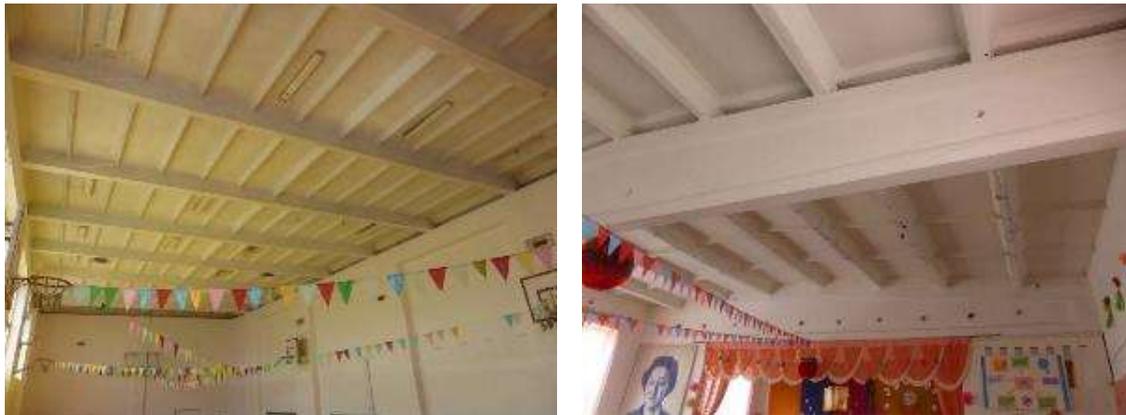
Figure 3-7. Typical wooden floor structures (Photos: S. Brzev).

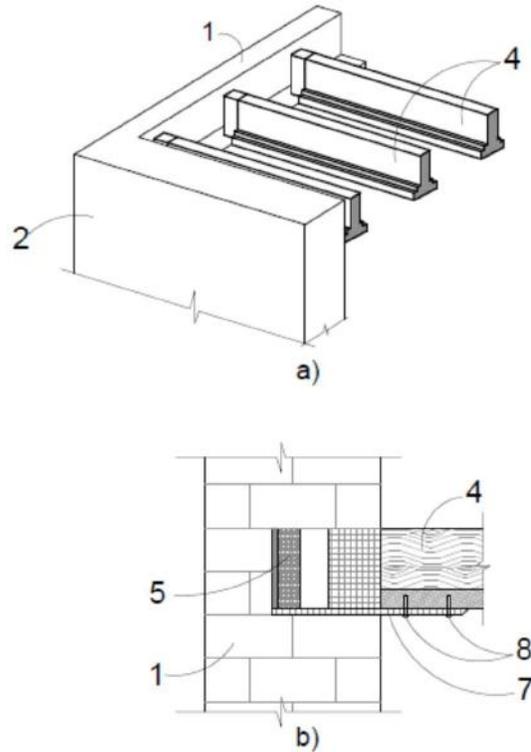
Figure 3-8. Wall-to-floor connection (1 - external load-bearing wall; 2 - external non-load-bearing wall; 3 - internal non-load-bearing wall; 4 - wooden beam; 5 - thermowell; 6 - waterproofing; 7 - anchor of strip steel; 8 - nails).

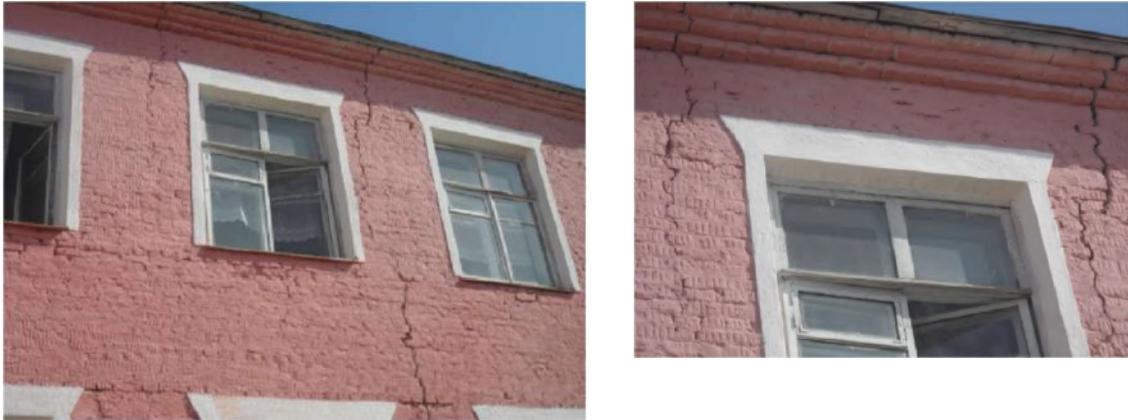
Figure 3-9. Damage to School Lenin, an unreinforced masonry building in Osh, KR due to the 2008 Karasuu earthquake (magnitude 5.6) (Photos: U. Begaliev).

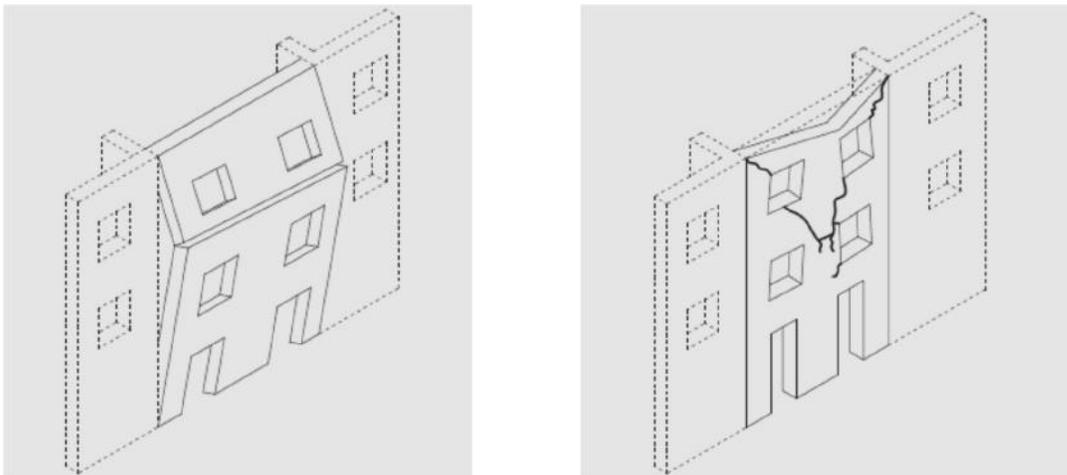
Figure 3-11. Out-of-plane collapse mechanisms for unreinforced masonry walls (D'Ayalla and Speranza, 2003).

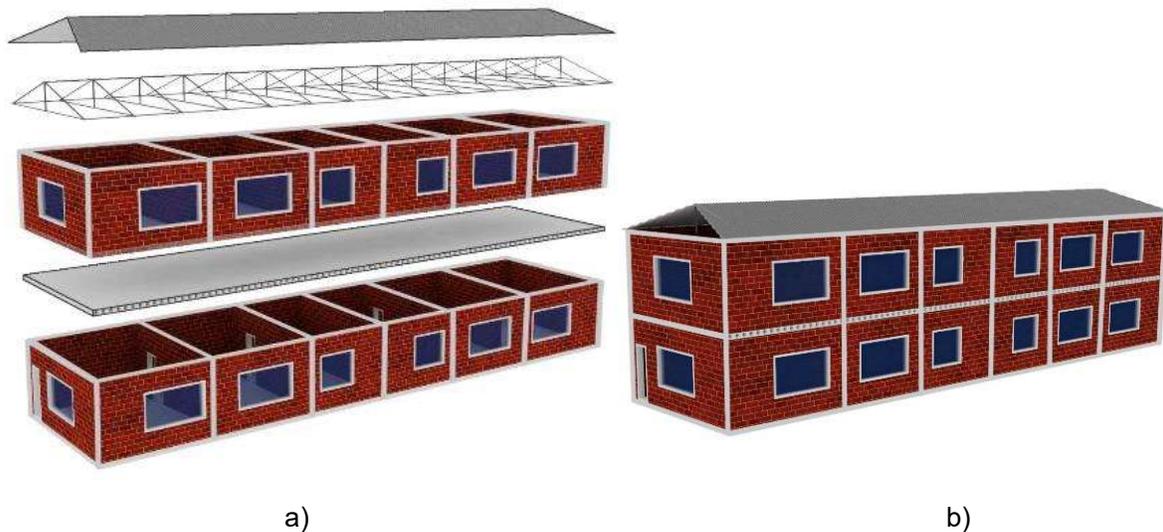
Figure 3-12. Confined masonry building with precast RC floors (EMCA 13): a) key elements, and b) an isometric view of the building.

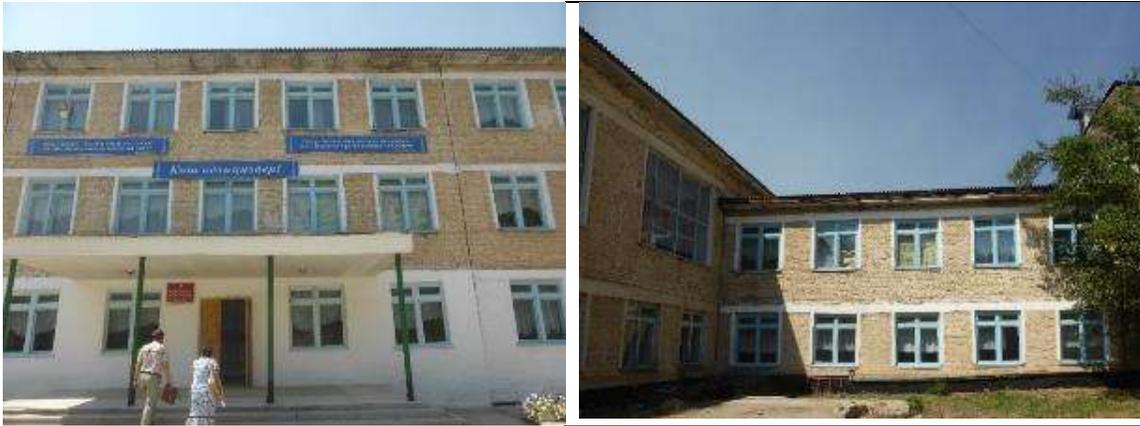
Figure 3-13. A typical school building (Bokombaeva School, Toktogul, built in 1972) (Photos: S. Brzev).

These are low-rise buildings, usually two- or three-story high, and are similar to housing typologies described by Begaliev and Uranova (2002). Key structural components of a typical building are illustrated in Figure 3-12. Photos of typical school buildings are shown in Figure 3-13 and 3-14. The walls were constructed using brick masonry in cement:sand or cement:lime:sand mortar. Clay masonry units (either solid bricks or multi-perforated blocks) were used for the wall construction. Typical brick dimensions are 250 mm by 120 mm by 88 mm (or 65 mm). The exterior walls are about 510 mm thick, while interior walls are about 380 mm thick. Horizontal and vertical RC confining elements are provided at critical locations in the building. These provisions were first introduced in 1957 (CH-8-57). These buildings have some features of confined masonry construction. Vertical RC confining elements were placed at wall intersections and at the openings. Horizontal RC bond beams (seismic belts) were constructed at the building perimeter at all floor levels to provide the confinement and diaphragm action for seismic load effects. Wall and floor construction details, including RC confining elements, are shown in Figure 3-15. It is also required to provide horizontal reinforcement (wire mesh) in mortar bed joints at each 7<sup>th</sup> layer. Exterior walls in these school buildings are usually perforated with large door and window openings.

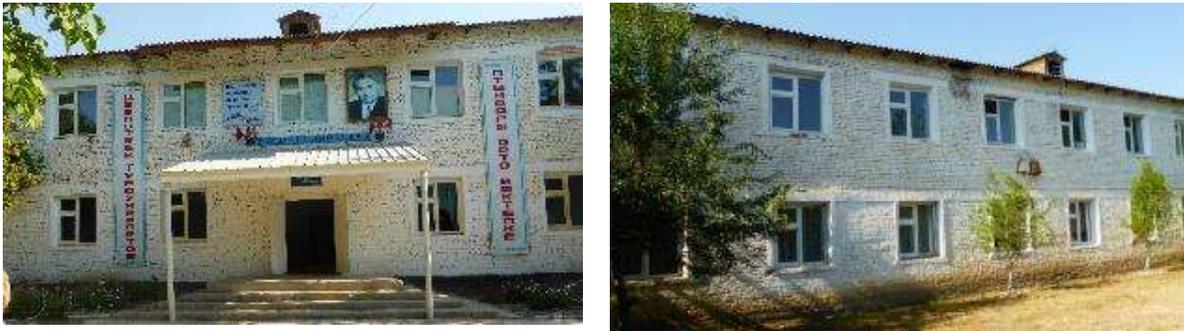
Figure 3-14. A typical school building (Turdumambetov school, Toktogul, built in 1973) (Photos: S. Brzev).

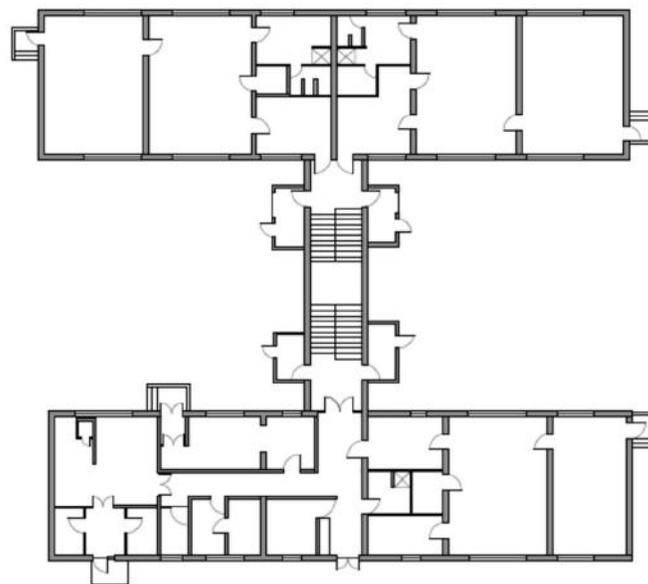
Figure 3-17. Typical plan of a masonry school building (kindergarten Ak Tilek, Balykchy).

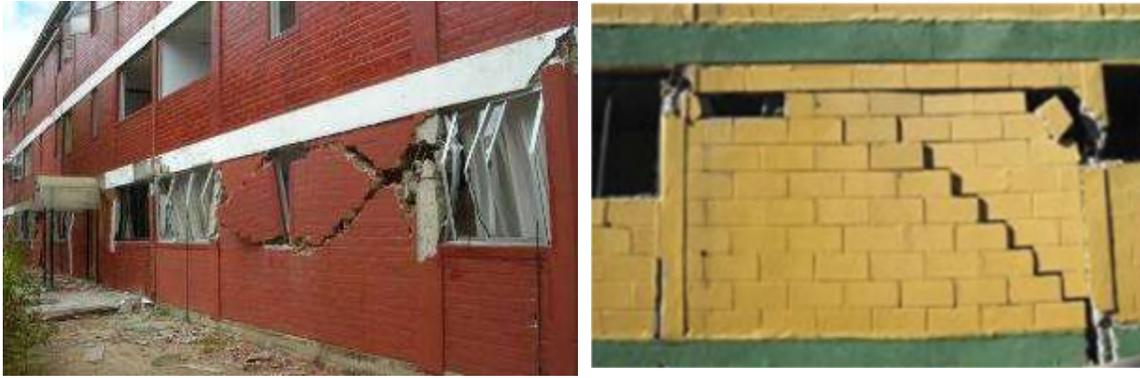
*Figure 3-18. Damage of confined masonry walls due to the 2010 Chile earthquake (Photos: M. Astroza).*

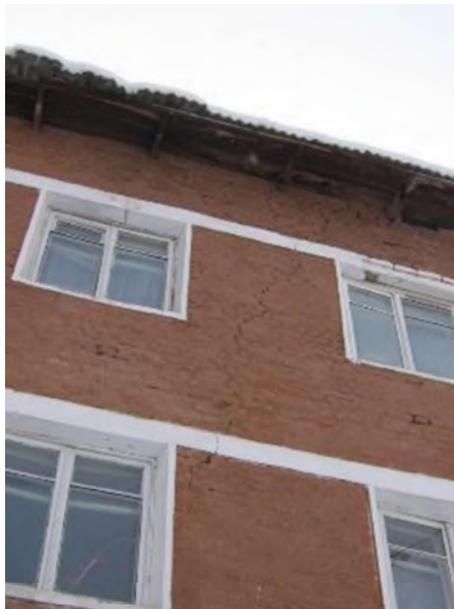
*Figure 3-19. Damage of a confined masonry school building due to the 2008 Osh, KR earthquake (Photo: U. Begaliev).*

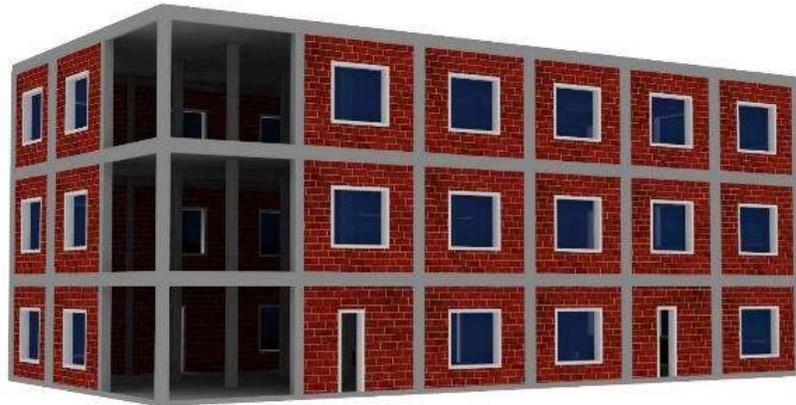
Figure 3-20. Monolithic RC frame building with masonry infills (EMCA 23).

These school buildings were mostly constructed in the 1990s or later. The main gravity and lateral load-resisting system is RC frame which consists of columns and beams. An isometric view of this building typology is shown in *Figure 3-20*. Photos illustrating a typical school building are shown in *Figure 3-21*. RC floor slabs are beam and slab systems where beams span between the columns and are cast monolithically with the slabs. The beam-to-column joints are rigid and enable transfer of bending moments between these elements. A detail of frame and wall construction is shown in *Figure 3-22*. Exterior walls, and possibly

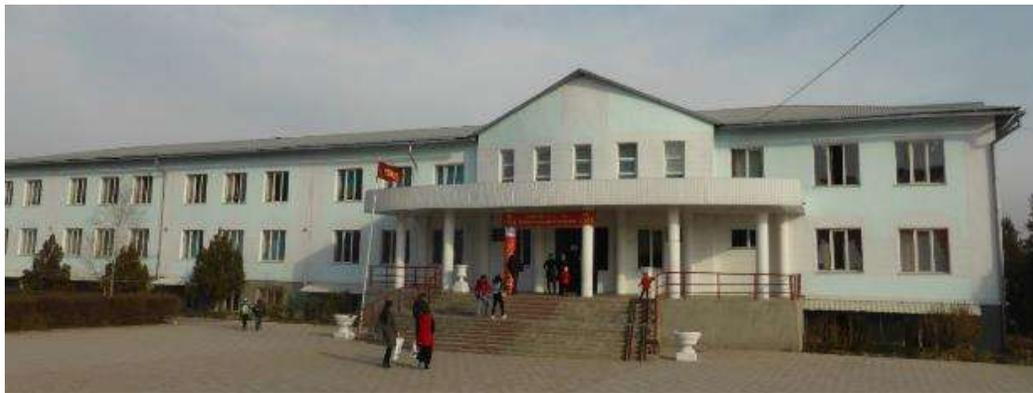
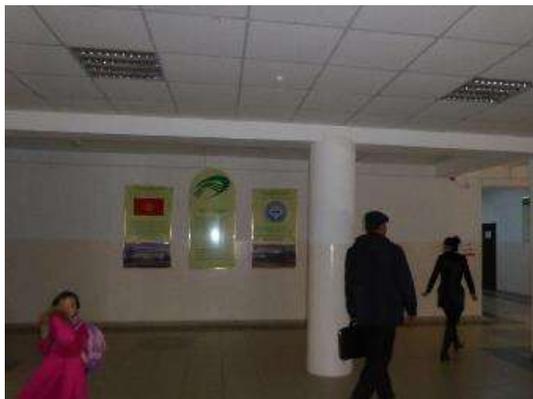
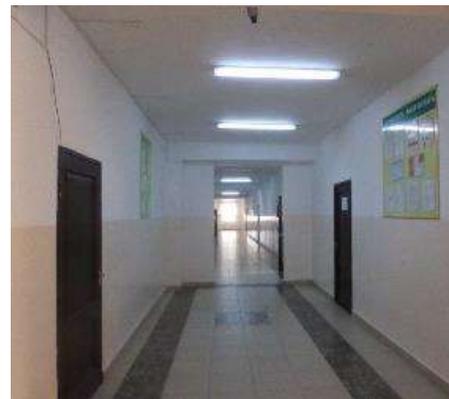
Figure 3-21. Typical RC frame school building (Ene-Say School #21, Bishkek, constructed in 2006): a) an exterior view; b) an interior view (lobby); and c) a typical corridor (Photos: S. Brzev).

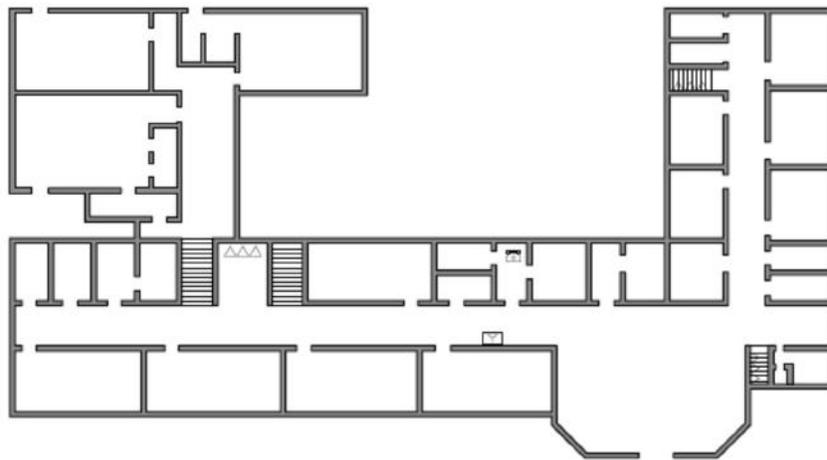
Figure 3-23. Typical floor plan for a RC frame building with masonry infills (Ene-Say School #21, Bishkek).

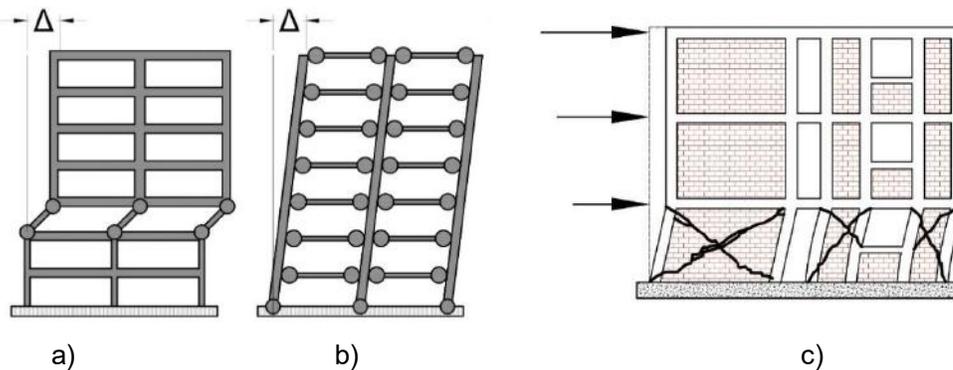
Figure 3-24. Seismic failure mechanisms for RC frames: a) “weak column-strong beam” mechanism; b) “strong column-weak beam” mechanism (Murty et al., 2006), and c) shear failure mechanism (Meli et al., 2011).

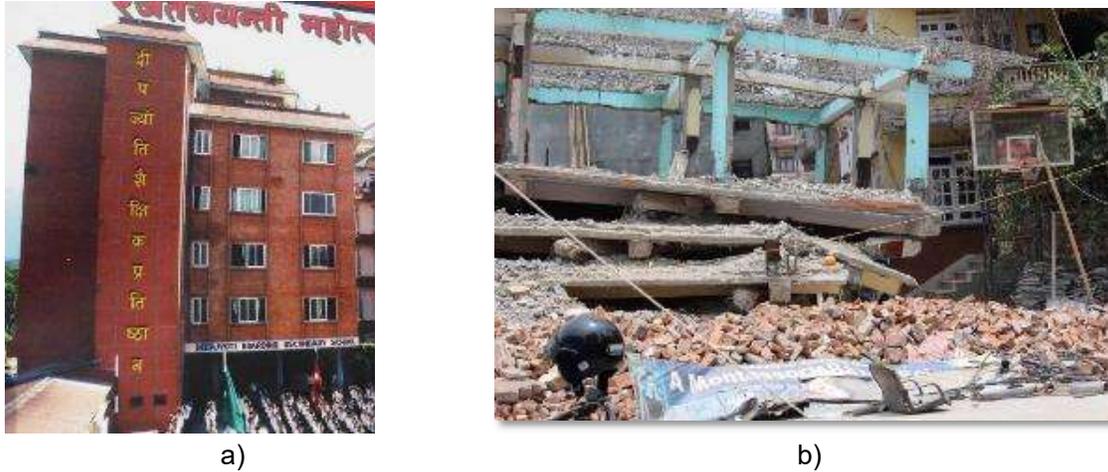
Figure 3-25. A complete collapse of a RC school building in Kathmandu, Nepal due to 2015 Gorkha earthquake: a) school building before the earthquake, and b) after the earthquake (Photos: S. Brzev).

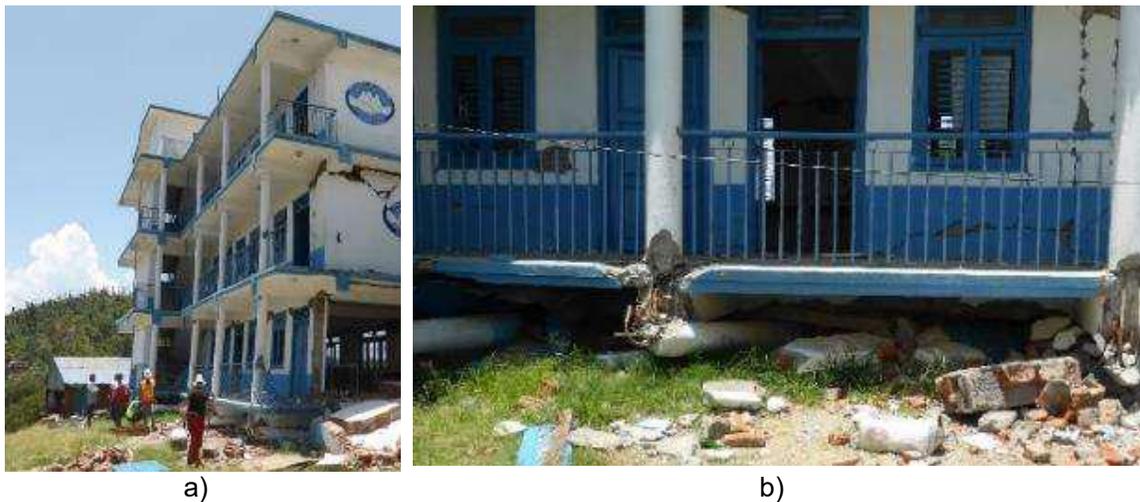
Figure 3-26. Ground floor collapse in a rural school in Sindupalchok District, Nepal due to the 2015 earthquake: a) an overall view of the building showing the collapsed ground floor, and b) a detail of the collapsed ground floor showing fracture of column reinforcement (Photos: S. Brzev).

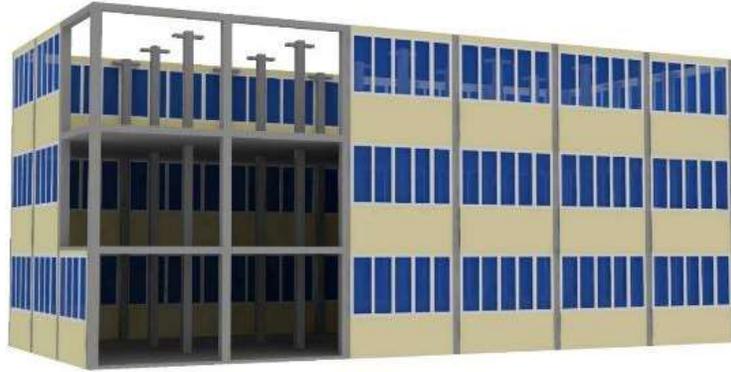
*Figure 3-28. A precast RC frame building with exterior precast RC panels (EMCA 34).*

This construction is known as Seria IIS-04 and it was one of the standard precast (prefabricated) construction systems in the former Soviet Union. It was developed in 1973, and it was described in detail by Khakhimov and Nurtaev (2002). An isometric view of this building typology is shown in Figure 3-28. Photos illustrating a typical school building are shown in Figure 3-29. This construction practice was used both for the construction of residential buildings (9- to 12-storey high) and also public buildings such as schools (1- to 4-storey high). All structural elements, e.g. foundations, columns, beams, slabs, staircases, wall panels, etc., were manufactured in specialized plants. The building assemblage started at the foundation level with precast RC footings. Subsequently, RC columns are erected in vertical position and joined by welding. Note that columns have corbels on two sides to receive RC beams and are connected above the floor level. Subsequently, beams are lifted in the final position. Beams and columns are joined by welding, and finally cast-in-place concrete is placed to fill the voids. Conceptual column-beam and floor-column connections are shown in Figure 3-30. Photos shown in Figure 3-31 illustrate these connections. A rigid beam-column connection is usually considered for seismic design of these buildings by design engineers in the KR.

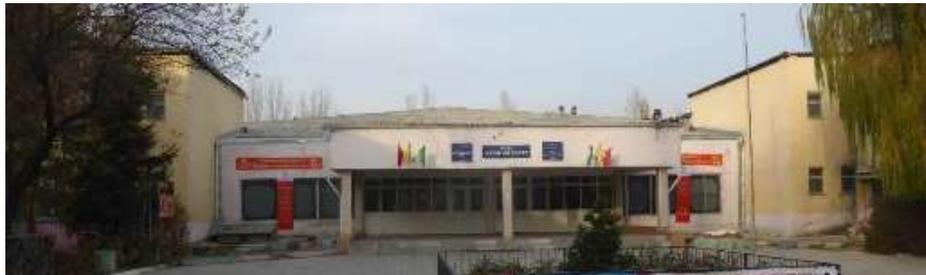
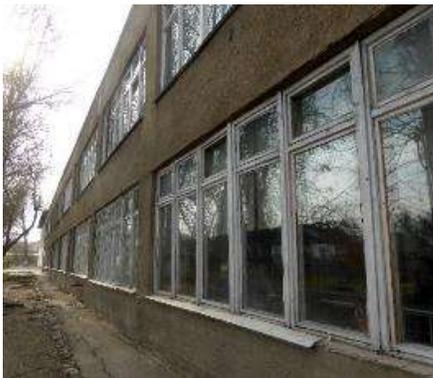
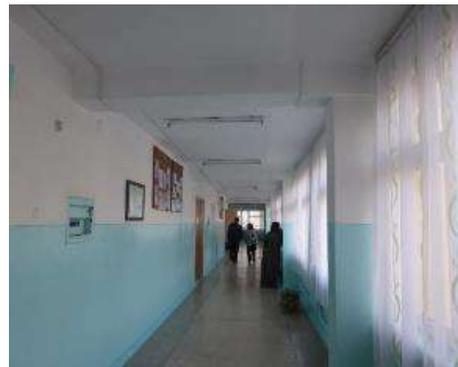
*Figure 3-29. Typical school buildings (School 1, Alamedin, and School 46, Sechenov Street, Bishkek): a) an exterior view - entrance; b) an exterior view showing precast wall panels, and c) a typical corridor (Photos: S. Brzev).*

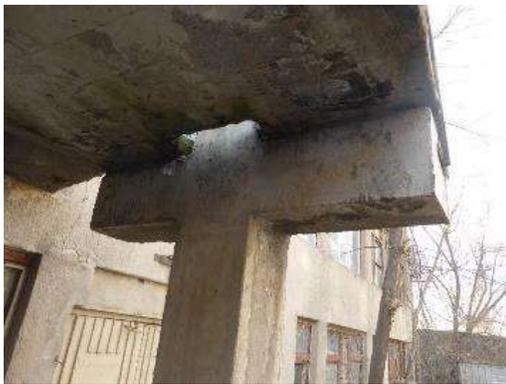
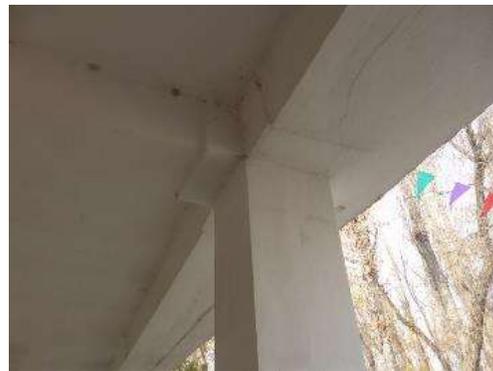
Figure 3-31. Frame connections in an existing school building: a) column-slab connection, and b) column-beam connection (Photos: S. Brzev).

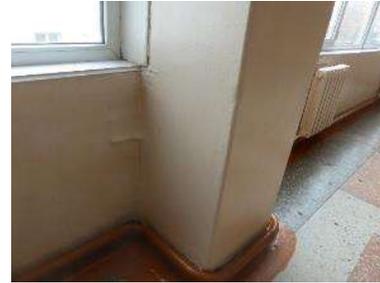
1 – column; 2 – steel plate anchorage to column; 3 – support table; 4 – wall panel; 5 – steel plate anchorage to wall panel; 6 – steel core; 7 – grappled from the steel corners  
a)

Figure 3-32. Exterior wall panels - connections: a) conceptual details (Source: Remstroyinfo), and b) panel in an existing school (Photo: S. Brzev).

Exterior cladding in these buildings consists of precast concrete panels which are connected to the columns by welding. Details of the panel-to-column connections are shown in Figure 3-32. A façade view of the school with exterior precast panels is shown in Figure 3-33.

4. **The stiffness of non-structural exterior walls was not considered in the analysis.** These walls are precast RC panels attached to the exterior columns by means of the welded connections (see Figure 3-32). It was assumed that the mass of the walls contributes to the seismic weight of the building. A discussion regarding the stiffness of RC frame with exterior precast walls is presented later in this section.

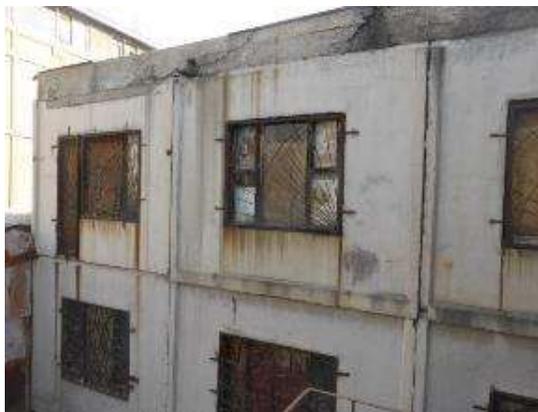
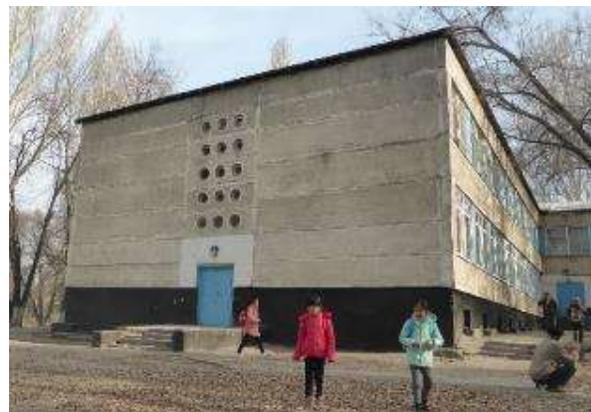
Figure 3-33. Exterior precast wall panels: façade view (schools in Bishkek) (Photos: S. Brzev).

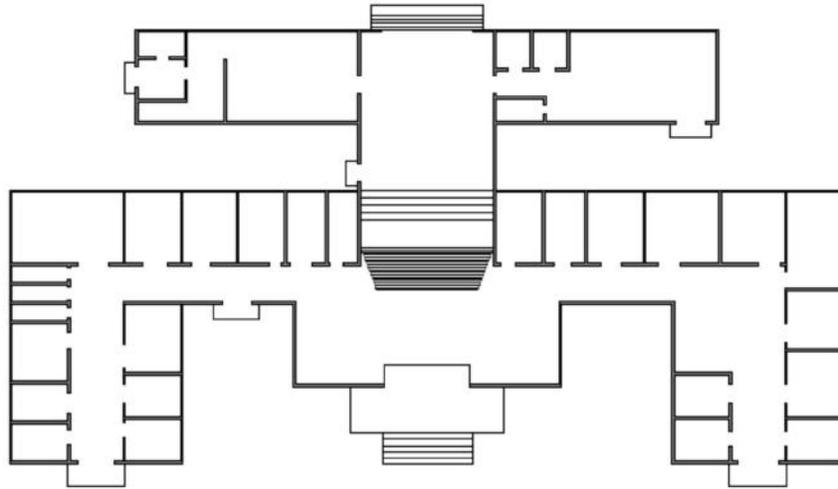
Figure 3-34. Typical floor plan for a precast RC school building (School #32, Bishkek).

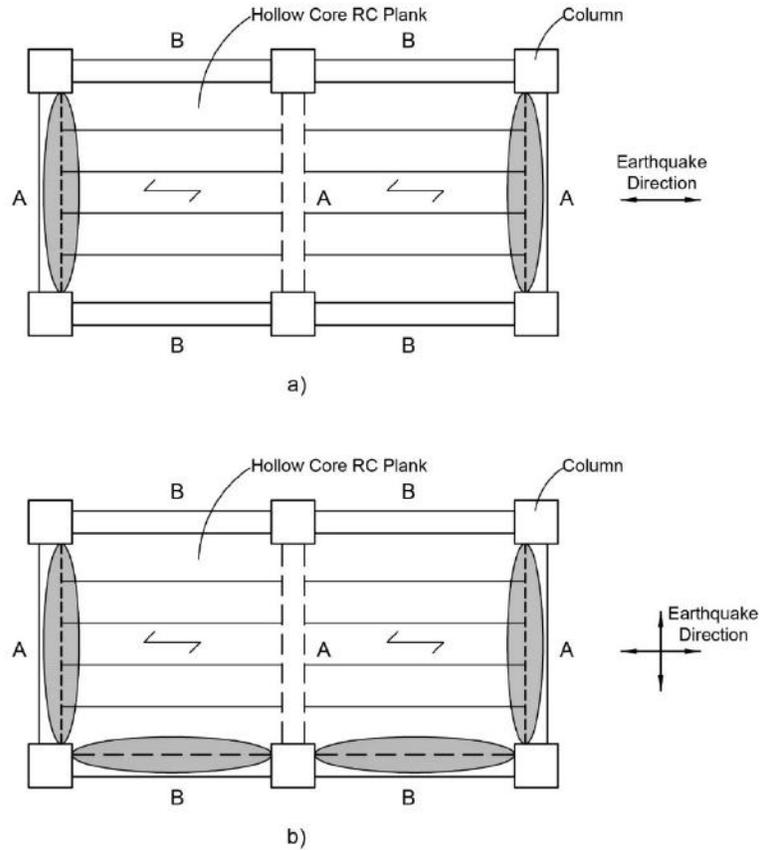
Figure 3-36. Regions of potential damage and loss of support in hollow core precast RC slabs – plan view: a) unidirectional earthquake action, and b) bi-directional earthquake action (based on Matthews, Bull, and Mander, 2001).

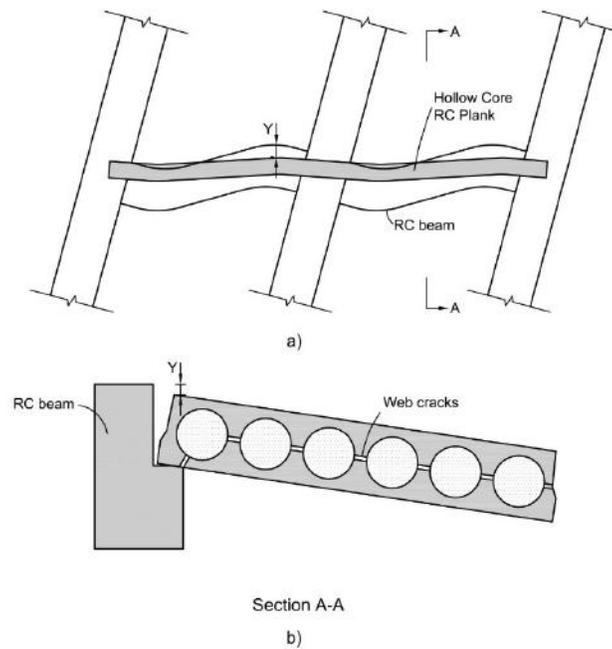
*Figure 3-38. Displacement incompatibility between the perimeter beam and hollow core precast floor slabs in RC framed structures: a) elevation view, and b) section showing horizontal splitting cracks in the webs of hollow core planks (based on SESOC, 2009).*

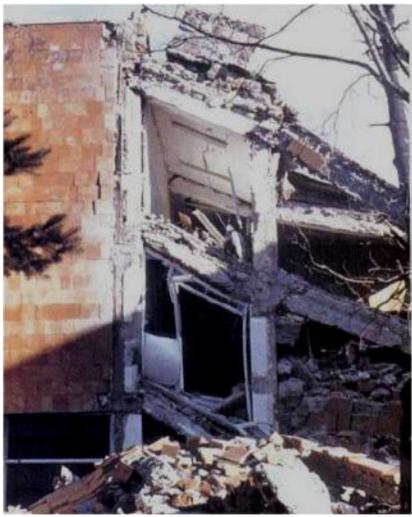
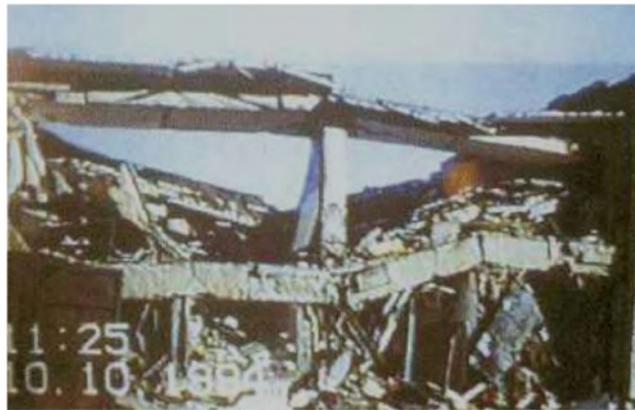
*Figure 3-39. Damage of precast RC frame buildings in past earthquakes: a) the 1988 Spitak, Armenia earthquake, and b) the 1994 Shikotansk, Russia earthquake (Photos: M. Klyachko; Khakimov and Nurtaev, 2002).*

Wylie and Lew (1989) reported damage of precast RC frame buildings in the 1988 Spitak, Armenia earthquake. Although most buildings affected by the earthquake were constructed as Seria 111 (which is different from Seria IIS-04 discussed in this section), typical damage patterns were similar. Buildings under construction at the time of earthquake provided an opportunity to show details of welded column and beam-column connections. Eccentricity in welded bar splices was observed in the columns. Failure of the column splices was observed in several buildings. In most cases, bars had buckled, steel ties (transverse reinforcement) failed due to 90 degree hooks, and concrete was crushed. This is illustrated in Figure 3-40. Beam-column connection was achieved by welding the bottom beam reinforcement to angles and column dowels at top. Poor performance of the floor diaphragms consisting of hollow core precast RC planks was also reported; this likely occurred because the planks were not interconnected and they did not have a reinforced concrete topping. It is expected that these floors contributed to the collapse of a five-story RC frame building in Spitak which housed communications equipment. The building had rigid cladding at the exterior and precast RC frames in the interior. The central portion of the building collapsed and the floor slabs caved in (see *Figure 3-41*). It is believed that the floor diaphragms were unable to span the distance between the shear walls and the frames.

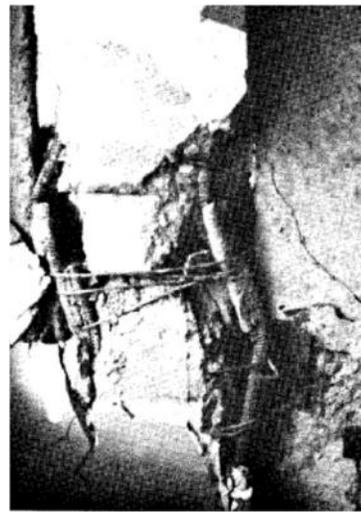
*Figure 3-40. Details of precast RC frame construction in Armenia at the time of the 1988 Spitak earthquake: a) column splice during construction, and b) failure of the column splice in the earthquake (Photos: Wylie and Lew, 1989).*

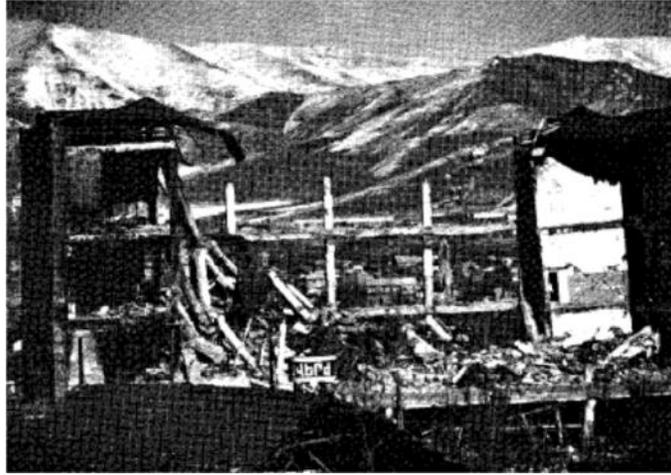
*Figure 3-41. Collapse of a 5-storey precast RC frame building in Spitak due to the 1988 Armenia earthquake was attributed to poor performance of hollow core precast RC slabs (Photo: Wylie and Lew, 1989).*

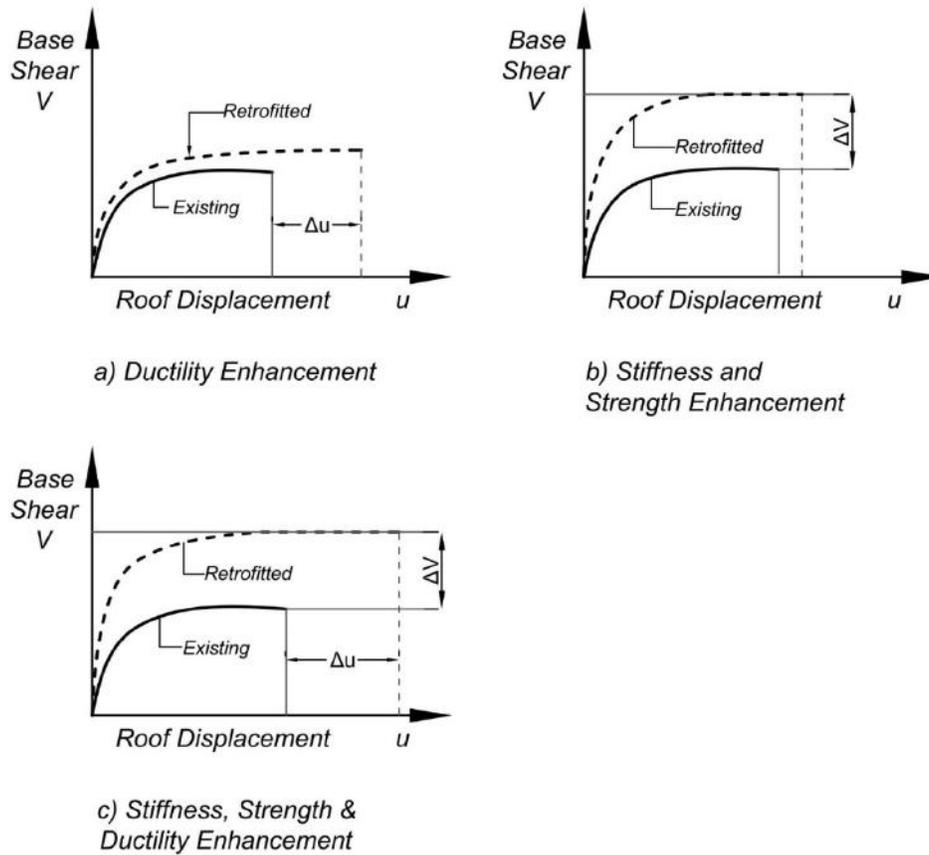
Figure 4-1. Seismic retrofitting goals (based on Thermou, Pantazopoulou, and Elnashai, 2004).

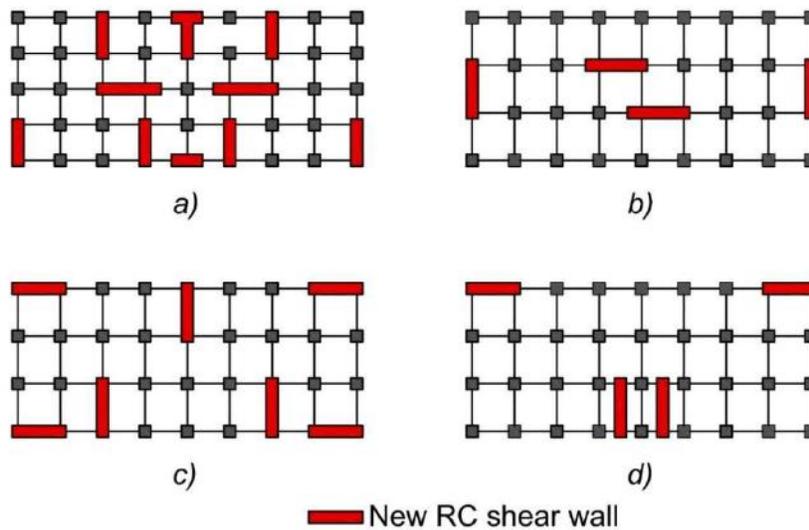
Figure 4-3. Possible layouts of new structural elements (RC shear walls) for retrofitting an existing RC structure (based on UNIDO, 1983).

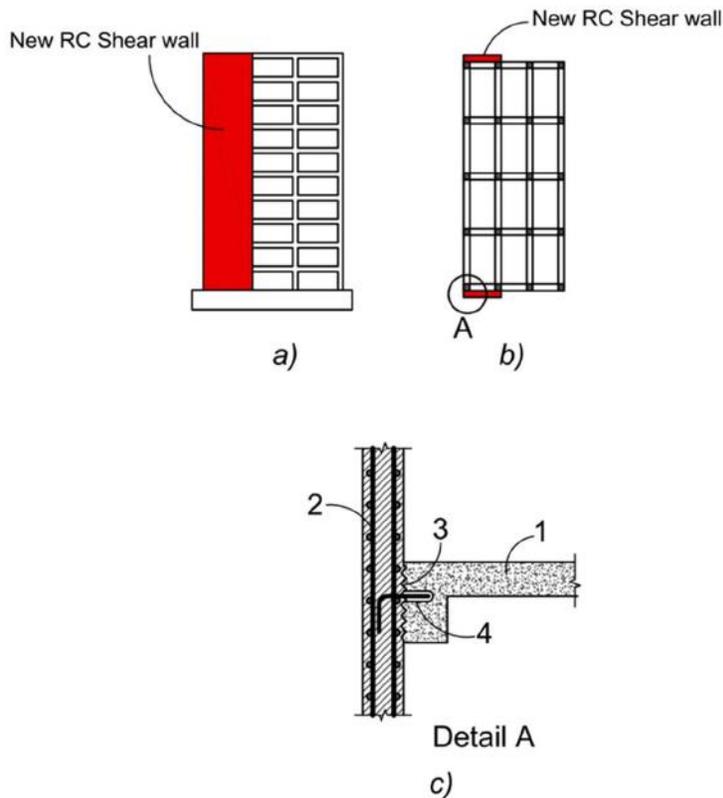
*Figure 4-4. Addition of new RC shear walls at the perimeter: a) elevation view; b) plan view, and c) wall-to-floor connection (1- existing RC slab; 2- new RC shear wall; 3- roughened interface between the new and existing concrete; 4- steel anchors).*

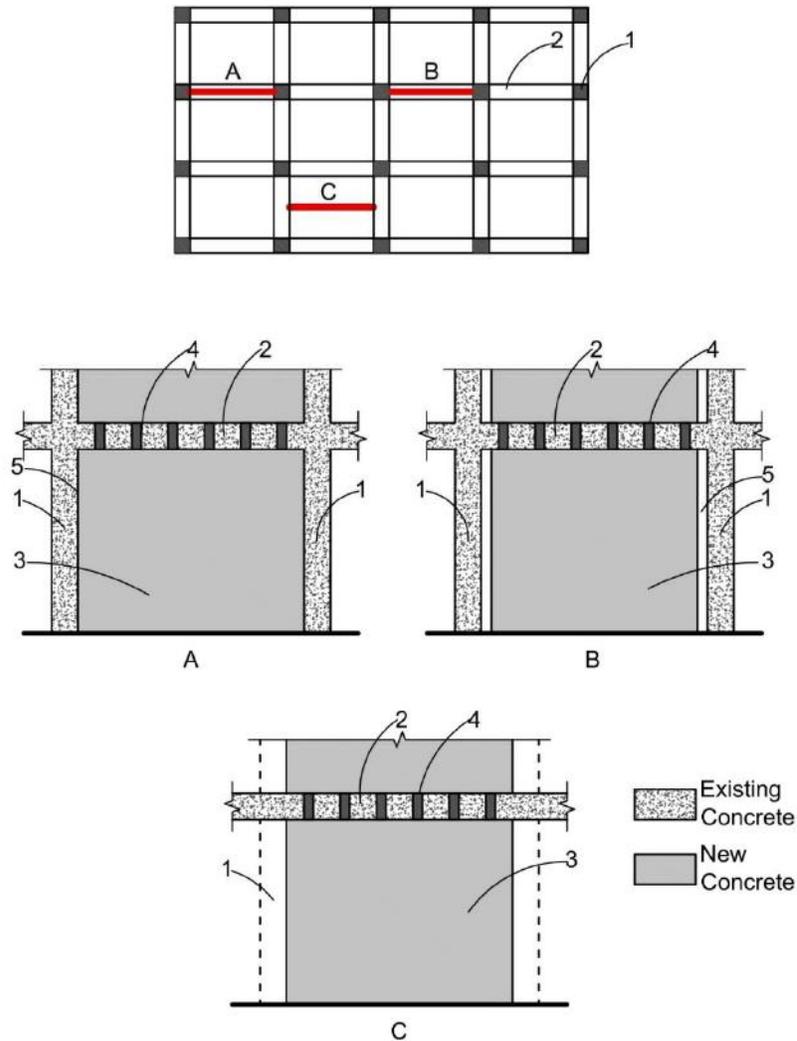
Figure 4-7. Various RC shear wall configurations: A – wall in line with the frame gridline, integrated with the columns; B – wall in line with the frame gridline, with gaps at the ends; C – wall offset with regard to the frame gridline (1- existing RC column; 2- existing RC floor slab; 3- new RC shear wall; 4- holes for passing the longitudinal wall reinforcement; 5- a gap between the new wall and the existing columns).

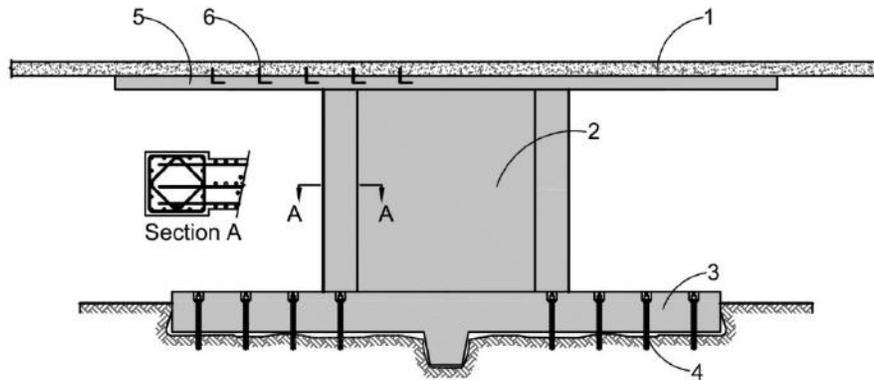
Figure 4-8. New RC shear wall with the foundations – note shear key and soil anchors at the foundation level: 1- existing RC slab; 2- new RC shear wall; 3- new RC foundation; 4- soil anchors; 5- new RC drag strut (collector); 6- steel anchors at the drag strut-to-slab interface (based on Nikolic-Brzev and Sherstobitoff, 1998).

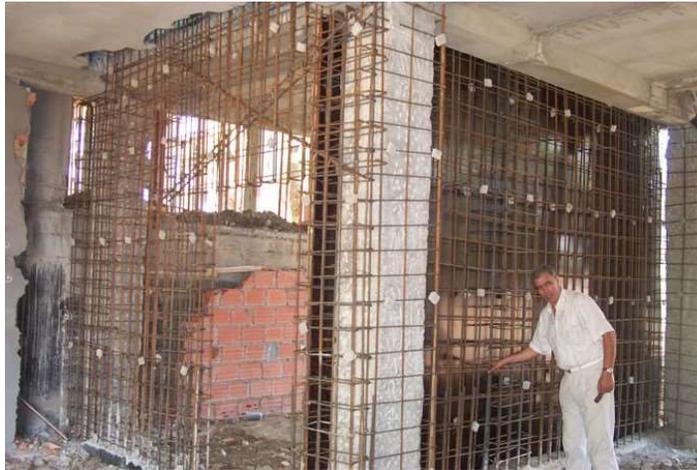
*Figure 4-11. An existing RC frame building retrofitted by constructing new RC shear walls after the 2003 Boumerdes, Algeria earthquake (Photo: M. Farsi).*

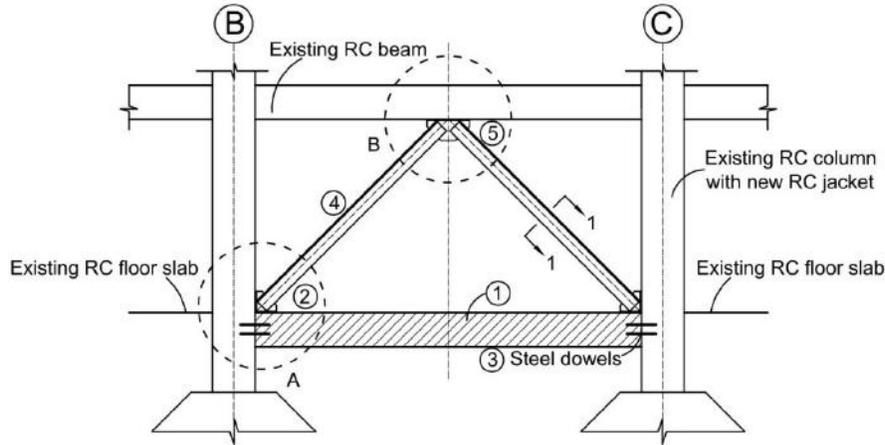
Figure 4-12. Example of added steel bracing in an existing RC frame: 1–new RC tie-beam; 2 – new steel gusset plate for the brace-to-column connection; 3 – steel dowels for brace-to-tie-beam connections (various locations); 4 – new double-angle steel braces; 5 – new steel gusset plate for the brace-to-beam connection.

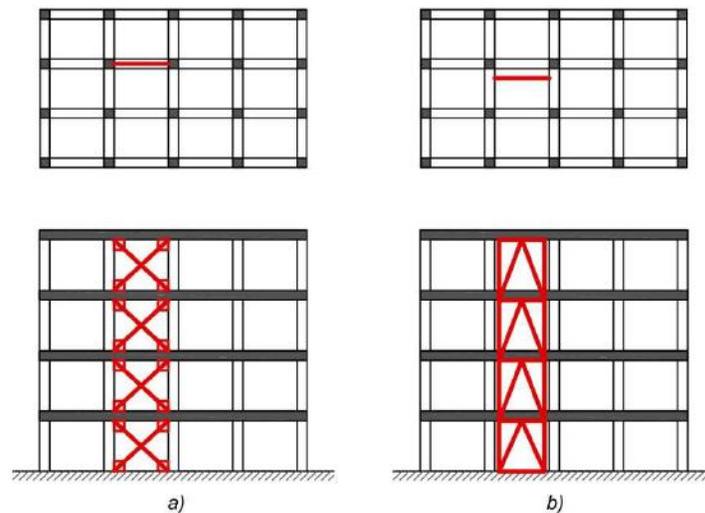
Figure 4-14. Bracing configurations: a) a bracing connected directly to the existing frame (“infill” configuration) and b) a bracing placed alongside of the frame.
