# **PRACTICAL SEISMIC DESIGN AND CONSTRUCTION MANUAL FOR RETROFITTING SCHOOLS IN THE KYRGYZ REPUBLIC**

Svetlana Brzev and Ulugbek Begaliev

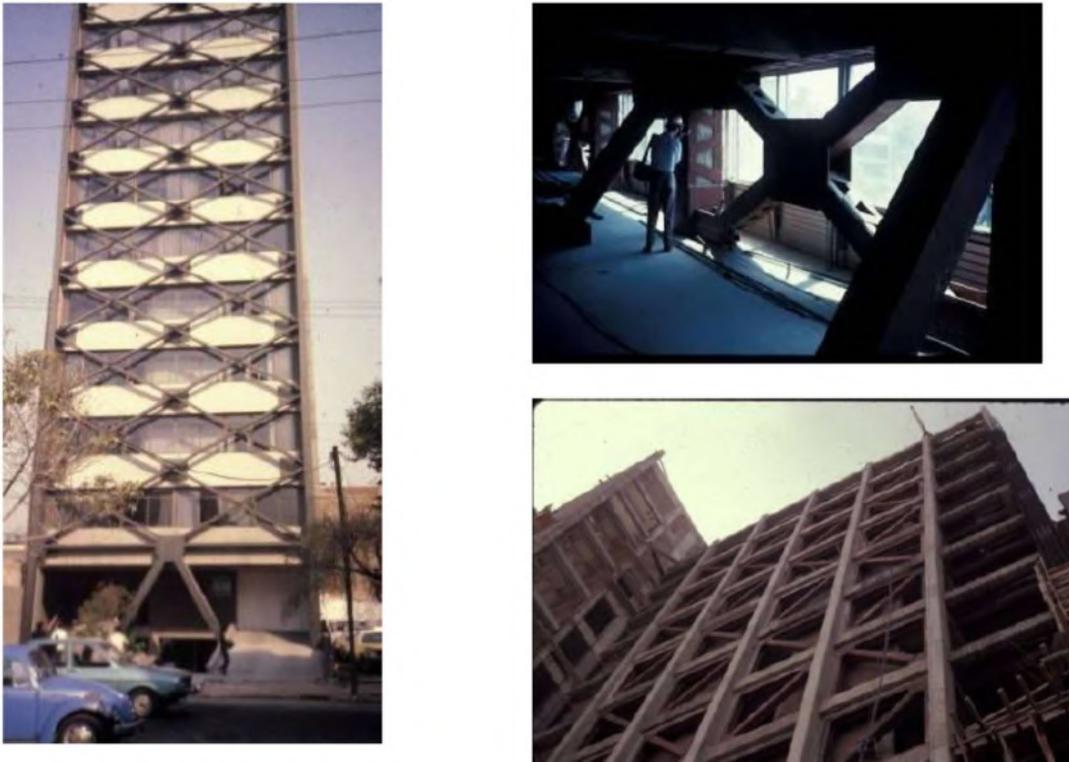
*Figure 4-17. Retrofitting of RC buildings with steel bracings after the 1985 Mexico City earthquake (Photos: Jirsa, 2010).*

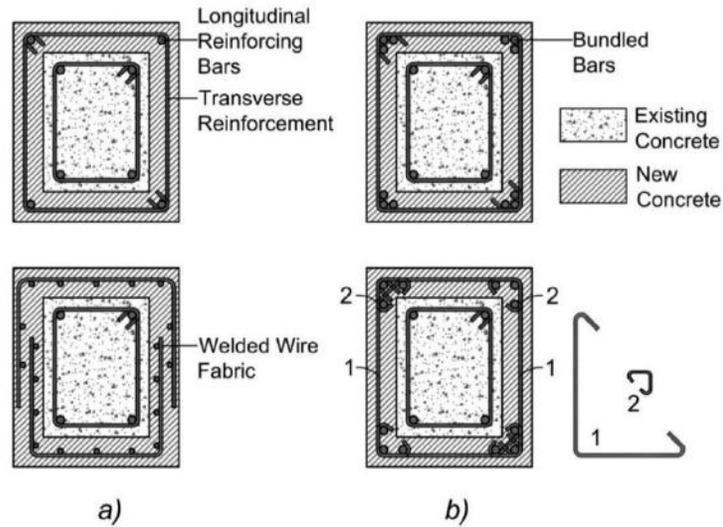
Figure 4-19. Cross-section and reinforcement for RC column jackets: a) jackets for enhancing axial and shear resistance and b) jackets for enhancing flexural resistance.

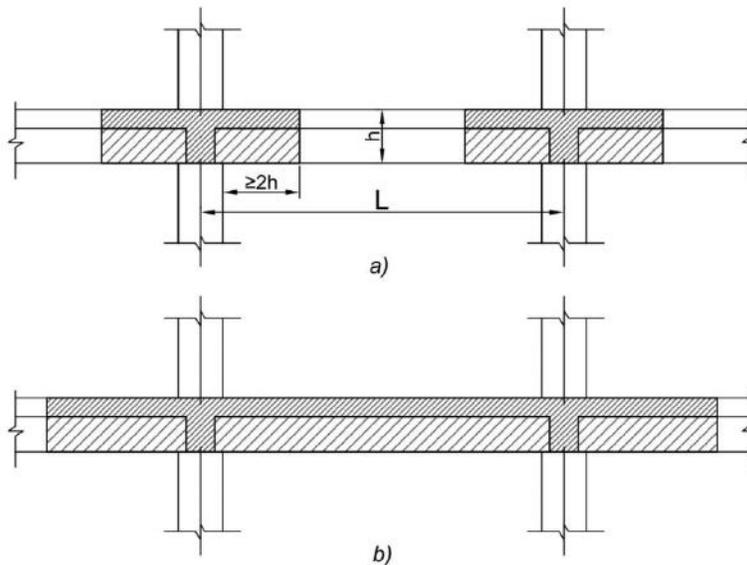
Figure 4-20. Different configurations of RC beam jackets: a) partial jacketing and b) continuous jacketing.

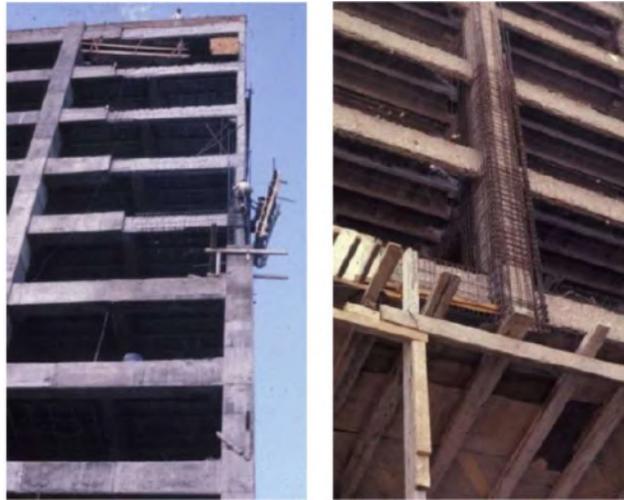
Figure 4-22. Beam and column jacketing of RC buildings in Mexico City after the 1985 earthquake (Photos: Jirsa, 2010).

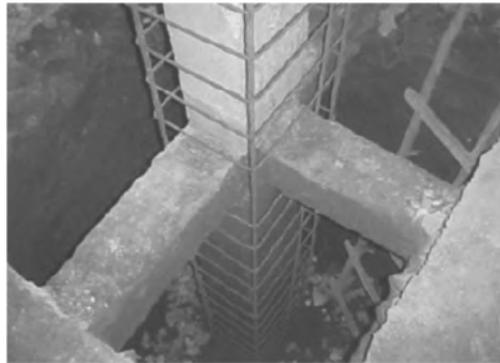
Figure 4-23. RC jacketing of an existing RC column after the 2001 Bhuj, India earthquake (Photo: Jain et al., 2002).

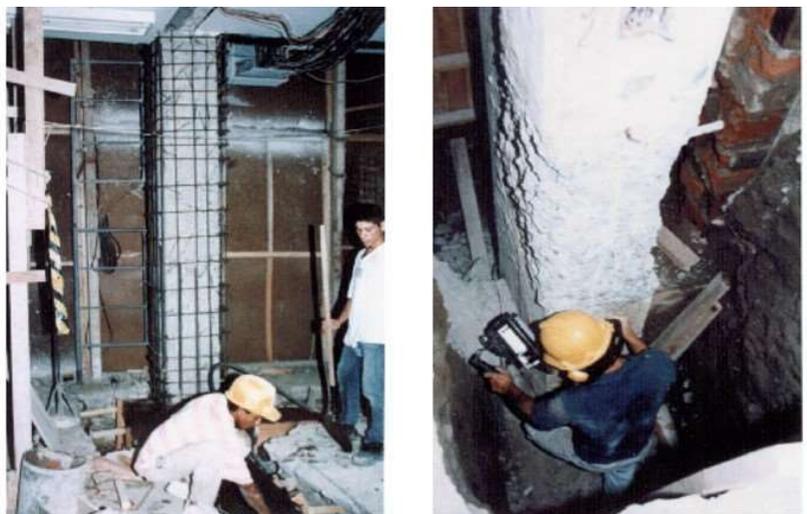
Figure 4-24. RC jacketing of an existing RC column in Colombia (Photos: Mejia, 2002).

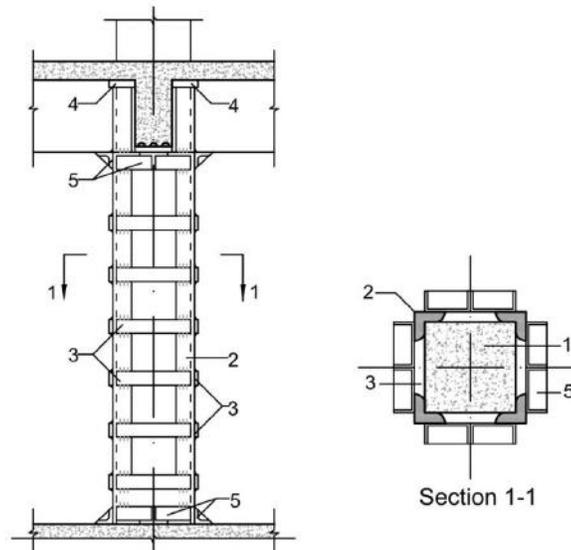
Figure 4-25. Steel jacketing of a RC column (1- existing column; 2- steel angle section; 3- steel strap; 4 – supporting plate; 5- top/bottom stiffeners) (UNIDO, 1983).

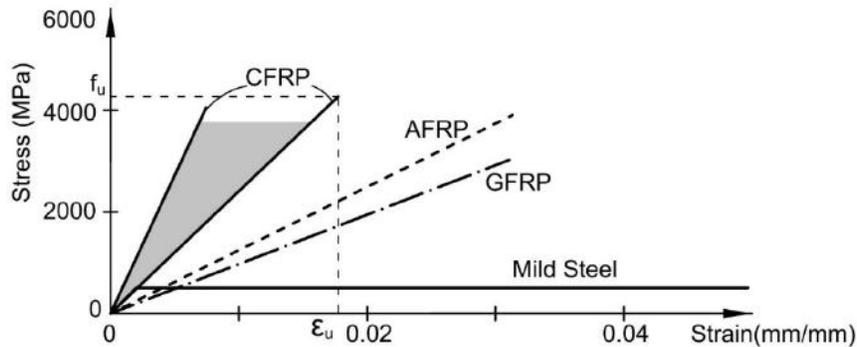
Figure 4-27. Uniaxial tension stress-strain diagram for various fibers used for the FRPs and steel: CFRP= carbon FRP; AFRP= aramid FRP; GFRP= glass FRP (based on Triantafillou, 2006).

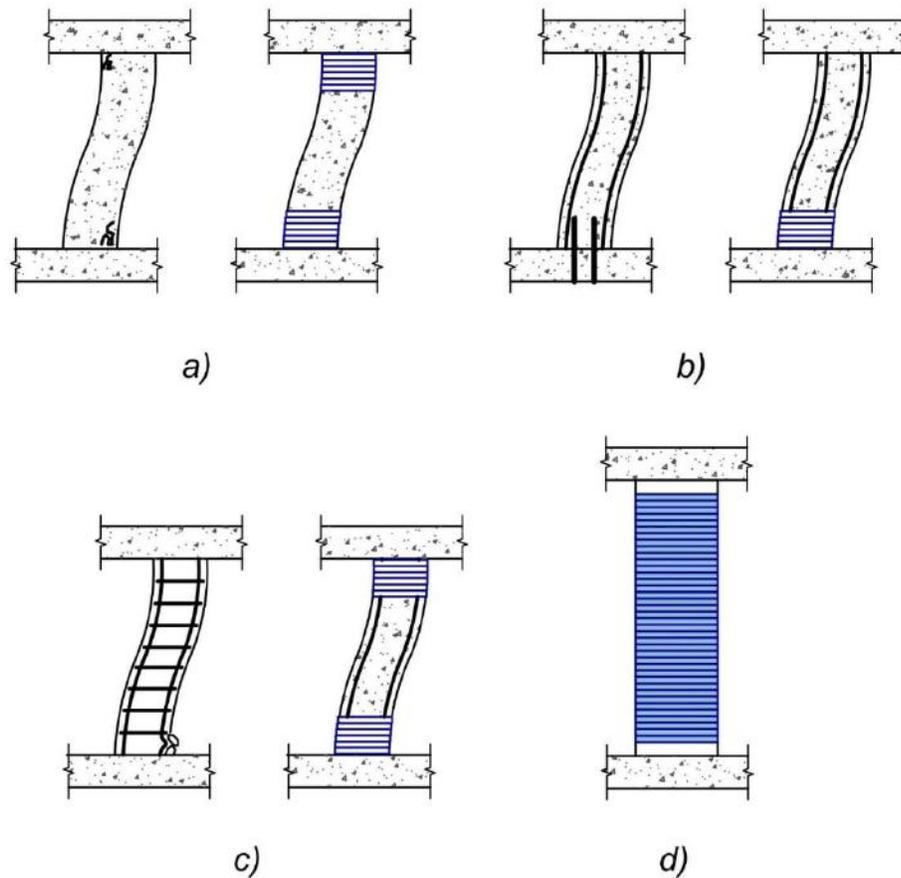
Figure 4-28. Retrofitting of RC columns using FRP overlays: a) confinement to increase lateral deformation capacity; b) confinement to prevent lap splice failure; c) confinement to prevent reinforcement buckling, and d) wrapping to increase shear capacity (Triantafillou, 2006).

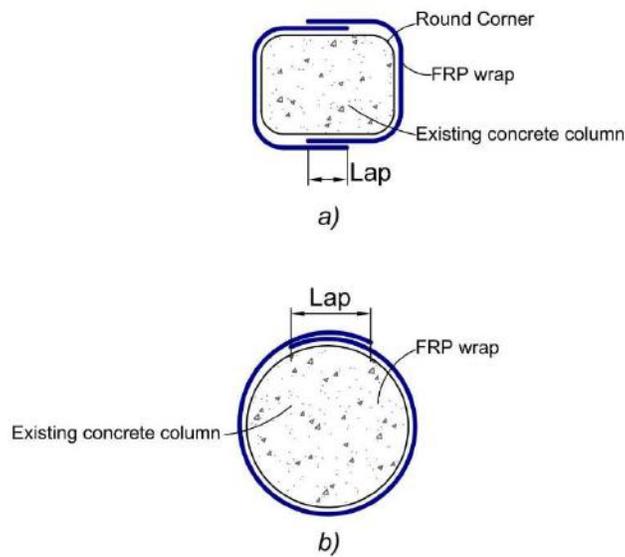
Figure 4-29. Seismic retrofit of RC columns using FRP overlays: a) rectangular section and b) circular section (FEMA 547, 2006).

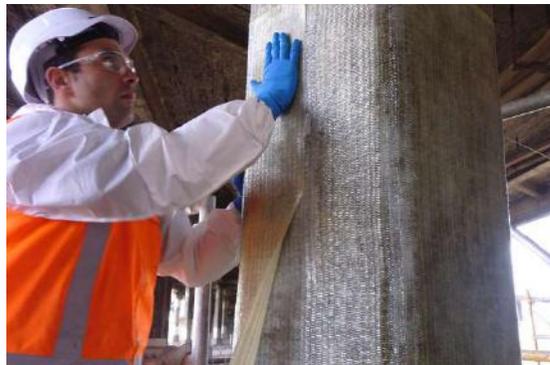
Figure 4-32. Jacketing of RC columns using FRP wraps: field application of a GFRP wrap<sup>1</sup>.

An example of retrofitting a RC column using GFRP wrap is shown in *Figure 4-32*.

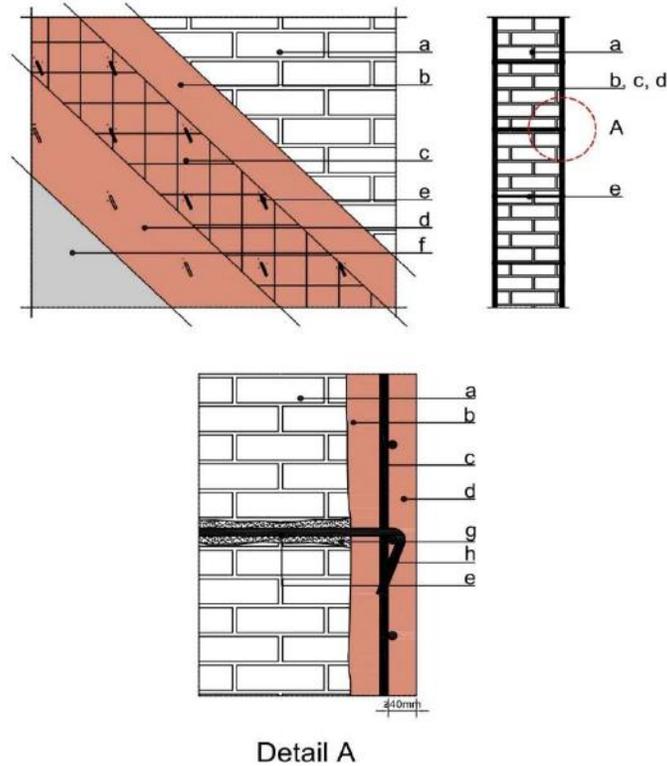
Figure 4-34. RC jacketing details: a) existing masonry wall; b) first layer of concrete jacketing; c) welded steel wire mesh; d) second layer of concrete jacketing; e) cross-connection steel anchors; f) plaster; g) hole in the masonry wall filled with epoxy resin or cement mortar grout, and h) steel anchor with a 90° degree hook (Source: ALL Ingegneria and AIRES Ingegneria).

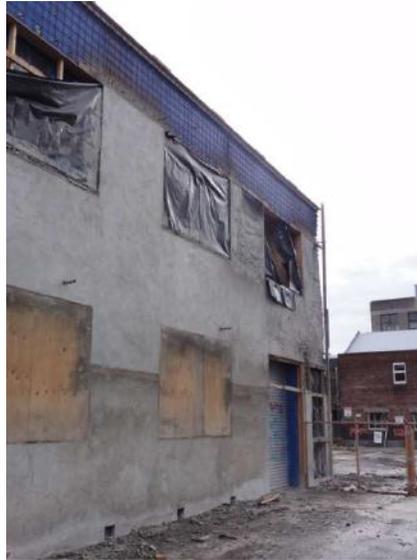
*Figure 4-36. Shotcrete application for retrofitting masonry walls in New Zealand after the 2011 earthquake (Photo: K.J. Elwood).*

RC jacketing is one of the most widely used techniques for the retrofitting of masonry buildings before and after earthquakes in many countries. This technique was used in the Balkan region after the damaging earthquakes in the 1970s and was documented by UNIDO (1983). RC jacketing was used to retrofit earthquake-damaged buildings in Italy (D'Ayala, Speranza, and D'Ercole, 2001) and Slovenia (Lutman and Tomažević, 2003). Kehoe (1996) reported that some unreinforced masonry buildings were retrofitted using shotcrete jacketing on exterior walls before the 1994 Northridge, California earthquake. There is no specific report regarding the performance of these buildings in the earthquake. Figure 4-36 shows an application of RC jacketing in New Zealand after the 2011 earthquake (magnitude 6.2).

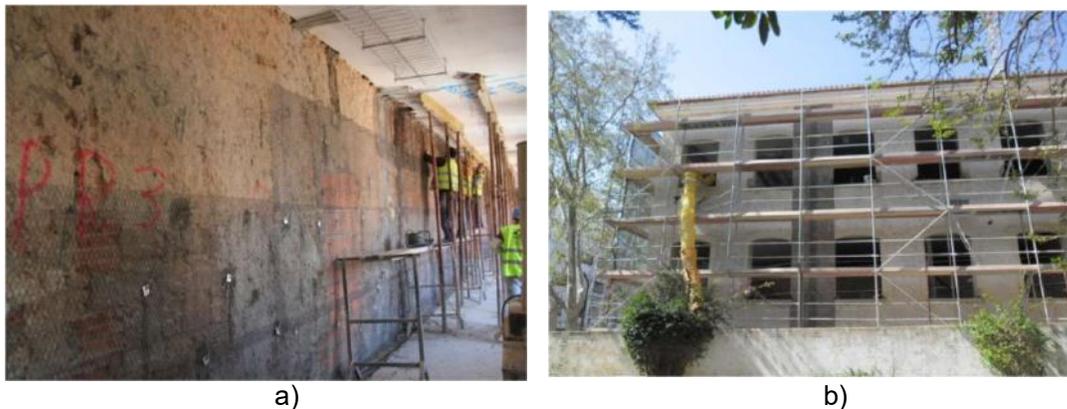
*Figure 4-37. Application of reinforced cement plaster for retrofitting a school in Portugal: a) steel mesh application to an interior wall and b) fiberglass application to an exterior wall (Photos: Proença et al., 2012).*

RP technique was used for seismic retrofitting of a 100-year old masonry school in Portugal as an earthquake mitigation activity (Proença et al., 2012). Galvanized expanded steel mesh was used to retrofit interior walls, while fiberglass mesh was used for exterior walls (*Figure 4-37*). Application of shotcrete jacketing for retrofitting of historic masonry buildings in the USA is discussed by Snow (1999), see *Figure 4-38*.

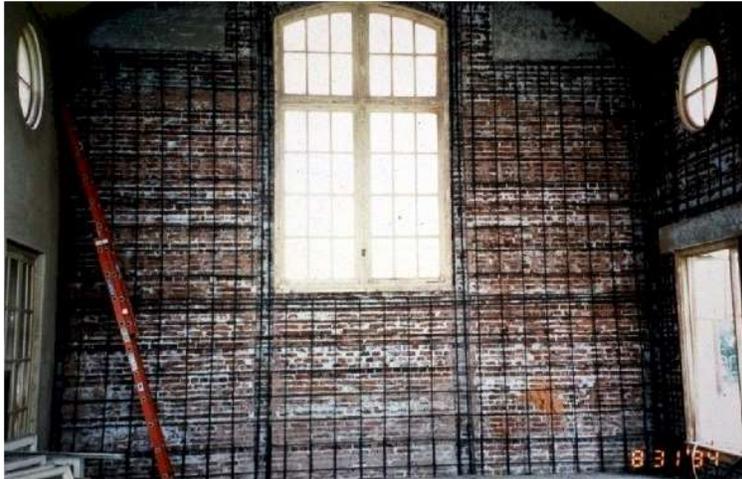
Figure 4-38. A field application of RC jacketing in an older brick masonry building in California, USA (Photo: J. Sherstobitoff).

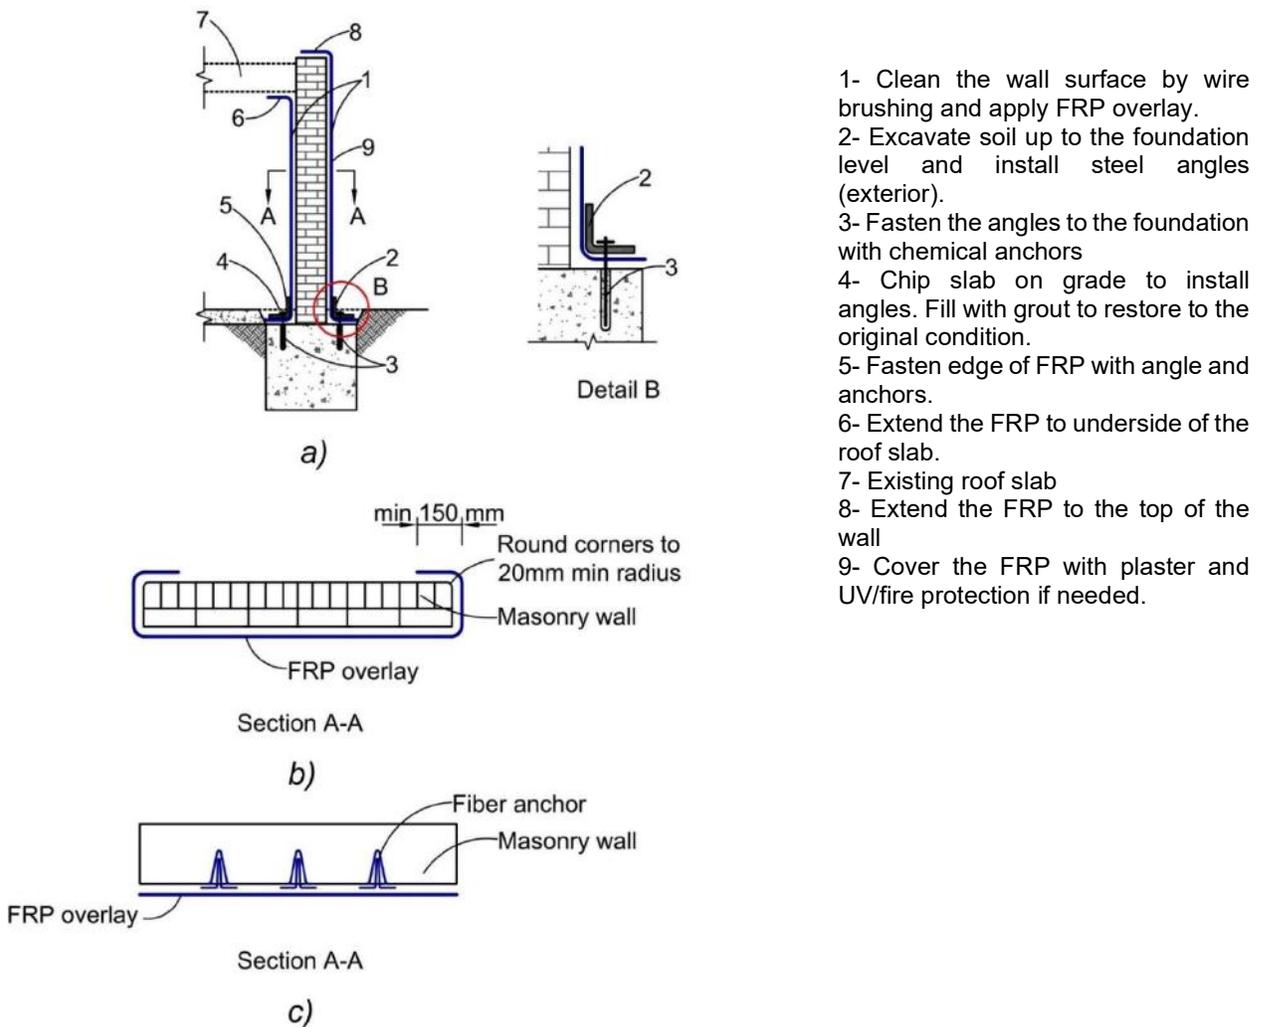
- 1- Clean the wall surface by wire brushing and apply FRP overlay.
- 2- Excavate soil up to the foundation level and install steel angles (exterior).
- 3- Fasten the angles to the foundation with chemical anchors
- 4- Chip slab on grade to install angles. Fill with grout to restore to the original condition.
- 5- Fasten edge of FRP with angle and anchors.
- 6- Extend the FRP to underside of the roof slab.
- 7- Existing roof slab
- 8- Extend the FRP to the top of the wall
- 9- Cover the FRP with plaster and UV/fire protection if needed.

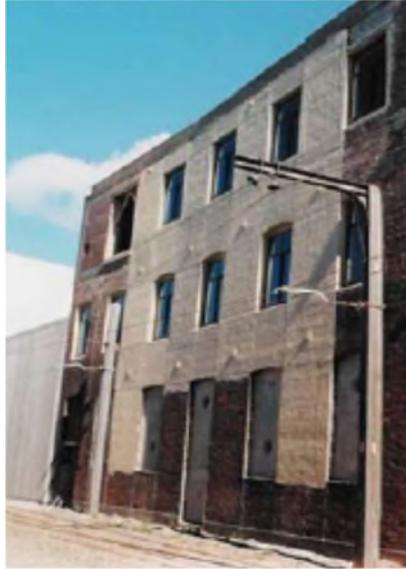
*Figure 4-41. A brick masonry building retrofitted with FRP overlays (visible at the exterior) in New Zealand (Photo: UA, 2011).*

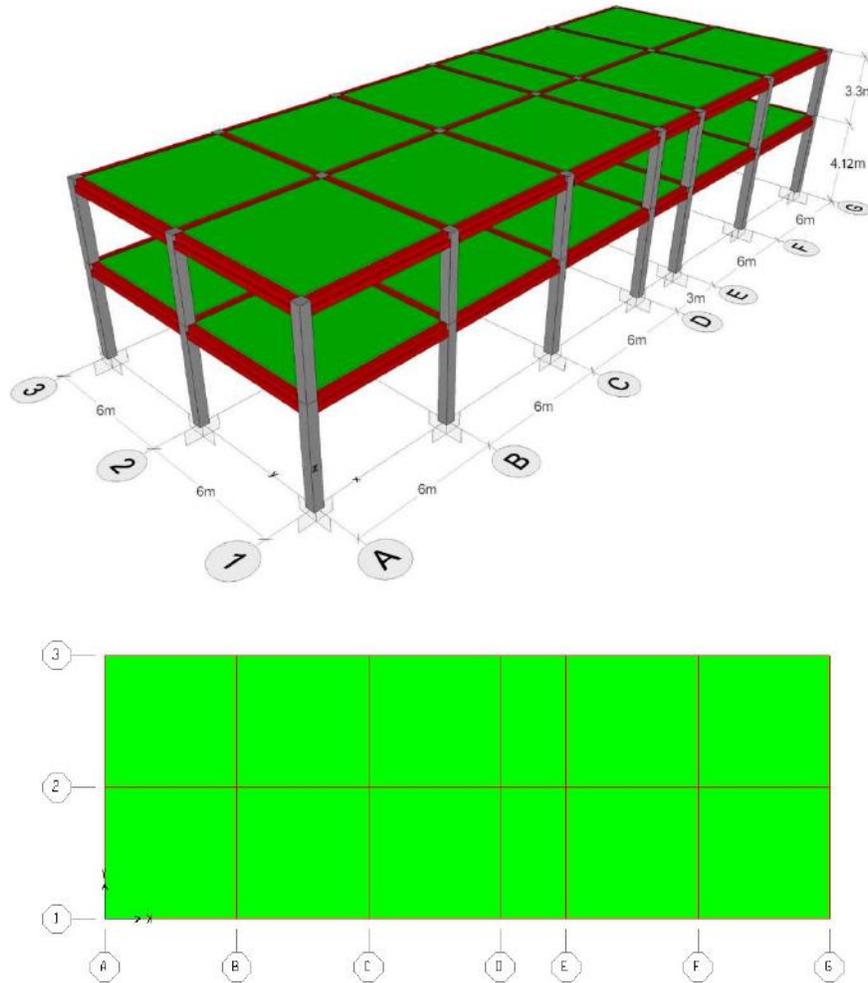
Figure 5-7. Numerical model of the frame structure for 3-D analysis (all dimensions in m).

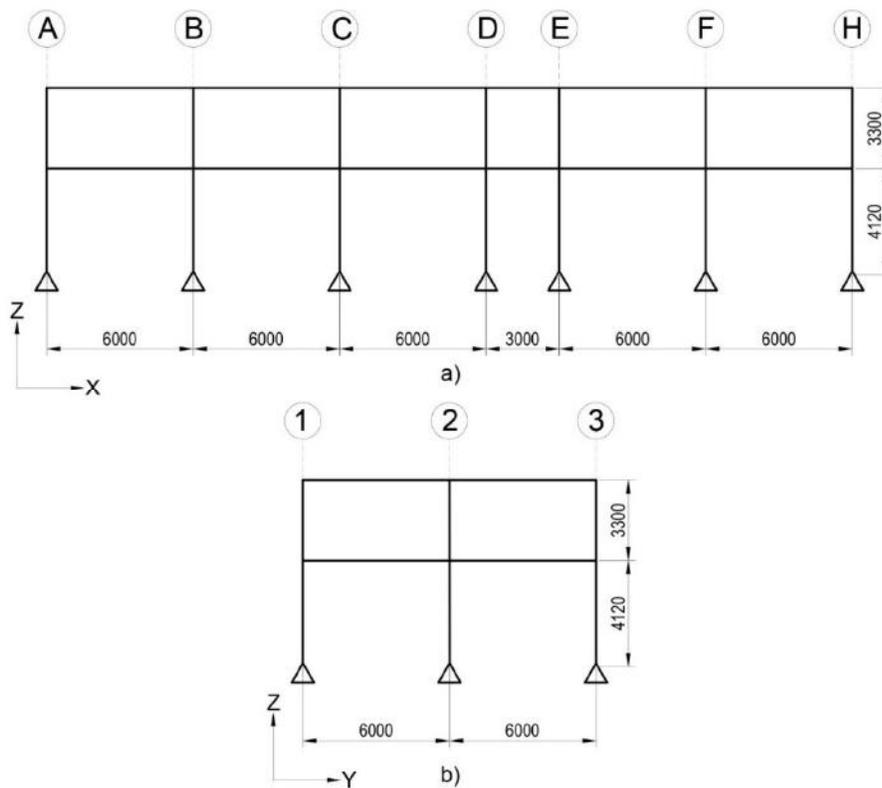
Figure 5-9. Numerical models for 2-D analysis: a) frame 1 in longitudinal direction and b) frame B in transverse direction (all dimensions in mm).

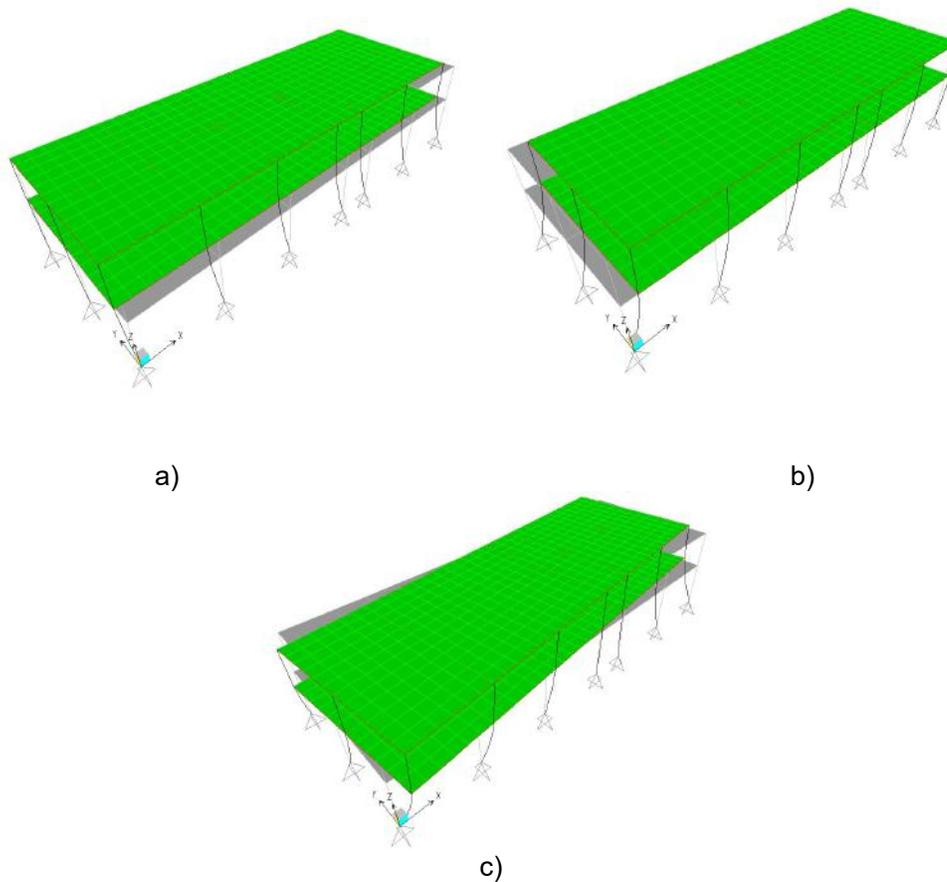
Figure 5-11. Mode shapes obtained as a result of the linear elastic analysis for model with the pinned supports: a) translational mode in X-direction; b) translational mode in Y-direction, and c) torsional mode.

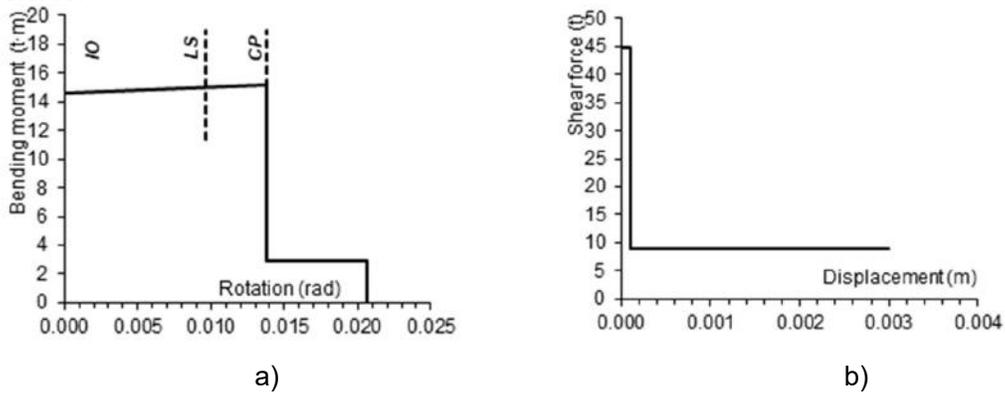
Figure 5-14. Beam hinge properties for Frame 1: a) moment hinge (BH-M3), and b) shear hinge (BH-V2).

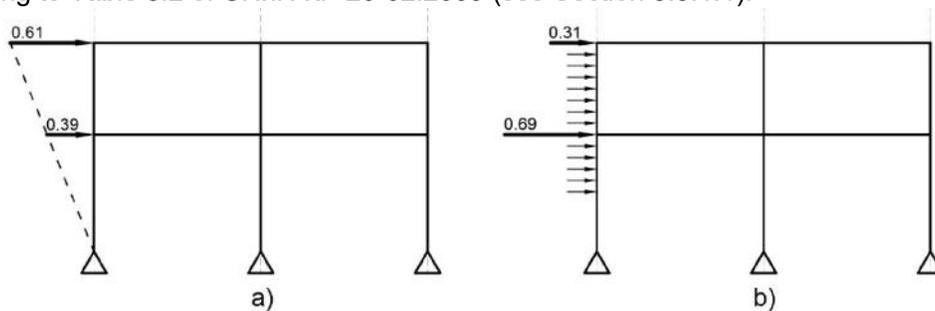
Figure 5-18. Load patterns for pushover analysis: a) LP1 – inverse triangular, and b) LP2 - uniform.

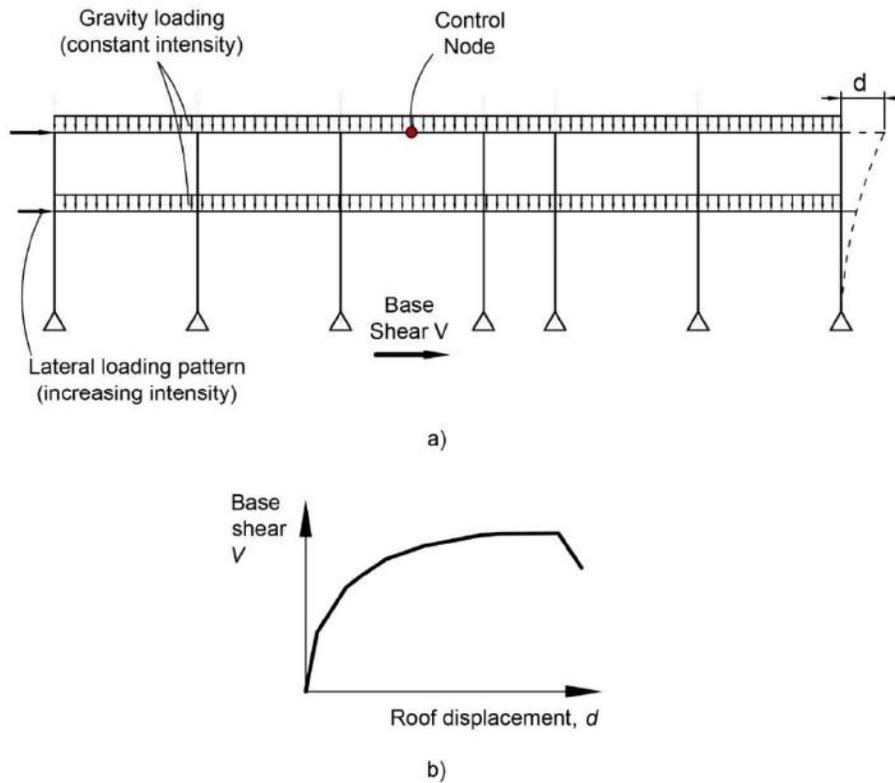
*Figure 5-19. Conceptual numerical model and a Capacity Curve obtained as an output from the pushover analysis.*

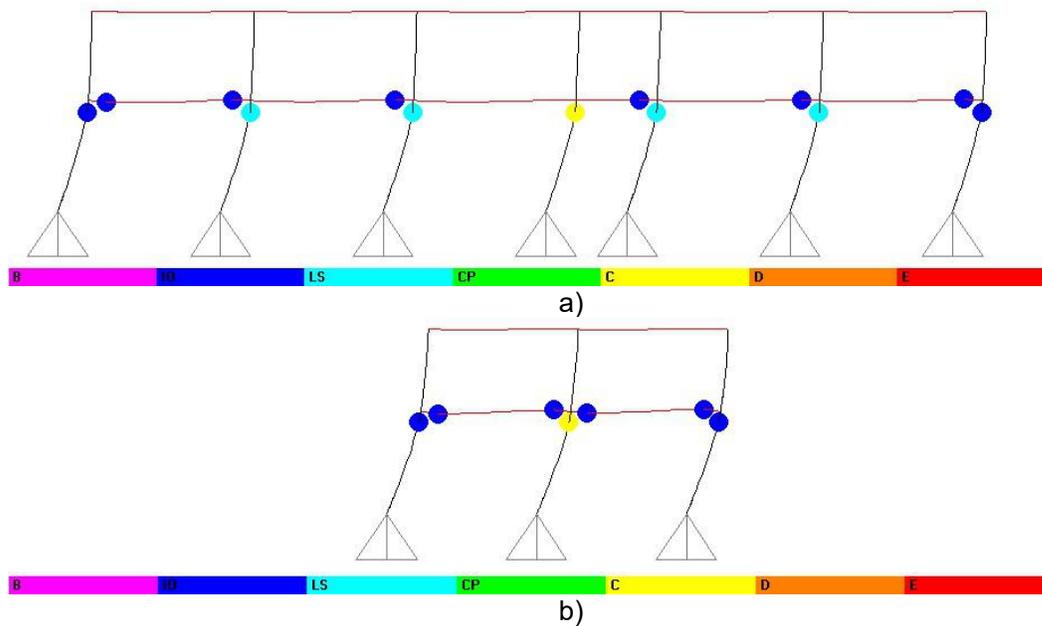
Figure 5-22. Deformed shape for load pattern LP2 at the maximum shear capacity (labelled with black solid circle on the capacity curves): a) Frame 1 (displacement 62 mm), and b) Frame B (displacement 83 mm).

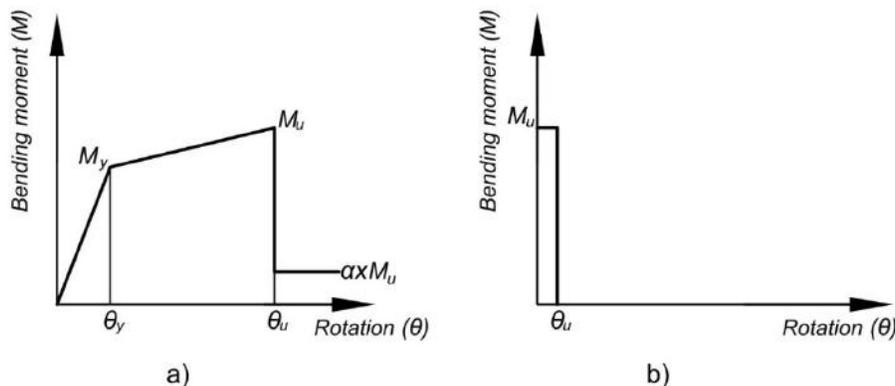
Figure 5-23. Flexural plastic hinges for the beam: a) Hinge BH-M3 for RC beam section (outside the connection) and b) hinge BH-MW simulating the behavior of a welded connection.

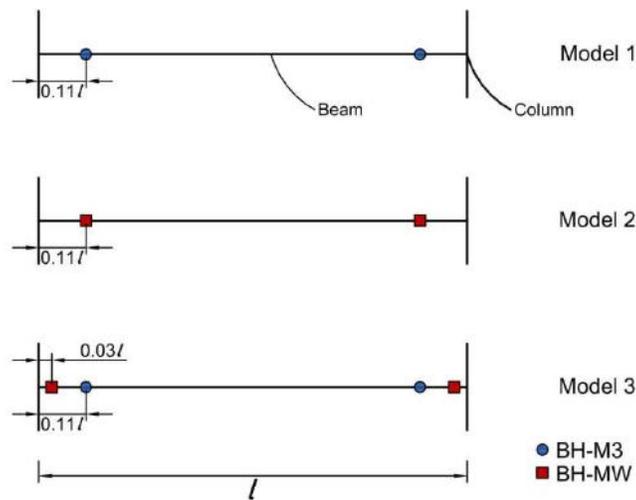
Figure 5-24. Numerical models for the RC beams in frames with different moment hinge properties (hinge BH-M3 is ductile and hinge BH-MW is brittle).

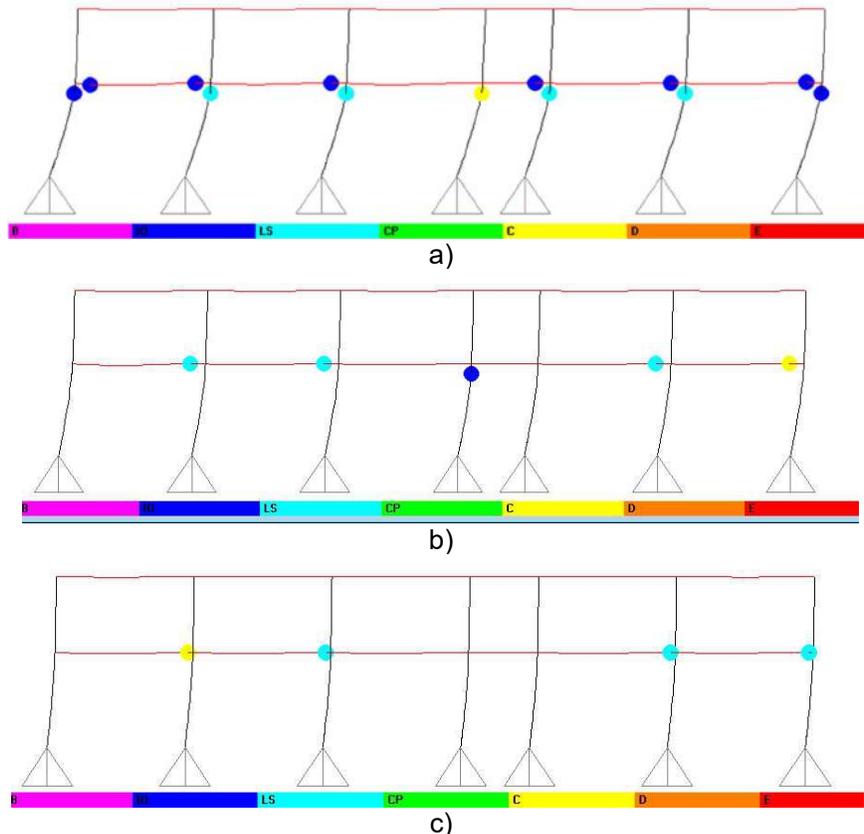
Figure 5-26. Deformed shapes for load pattern LP2 at the maximum shear capacity: a) Model 1; b) Model 2, and c) Model 3.

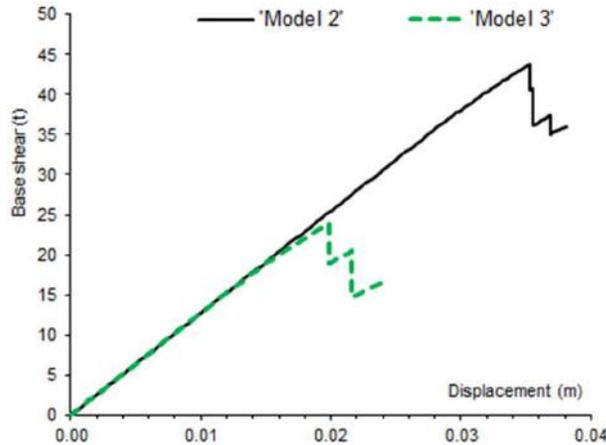
Figure 5-27. Capacity curves for Frame 1: Model 2 and Model 3.

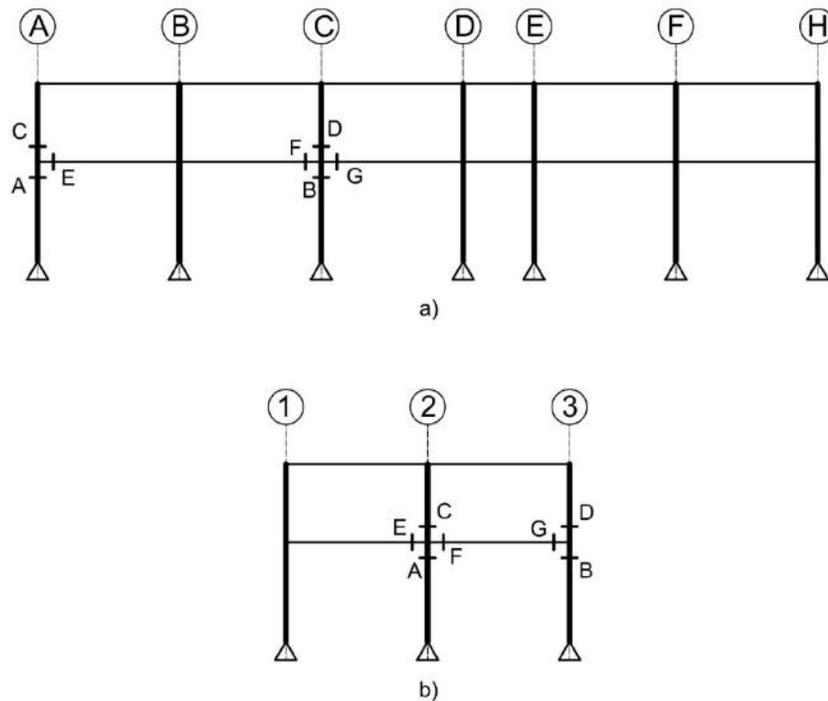
Figure 5-34. Reference frames for seismic evaluation of the retrofitted building (RS1): a) Frame 1 and b) Frame B.

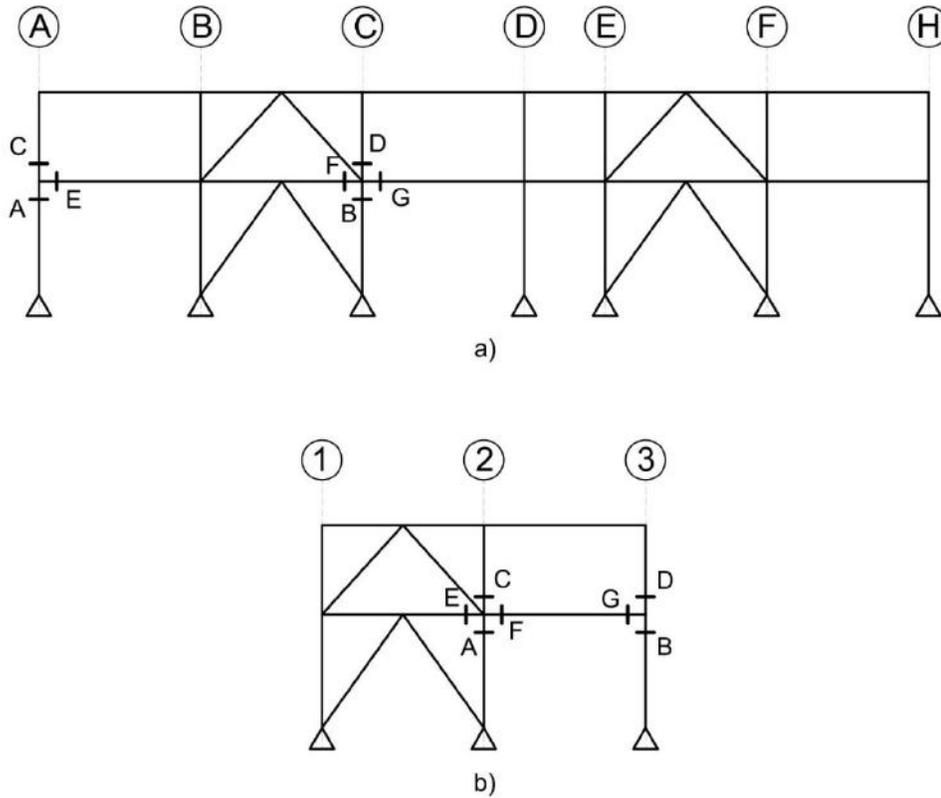
Figure 5-48. Reference frames for seismic evaluation of the retrofitted building (RS2): a) Frame 1, and b) Frame B.

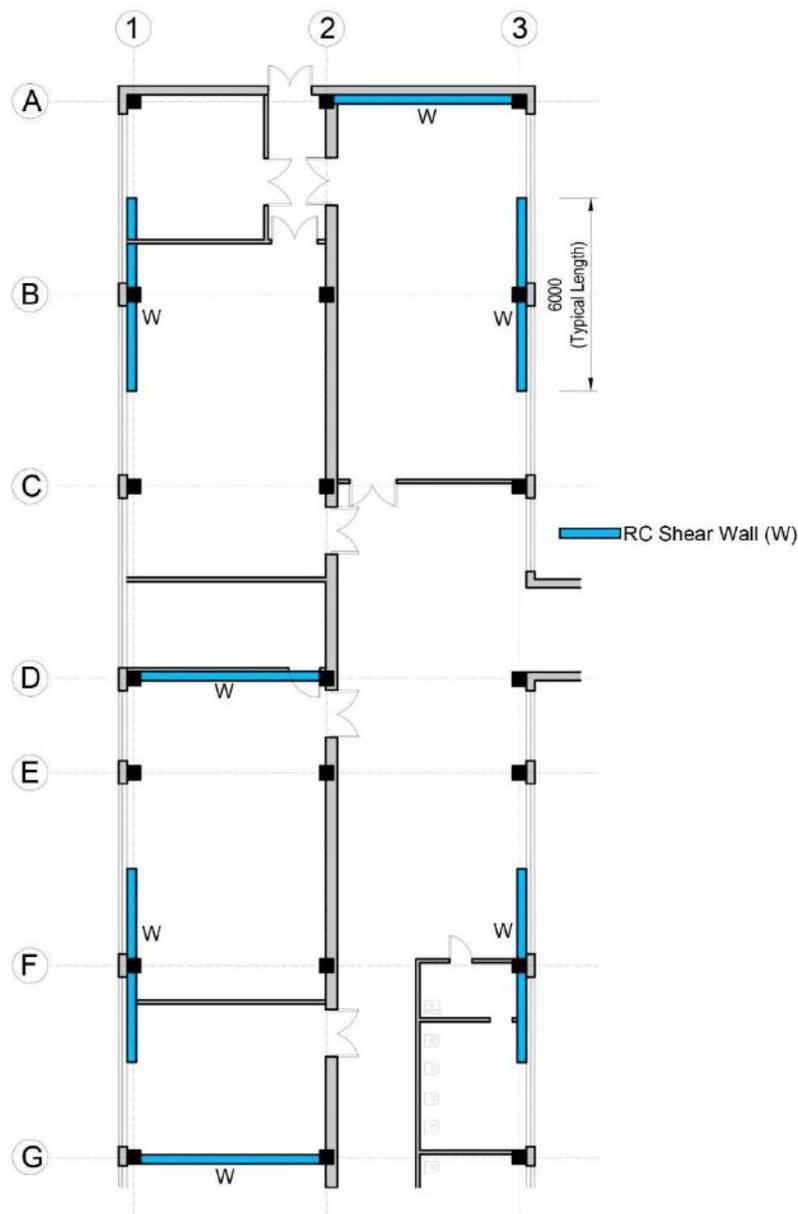
*Figure 5-55. Floor plan of the retrofitted building with RC shear walls (RS3).*

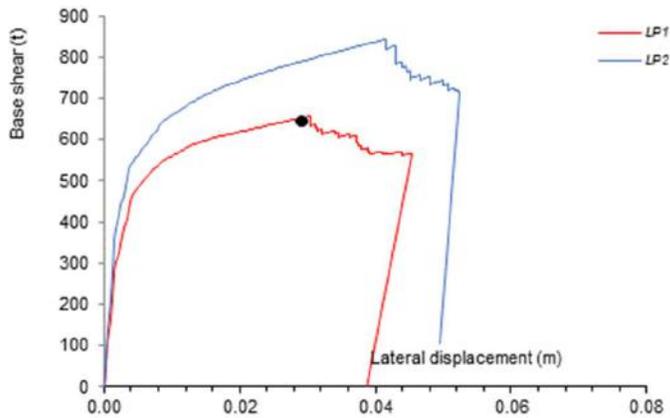
Figure 5-65. Capacity curve for Frame 1 (RS3) (LP1: maximum force 656.51 t and the corresponding displacement 31 mm).

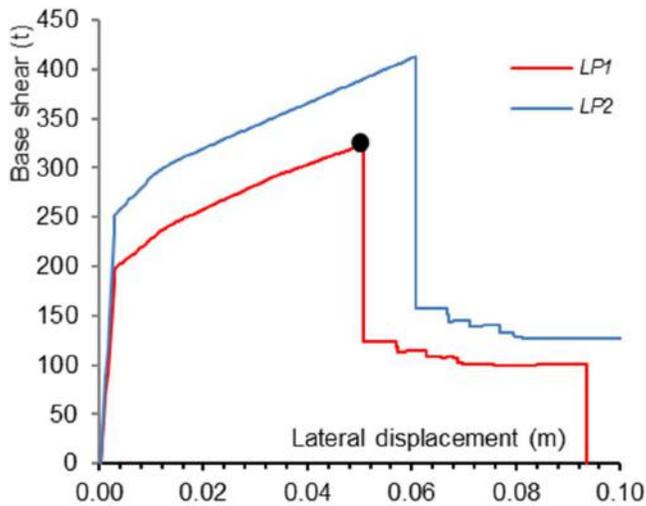
Figure 5-66. Capacity curve for Frame D (RS3) (LP1: max force 323.79 t and the corresponding displacement 51 mm).

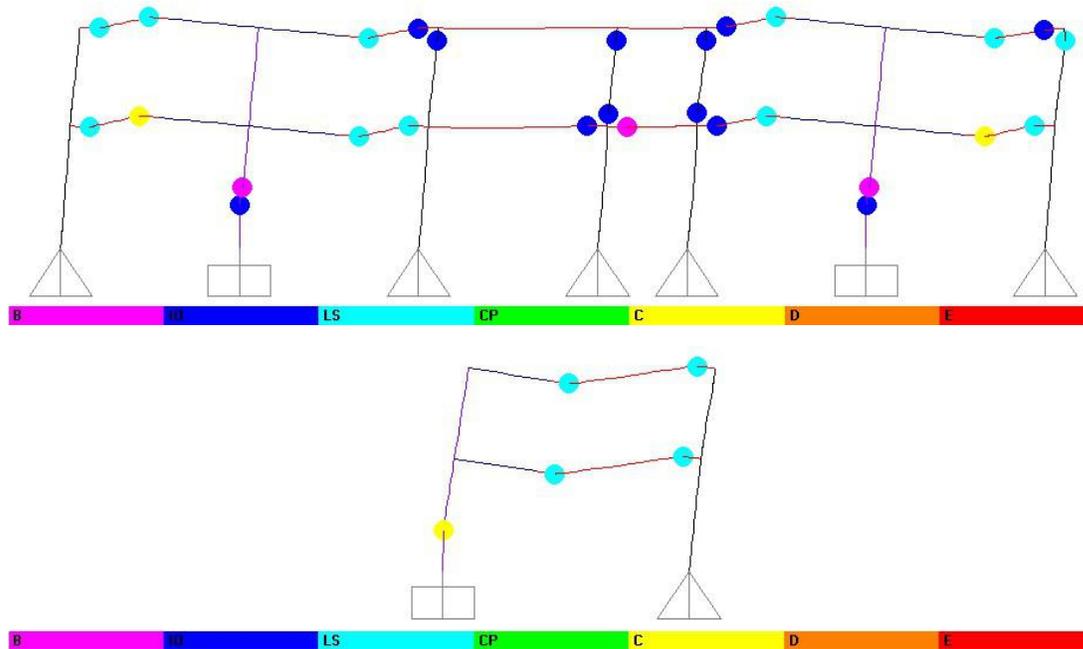
Figure 5-67. Deformed shape for RS3, load pattern LP1, at the maximum shear capacity (labelled with black solid circle on the capacity curves): a) Frame 1 (displacement 31 mm and b) Frame D (displacement 51 mm).

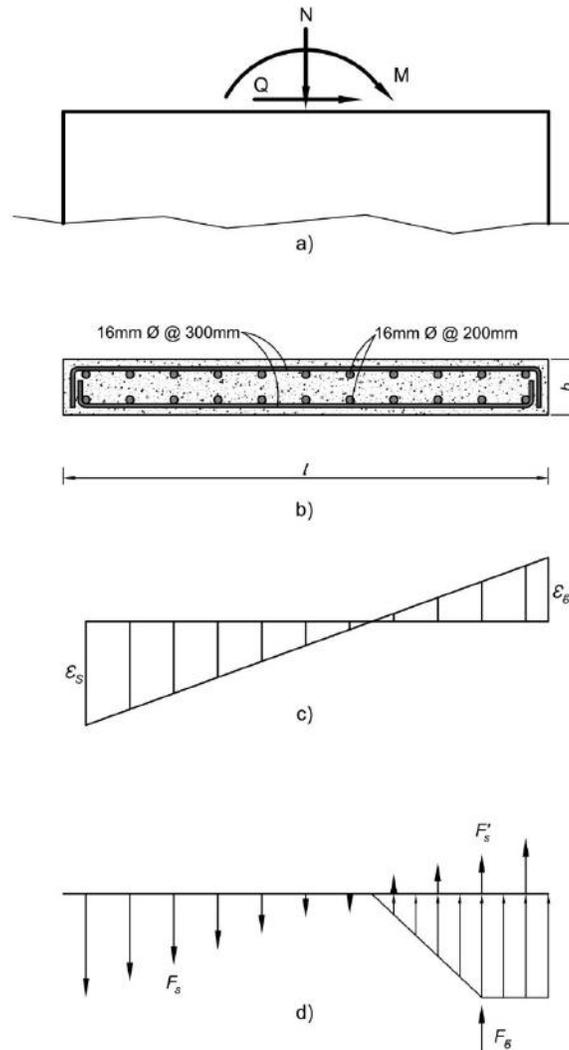
Figure 5-68. RC shear wall subjected to shear force, axial load and bending: a) wall elevation showing design forces; b) wall cross-section; c) strain distribution, and d) distribution of internal forces.

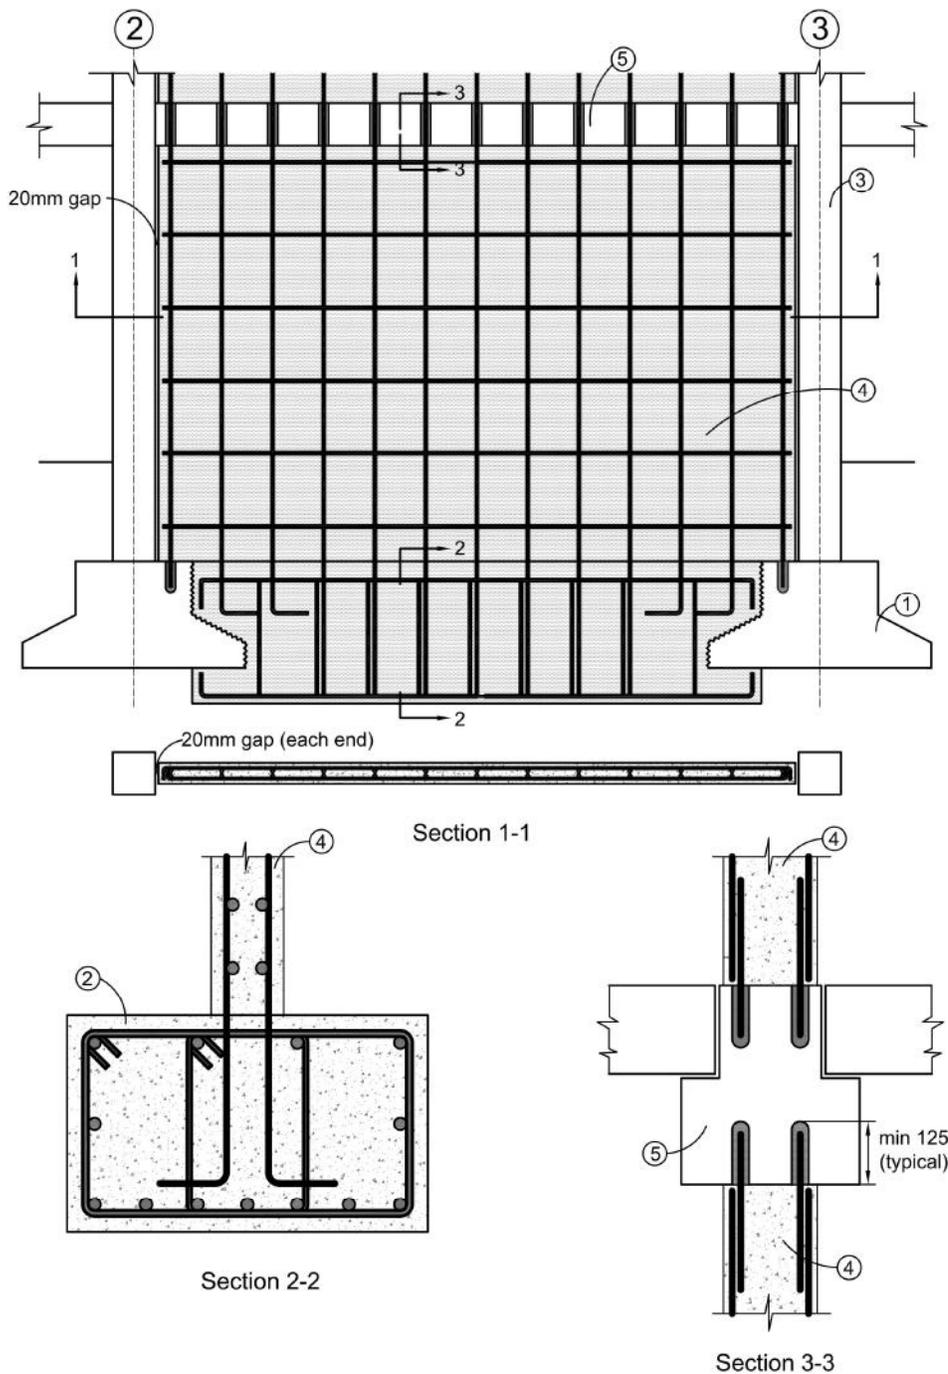
Figure 5-69. Construction details for a RC frame retrofitted with RC shear walls (RS3): 1 - existing column footing; 2 - new foundation for RC shear wall; 3 - existing RC column; 4 - new RC shear wall; 5 - existing RC beam.

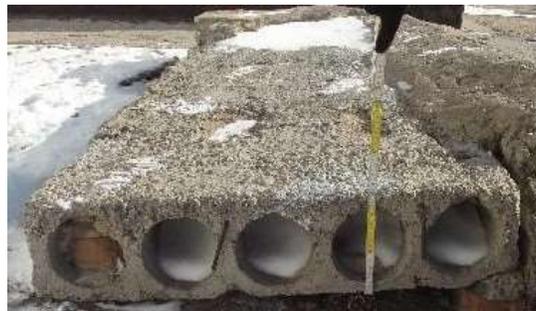
Figure 6-4. A typical hollow core RC planks used for floor construction in the existing masonry buildings (Source: JV ALL Ingegneria – AIREs Ingegneria).

Floor system consists of precast reinforced concrete hollow core slabs. The slabs are in the form of 1.2 m wide hollow core RC planks with 22 cm thickness (see Figure 6-4). The planks are laid in the transverse direction of the building and are supported by longitudinal walls. Monolithic RC seismic belts were constructed in all walls at the floor level. The details of floor slab-to-wall connections are shown in Figure 6-5.

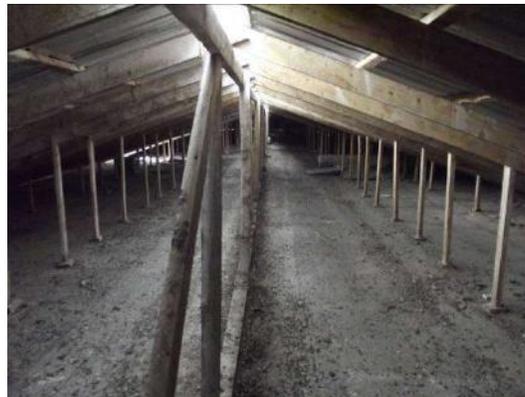
The roof system consists of pitched roof with timber rafters supported by exterior walls and vertical timber posts supported by the RC slabs (Figure 6-6). The roofing is made of Corrugated Galvanized Iron (CGI) sheets. Approximate distance between the posts, which support the rafters, varies from 180 to 200 cm. The principal rafters have 140x50 mm cross-section and are provided at 80 to 100 cm spacing. The secondary rafters have 40x40 or 50x50 mm cross-sectional dimensions and are provided at 50 to 60 cm spacing. The roof system was not included in the original design, and it can be considered a non-engineered structure (it was not designed with engineering input). The sizes of timber elements and their connections were selected based on the experience of local artisans.

Figure 6-6. An interior view of the existing non-engineered roof structure (Source: JV ALL Ingegneria – AIREG Ingegneria).

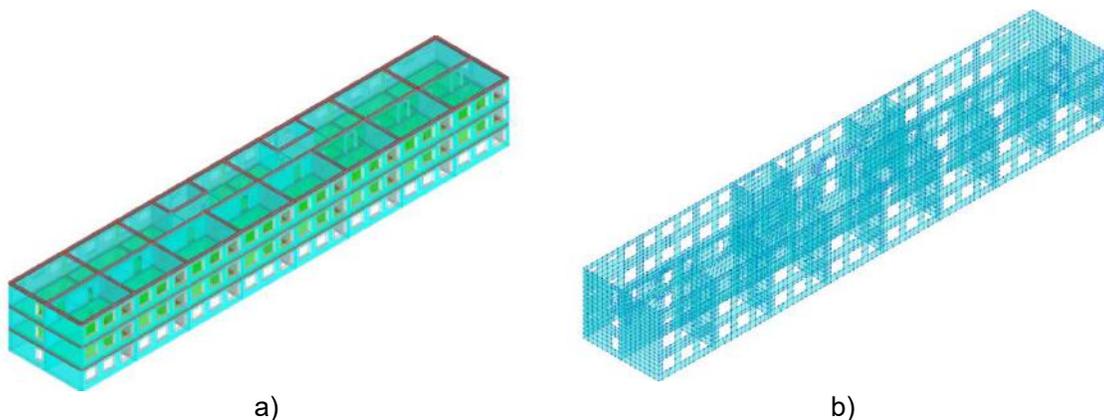
Figure 6-7. Numerical model for Block A: a) a 3-D extruded view and b) FEM mesh.

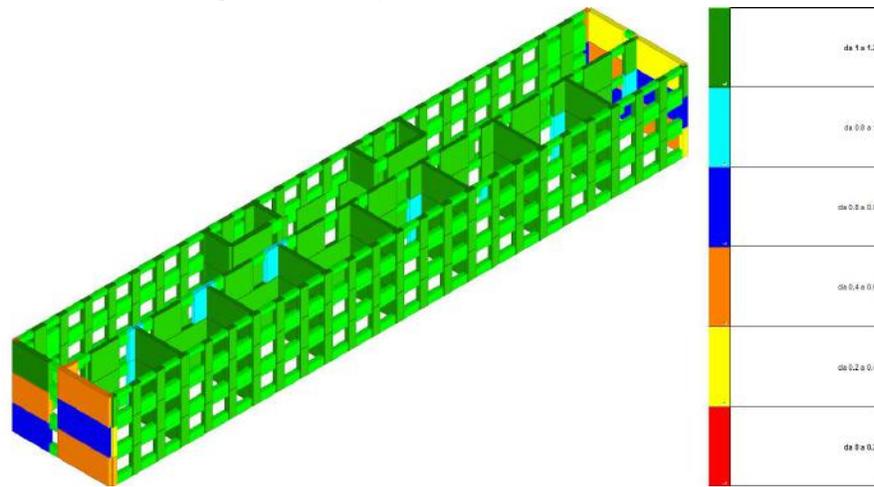
Figure 6-9. Seismic Vulnerability Index for the existing building: bending failure mechanism (minimum seismic vulnerability index  $I(pga) = 0.250$ ).
