# **PRACTICAL SEISMIC DESIGN AND CONSTRUCTION MANUAL FOR RETROFITTING SCHOOLS IN THE KYRGYZ REPUBLIC**

Svetlana Brzev and Ulugbek Begaliev

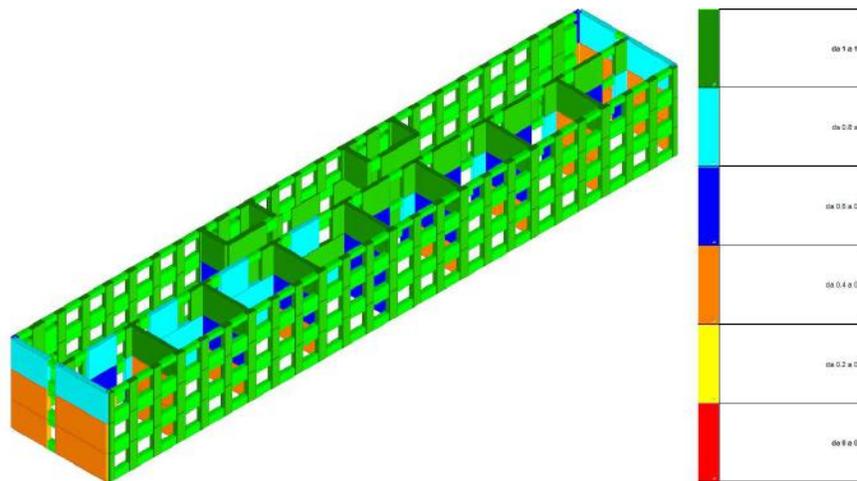
Figure 6-10. Seismic Vulnerability Index for the existing building: shear failure mechanisms (minimum seismic vulnerability index  $I(pga) = 0.411$ ).

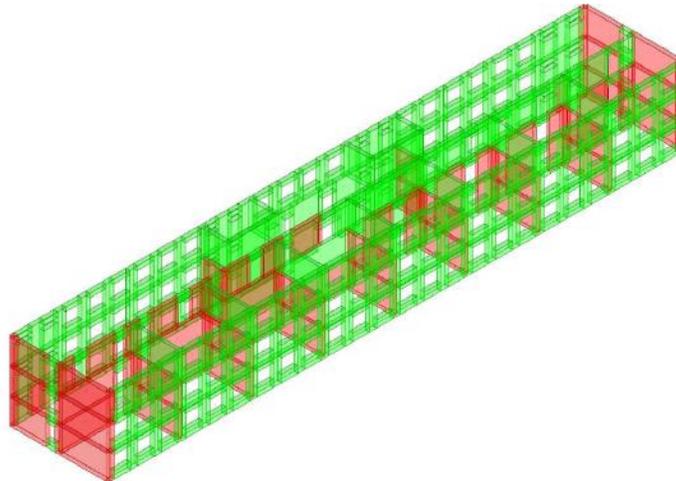
Figure 6-11. A numerical model of the building showing critical vulnerable walls (in red color) which were identified as a result of the seismic assessment.

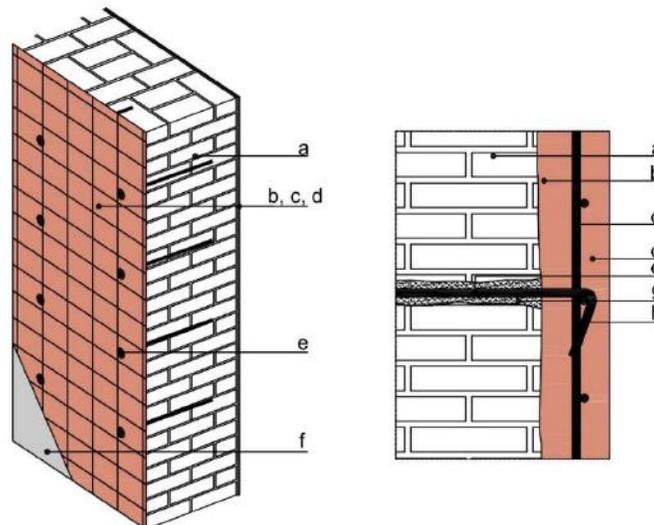
Figure 6-12. RC jacketing of an existing masonry wall: a) existing masonry; b) first layer of concrete; c) steel wire mesh; d) second layer of concrete; e) steel anchors; g) a hole in the masonry wall filled with epoxy resin or cementitious grout, and h) steel anchor with a 90-degree hook.

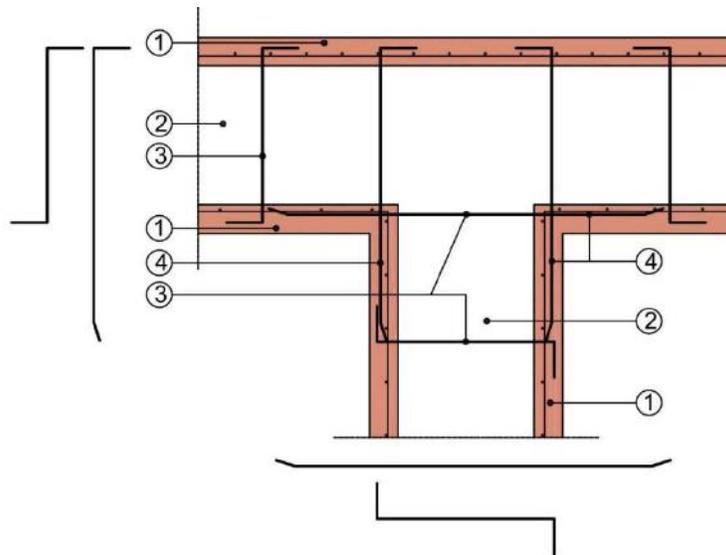
Figure 6-20. RC jacketing of masonry walls at T-junctions: 1) RC jacketing; 2) existing masonry wall; 3)  $\text{Ø}12$  through-wall steel bars at the junction at 500 mm spacing horizontally and vertically, and 4)  $\text{Ø}12$  through-wall steel bar at 500 mm spacing.

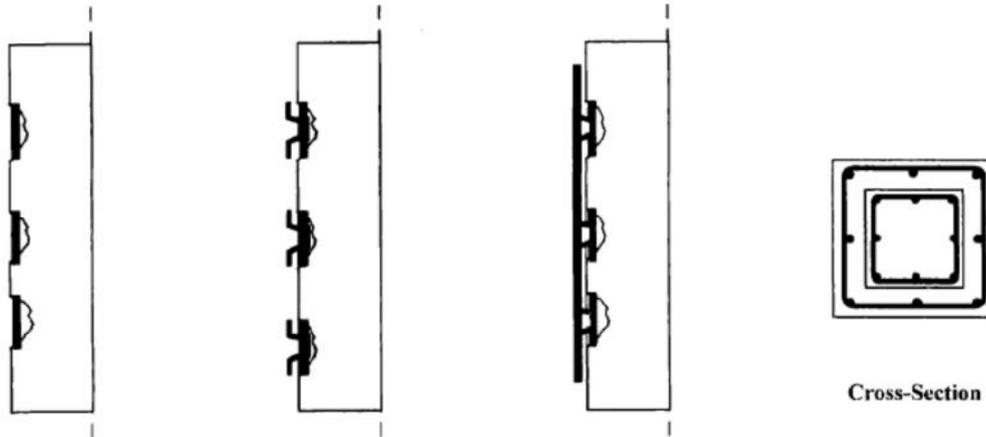
Figure A-1. U-shaped steel rebar welded to existing and new corner bars are not recommended for RC jacketing (FIB, 2003).

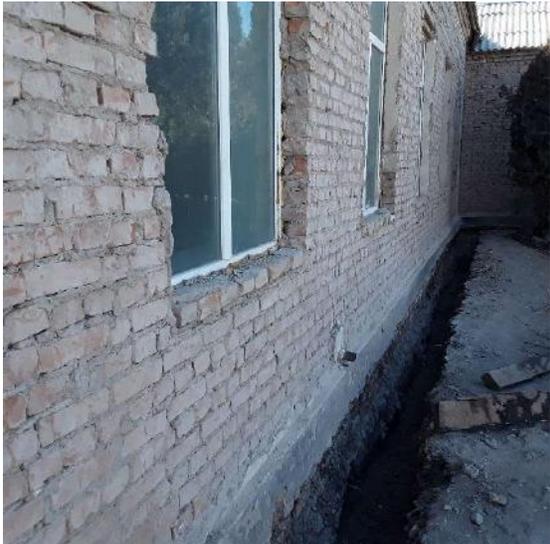
Excavation and removal of soil on both sides of the wall to provide space for new reinforced concrete foundation beams

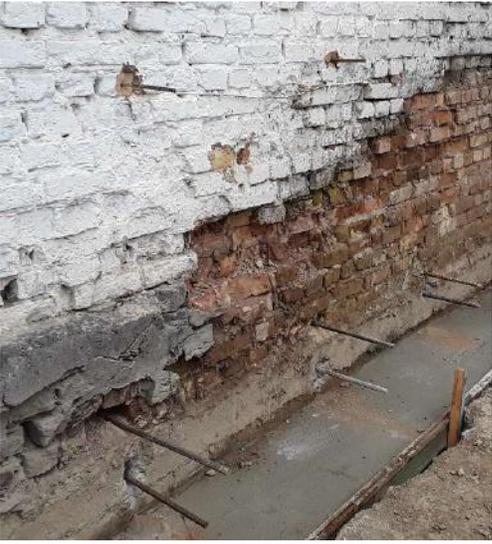
Horizontal anchors drilled into the existing foundation to ensure joint action of the existing foundation and new beams

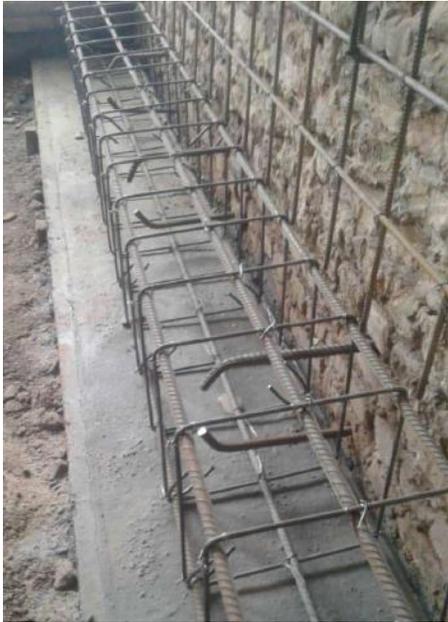
Reinforcement for the new reinforced concrete foundation beam (Credit: Enkon)

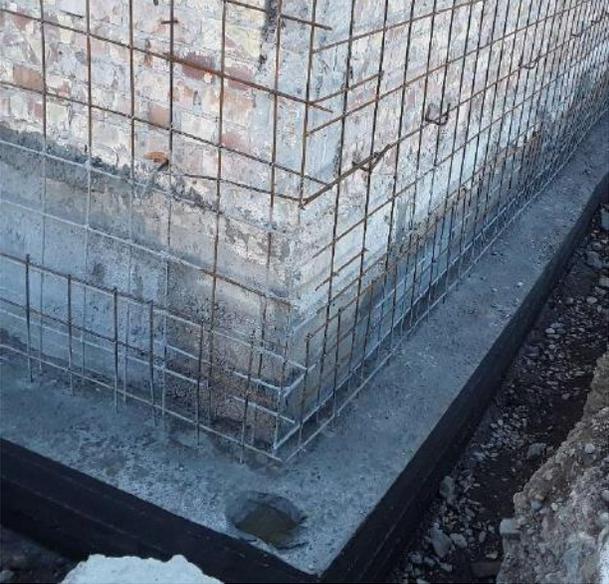
New foundation beams after the concrete construction

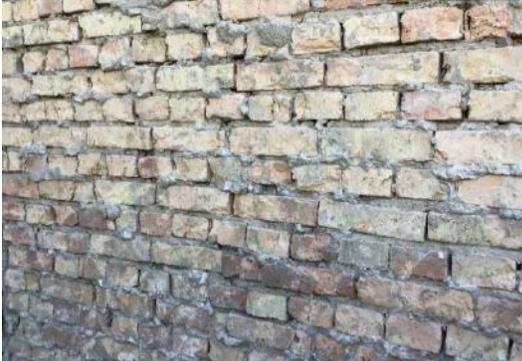
Wall surface needs to be prepared for retrofit by removing the original plaster

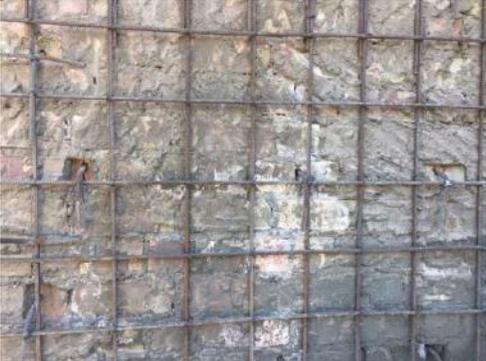
Inadequately cleaned wall surface (original plaster had not been completely removed)

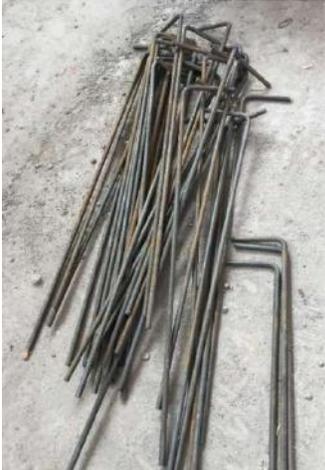
Anchors ready for the installation

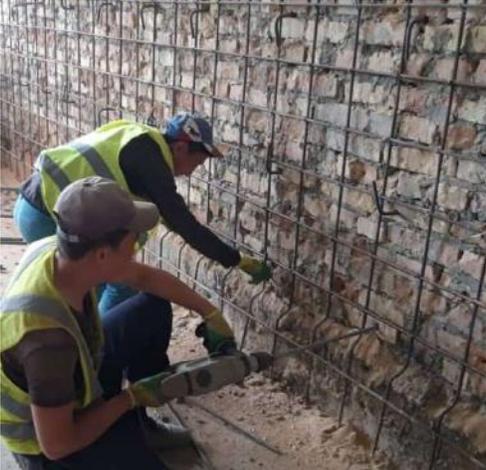
Drilling of holes in the wall for anchor installation (Credit: Enkon)

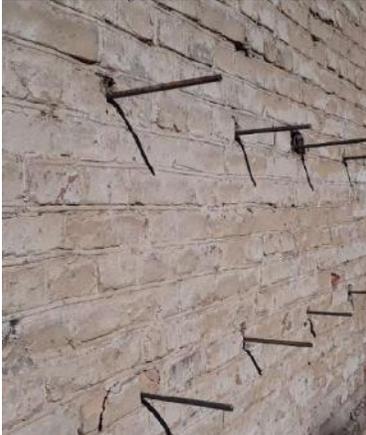
Wall anchors after the installation (note straight bars - before the bending of hooks)

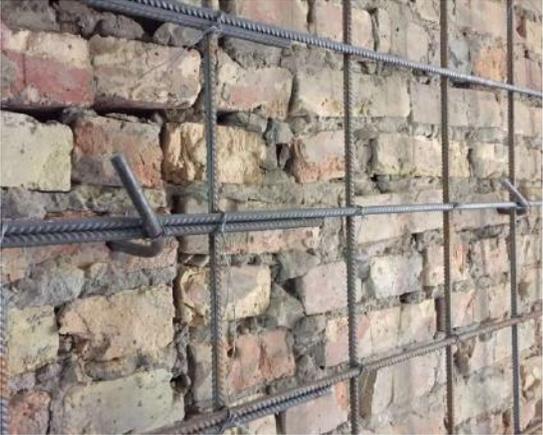
Wall anchors in the final position (after the wall reinforcement is placed and the anchor hooks were created)

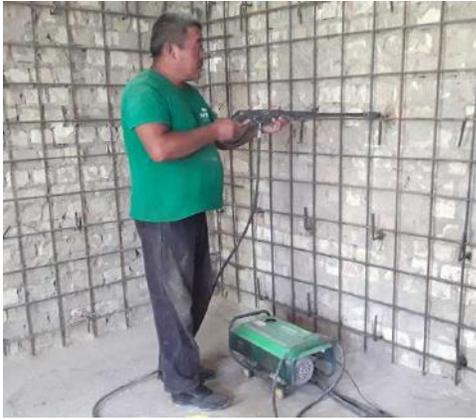
Injecting grout in anchor holes

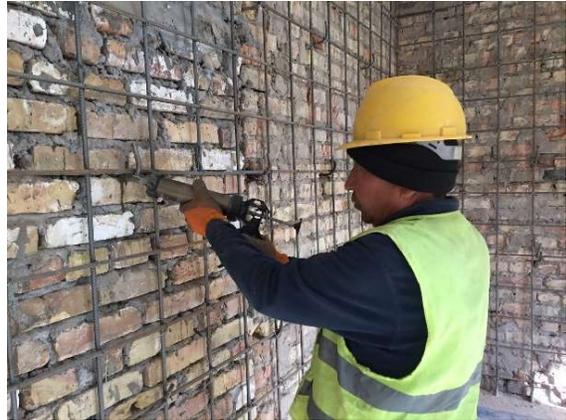
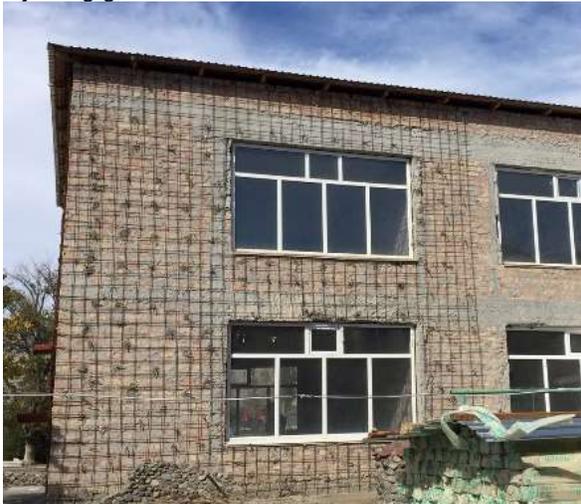
Exterior walls after the reinforcement installation

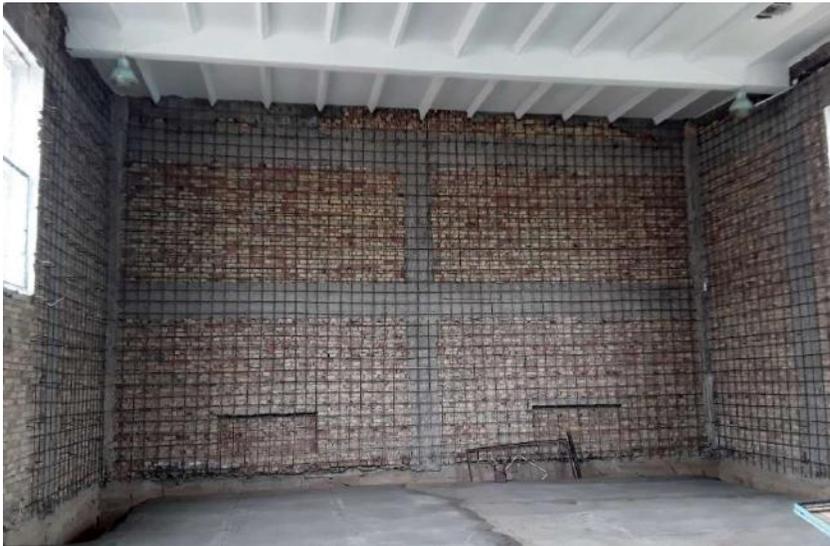
Interior walls after the reinforcement installation

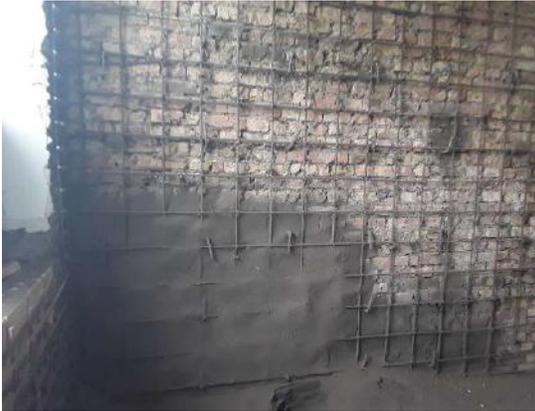
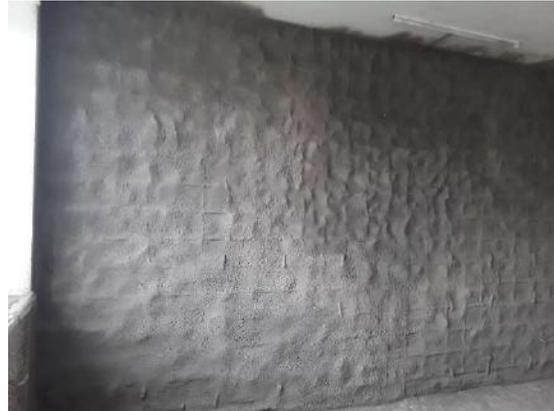
Reinforced wall surfaces are covered by the shotcrete (sprayed concrete) in 2 layers (photos show 1<sup>st</sup> layer)

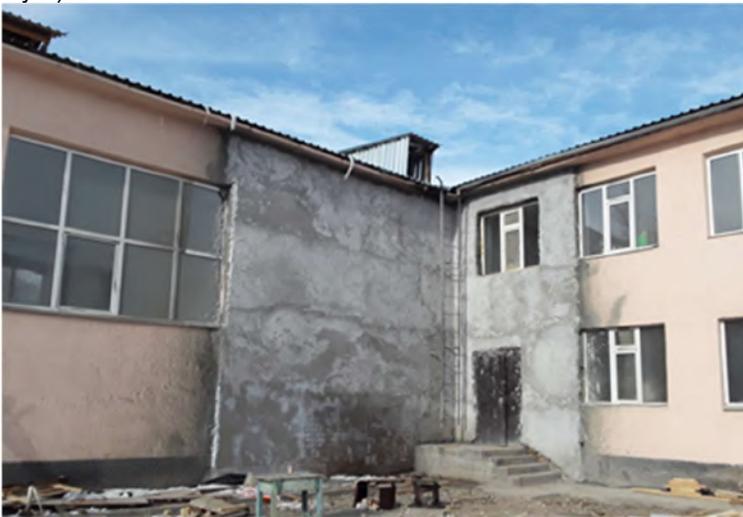
Exterior walls after the completed shotcrete application

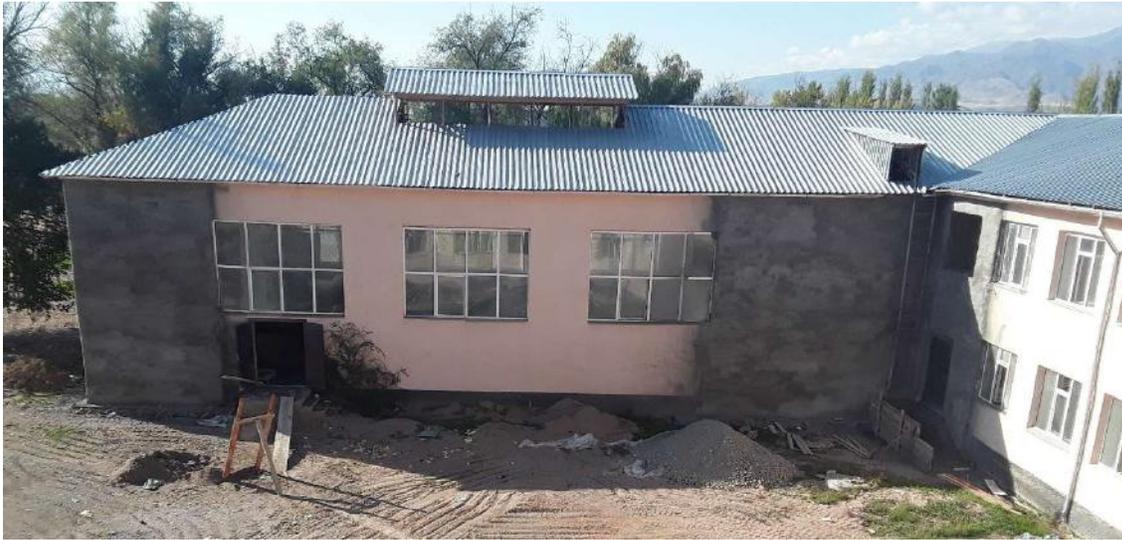
An exterior view of the building after the shotcrete application

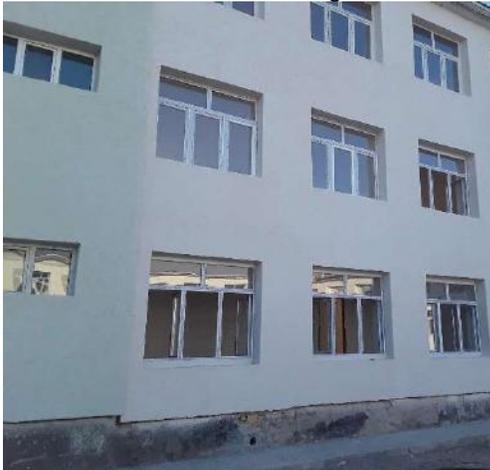
Exterior walls after the retrofitting
