Damage, Loss, and Needs Assessment for Disaster Recovery and Reconstruction after the low pressure system associated with Tropical Storm Ida

Prepared by the Government of El Salvador with the support of the international community

November 2009

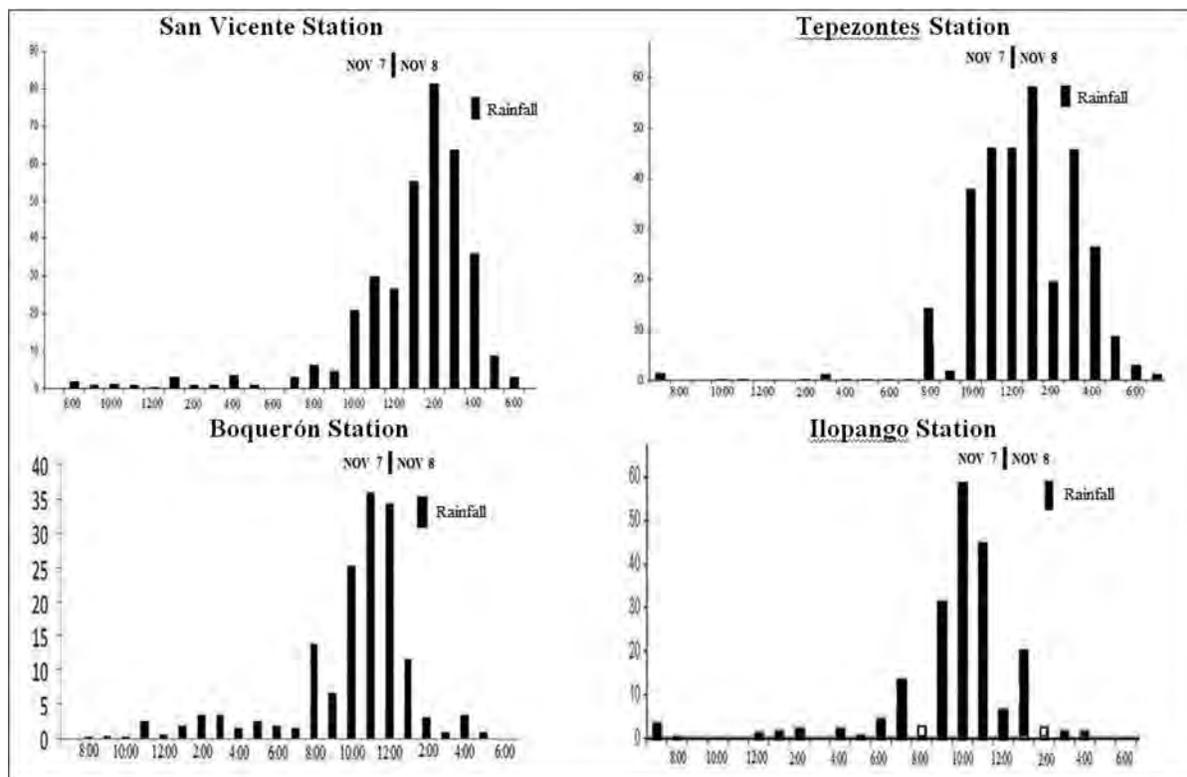
GRAPH 1. RECORDED PRECIPITATION

Precipitation recorded during the period between 7:00 a.m. on November 7th and 7:00 a.m. on November 8th at the weather stations of San Vicente, Tepezontes, Boquerón and Ilopango.

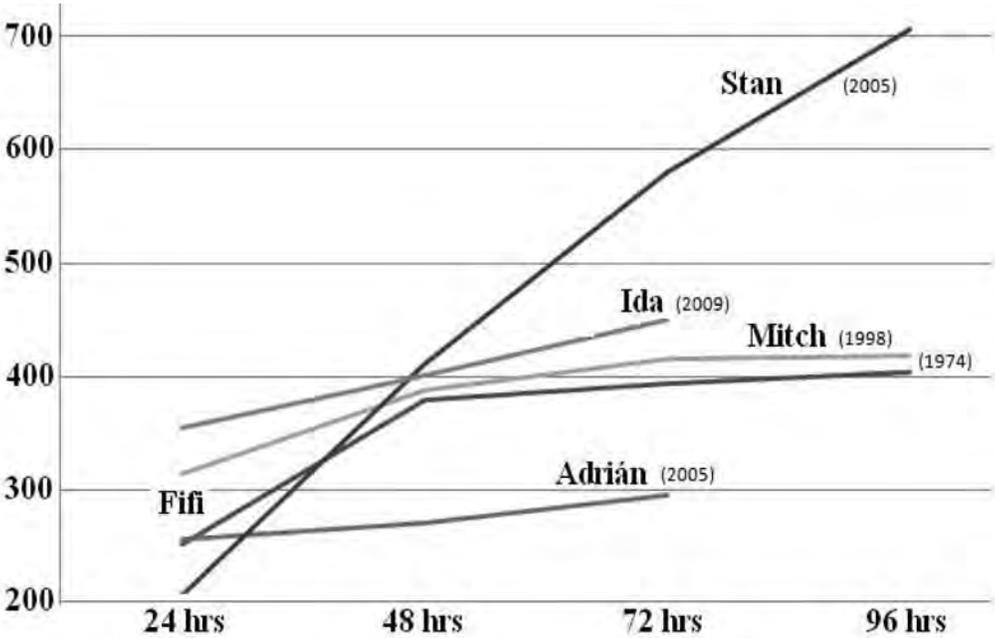
GRAPH 2. MAXIMUM LEVELS OF PRECIPITATION RECORDED IN THE ZONE OF SAN VICENTE DURING RECENT EXTREME EVENTS

The maximum critical levels of precipitation that cause landslides in the zone of San Vicente during tropical storms are above 200 mm and rain that exceeds 300 mm.

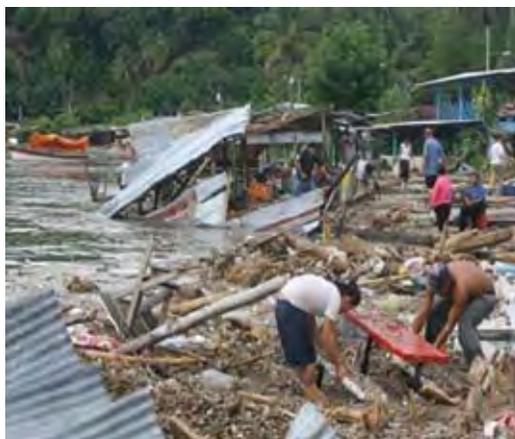
IMAGE 16. LAKE ILOPANGO

In terms of damages, aquaculture was the most affected, in the amount of US\$299,800, especially to pond gates. Production losses refer to captures that could not be made, totaling more than US\$1 million, divided into US\$857,000 for artisanal fishing and US\$179,000 for industrial fishing, including white shrimp, juvenile southern white shrimp and prawn.

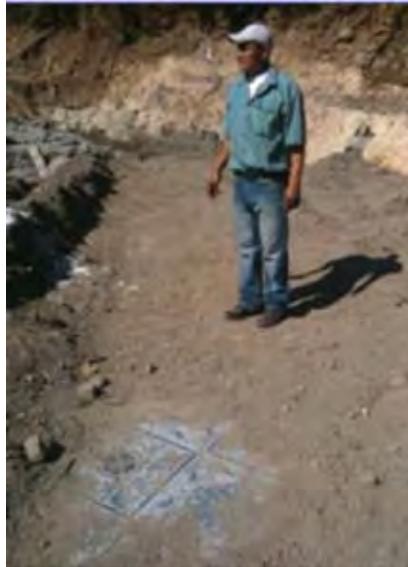
IMAGE 18. VERAPAZ

It is estimated that 3,003 homes were totally destroyed or were classified as being at high risk and could not be rebuilt on their original sites due to their exposure to future disasters. Applying urban standards of 140 m² per lot, which include the 30% needed for urbanization, the amount of land needed to relocate these homes is 42 hectares.

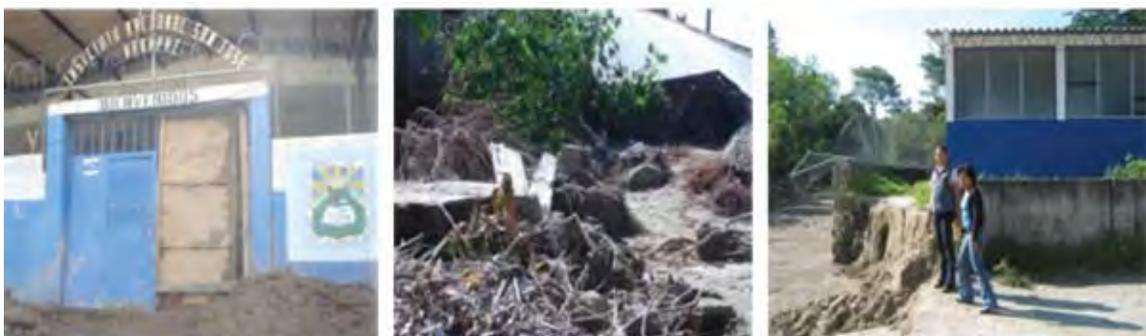
IMAGE 19. SCHOOLS

The classification of moderate damages takes into account all damages to roofs due to flooding and cave-ins, to gabions, temporary classrooms, fencing, floors and embankments. These damages totaled US\$2,146,995.

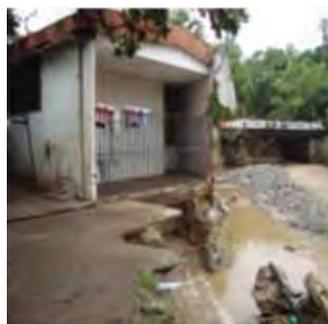
IMAGE 23. DAMAGES IN ISRI. DEPARTMENT OF SAN SALVADOR

The language and communication unit of the Salvadoran Institute for Comprehensive Rehabilitation (*Instituto Salvadoreño de Rehabilitación Integral* -ISRI) experienced serious flooding and a landslide on the land where it was built. Equipment to measure evoked potential, cameras, equipment for hearing tests,

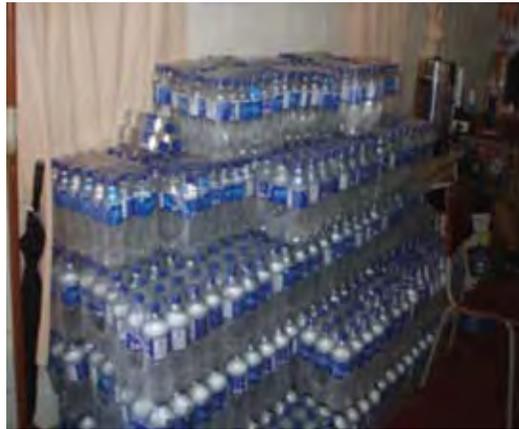
IMAGE 28. WATER FOR SHELTERS

In the cases of places that became isolated due to landslides, such as the municipality of Paraíso de Osorio in the Department of La Paz, ANDA used Air Force helicopters as a means of transporting drinking water, which was carried in a special device that contained 20 barrels.

Water provision was completed through the adoption of potabilization measures, as well as the installation of means to store water in shelters and the delivery of water tanks to families for water storage under optimum conditions. ANDA rented pipes to serve 36 shelters, a need that is expected to last three months; 10,000-liter plastic tanks were also supplied and installed.
